RESERVE STUDY

[YOUR PROPERTY NAME]

Report #: 17918-0

January 1, 2019 through **December 31, 2019**

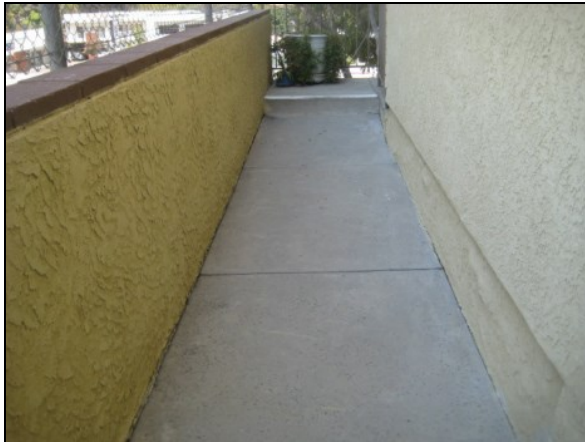
Comp #: 103 Concrete Sidewalk - Repair

Funded?: No. Typically a long life component. No anticipation to replace. Repair as needed out of Operating Funds, not Reserves

Comments: Signs of pitting, cracking, and fading were noted. Nothing appearing structural, all generally smooth and intact (no lifting or unevenness). Typically a long life component. No anticipation to replace.

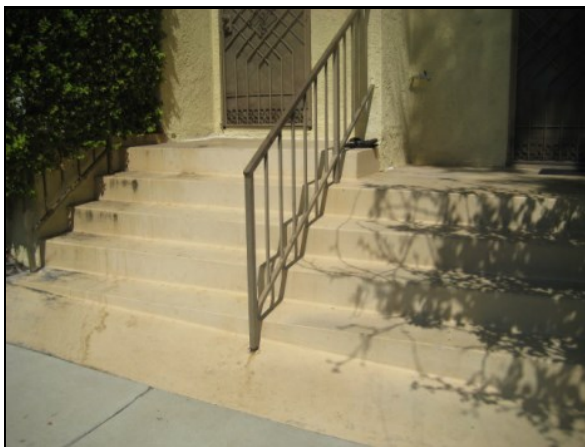
Comments: Significant staining and noted deterioration (surface worn through). Due for cleaning and painting at this time. Note: Best to coordinate with 106 Patio Deck Paint/Seal.

Higher estimate, some addnl repairs needed

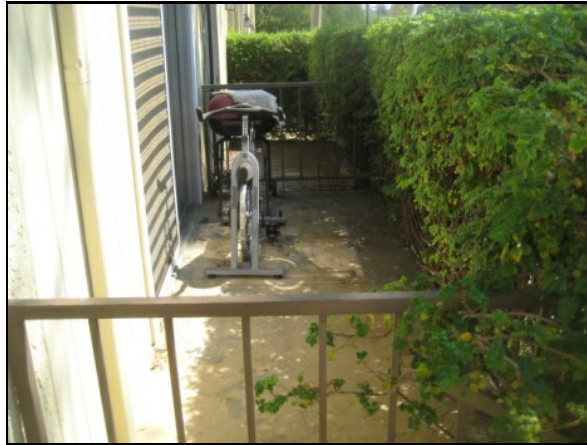
Comments: Significant staining and noted deterioration (surface worn through). Due for cleaning and painting at this time. Note: Best to coordinate with 105 Entry Deck/Stair Paint/Seal.

Higher estimate, includes addnl repair projects

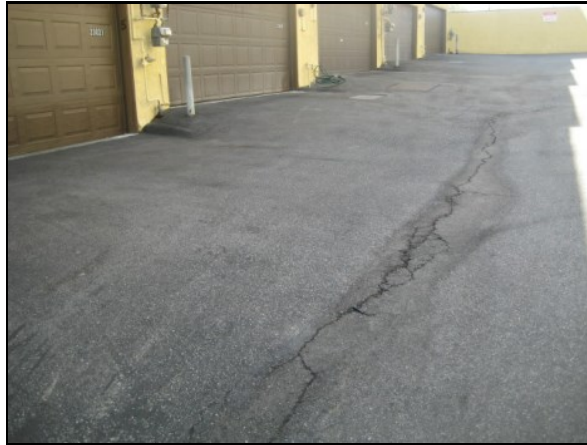
Comments: Smooth and driveable (no potholes or areas of significant alligating and failure) but significant lateral and longitudinal cracks. Functional but showing some age and normal deterioration due to age.

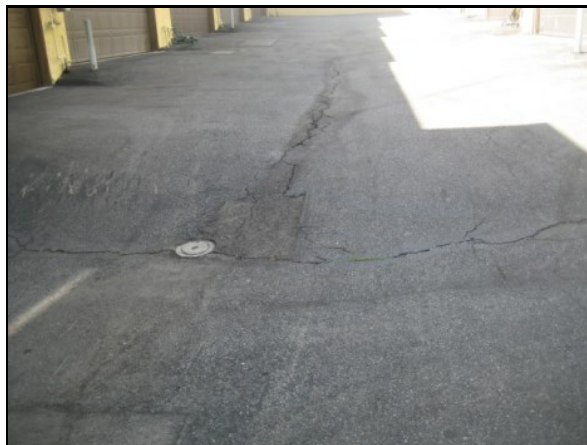
Comp #: 202 Asphalt - Seal/Repair

Comments: Surface is dry. Seal has worn off crowns of aggregate and seal has withdrawn and shrunk from aggregate. No looseness yet. Dryness evident in cracks appearing. Poor general condition due for sealing at this time.

Lower estimate to clean, seal, and repair,
\$.25/Sq Ft

Higher estimate, \$.35/Sq Ft (due to small quantity & crack repairs)

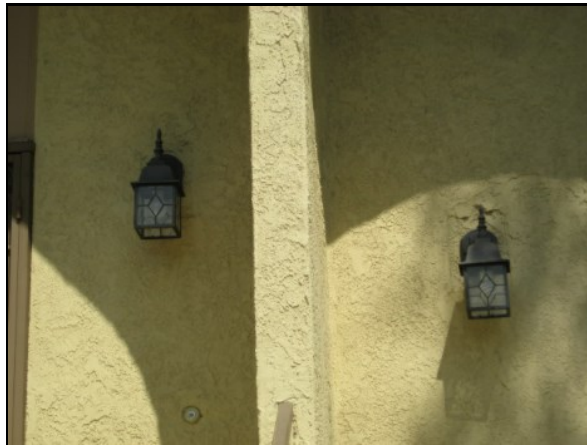
Comp #: 324 Wall Lights - Replace

Comments: Intact and assume all are functional (inspected during daylight hours). Showing age and surface dullness but no significant deterioration. Appears to be in fair condition overall.

\$100/light, lower estimate to replace

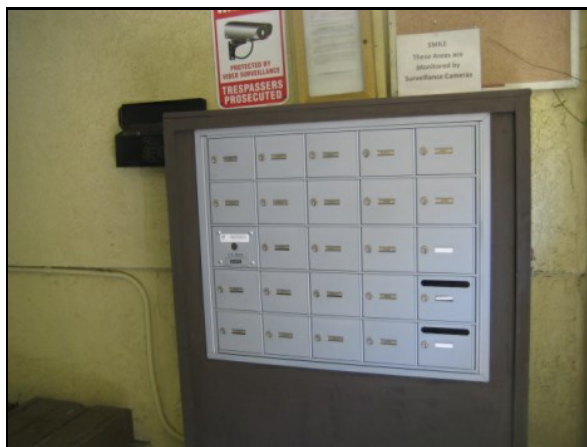
Comp #: 403 Mailboxes - Replace

Comments: Good condition. Still in relatively new condition. No deterioration (scuffing scratching pitting) noted to structure or surface finish.

Lower estimate to replace, \$50/box

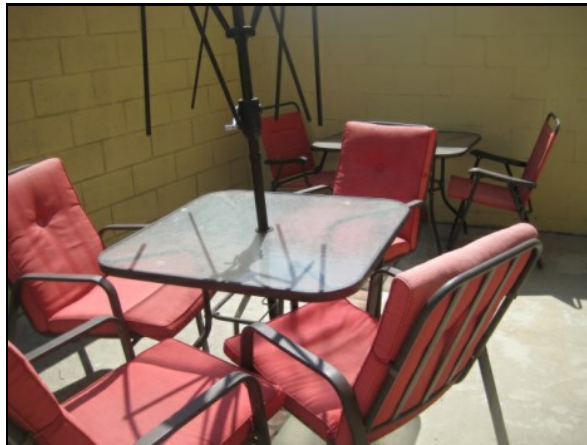
Comp #: 404 Spa Area Furniture - Replace

Comments: Six chair two table one sofa/lounge one coffee table. Metal frame pieces upholstered cushions. General poor & faded condition.

Lower estimate to replace with similar pieces

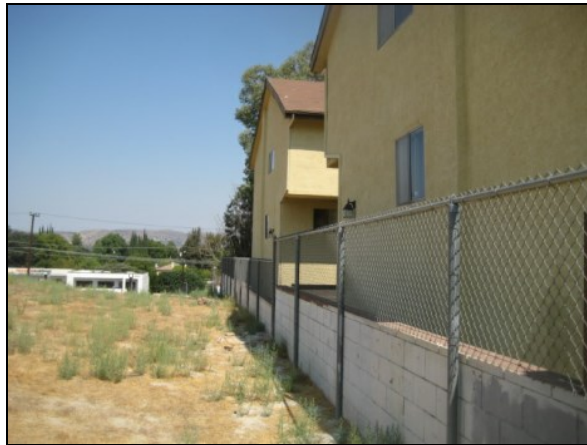
Comp #: 502 Chain Link Fence - Replace

Comments: Assume to be original and association's responsibility. Fair condition. Establishes a perimeter barrier to the association. No significant aesthetic purpose. No signs of significant deterioration (stretching leaning). Expect a long useful life.

\$23/LF, lower estimate to replace

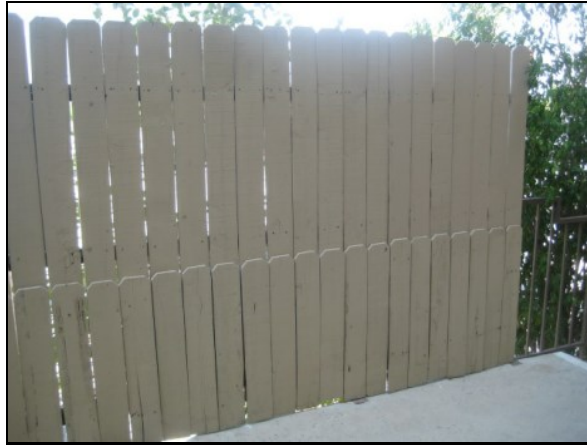
Comp #: 505 Wood Fence - Replace

Funded?: No. too small for Reserve designation. Replace as a minor operational budget project.

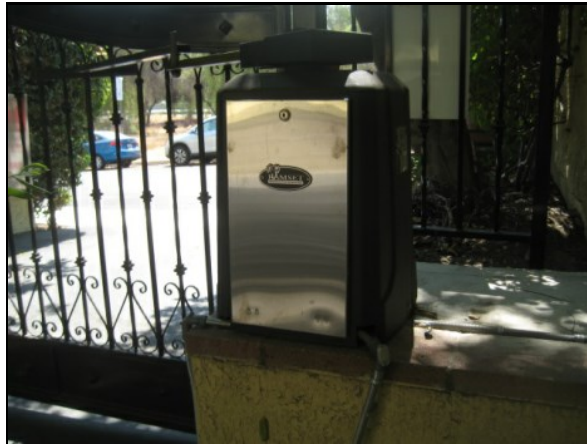
Comp #: 705 Gate Operator - Replace

Comments: (2) Ramset 300 openers. Both in fair to good appearing condition. East unit serial # 56619. West unit serial # 55987.

Observed in good functional condition.

Lower estimate to replace, similar size/type units

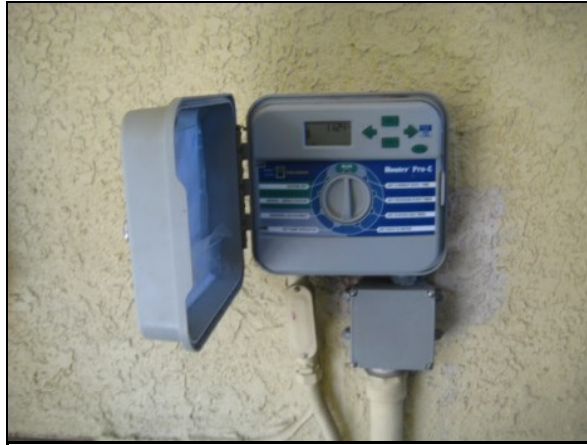
Comp #: 1003 Irrigation Controller - Replace

Funded?: No. Too small cost for Reserve designation. Replace as a minor operational landscape project as necessary.

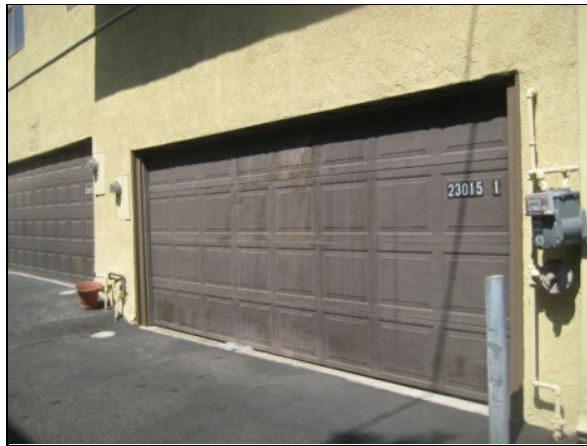
Comments: General poor condition. Dry, faded, and discolored. Aluminum sectional roll-up doors. In need of paint at this time for aesthetic reasons. Note that replacement is the responsibility of individual home owners, per Governing Docs.
