Client: 9999HR Sample High Rise

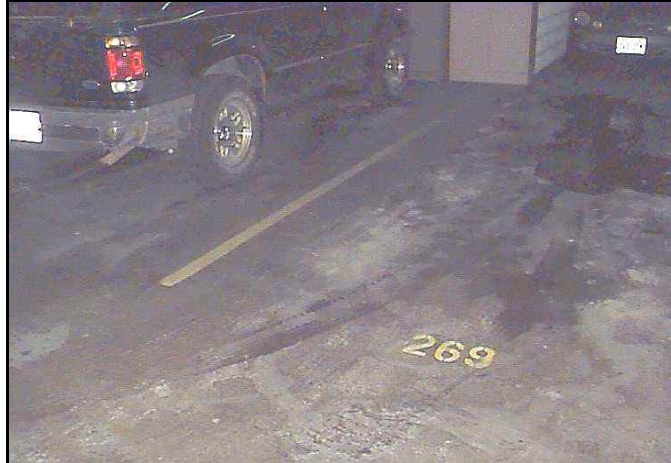
**Comp #:** 205 Concrete Pkg Surface - Repair

Evaluation: Parking is owned by another organization, of which this association has a share. Therefore not the primary maintenance responsibility of this association. Funded through monthly contributions to that other organization.

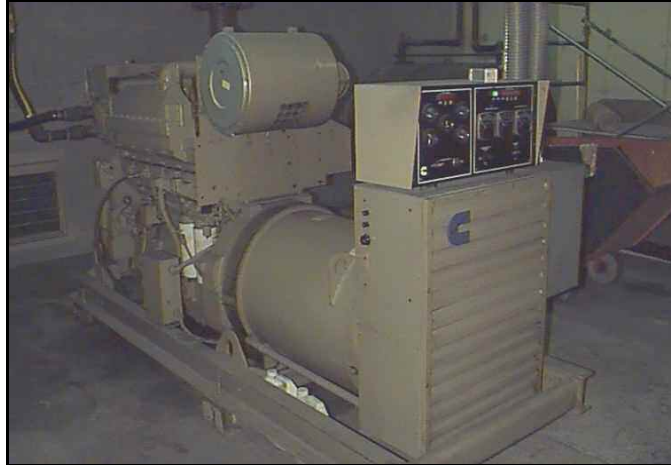
**Comp #:** 302 Generator - Replace

Evaluation: Unit currently has only 519.5 hrs of use. Run weekly, and serviced professionally every 6 mos. Under this work load, expect only minor service-related repairs, not total replacement.

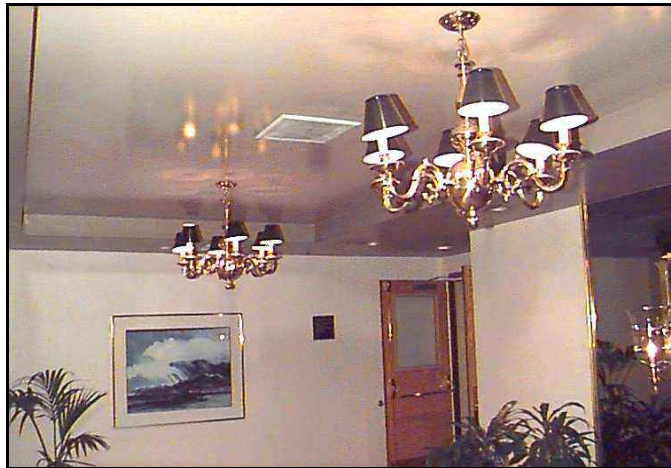
**Comp #:** 304 Light Fixtures - Replace

Evaluation: Lights are still attractive and in good functional condition. Expect very extended life from current fixtures.

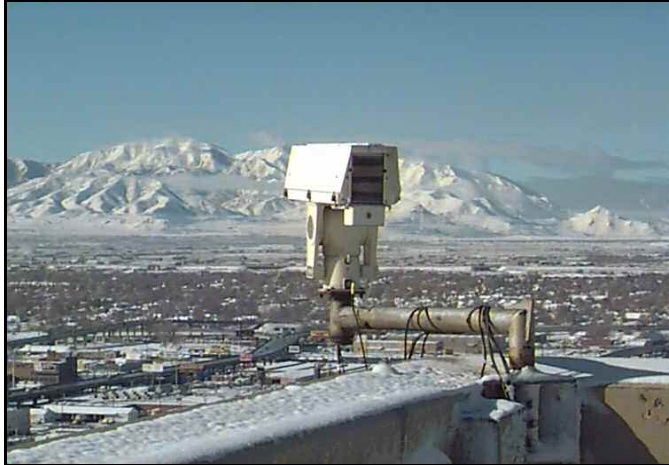
**Comp #: 305 Closed Circuit TV - Replace**

Evaluation: Generally functional, not all cameras & monitors working. Expect ongoing effort to repair components locally will keep system working indefinitely.

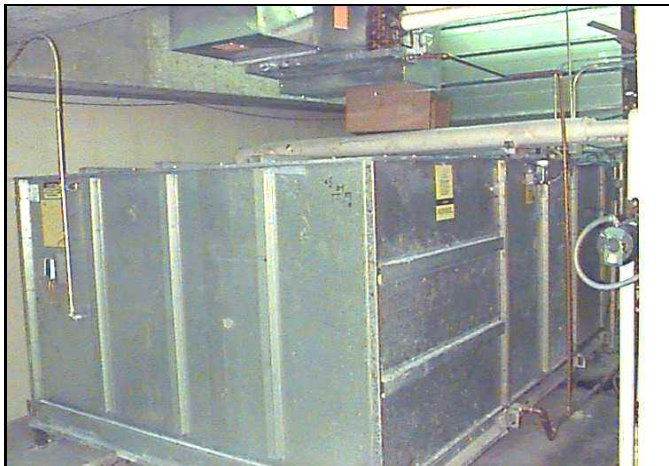
**Comp #: 306 Air Handlers - Replace**

Evaluation: Bearings and motors require continual repairs and service. Expect random failures, but not annually. Best to plan for more significant repair expenses at approximately this interval.

Lower estimate for periodic air handler repair expense

Higher labor and materials estimate

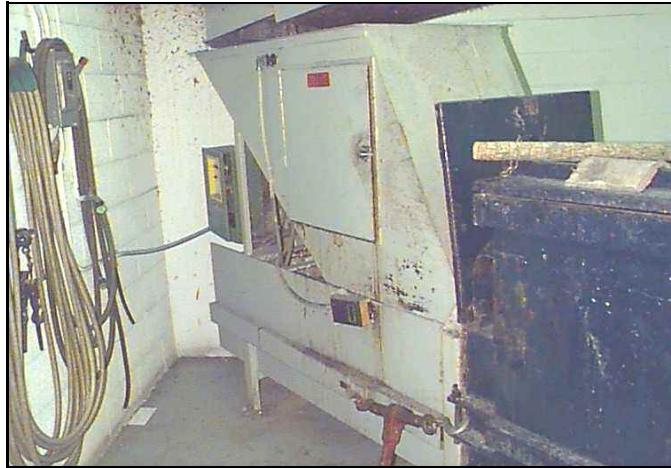
**Comp #: 308 Trash Compactor - Replace**

Evaluation: Fair, good functional condition, showing age. Serviced as required, cleaned as needed. No current problems.

Best Case: \$10,000.00  
Lower estimate for major repairs to two units

Worst Case: \$18,000.00  
Higher estimate, replacement

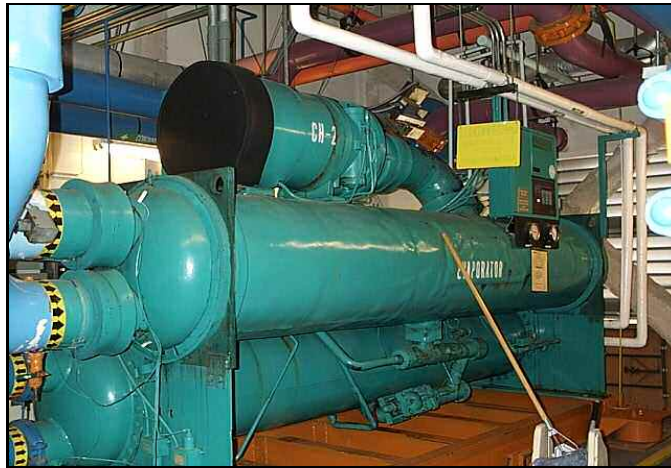
**Comp #: 309 Chillers - Replace**

Evaluation: Good general operational condition. No problems at this time, just normal age. Good regular professional service.

Best Case: \$200,000.00  
Lower estimate to replace two chillers (installed)

Worst Case: \$250,000.00  
Higher equipment or installation costs

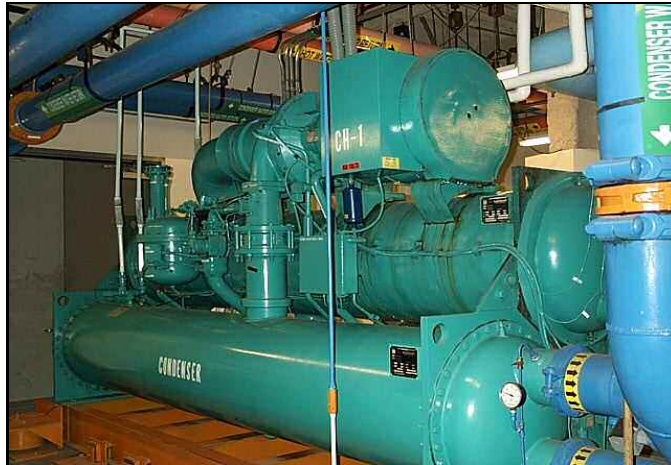
**Comp #: 309 Chillers -Retrofit**

Evaluation: Units received their normal four year retrofit last year. Continued alternating use means no exceptional high duty cycles. Four year retrofit program has been very successful through association's history, expect to continue that successful pattern.

Lower estimate for labor and materials

Higher labor and materials estimate

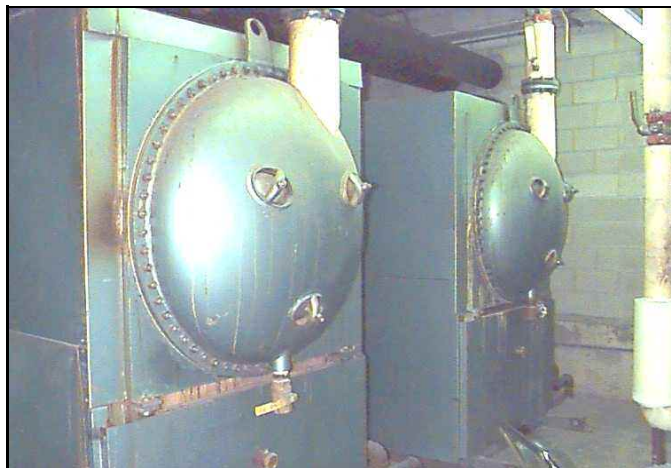
**Comp #: 310 Boilers - Refurbish**

Evaluation: Both had major scheduled maintenance (retubed) last year. Boilers operate in an alternating manner. Expect very extended life with refurbishment every five years.

Lower estimate for retubing project, two boilers

Higher estimate, includes some addn'l. other projects
