Client: 9999W Sample Worship Facility

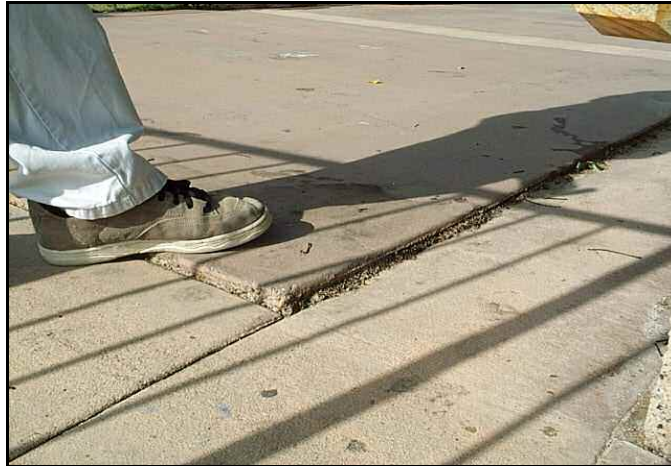
Comp #: 103 Concrete Deck/Walk - Repair

Evaluation: General fair condition. Local lifting around central planter area (see photo). Expect some local grinding will be required to minimize "trip & fall" hazard. Some mineral staining at patio, may need chemical wash or scrub. Concrete is typically a long life or lifetime component. Minor repairs may be required but should be considered a maintenance issue.

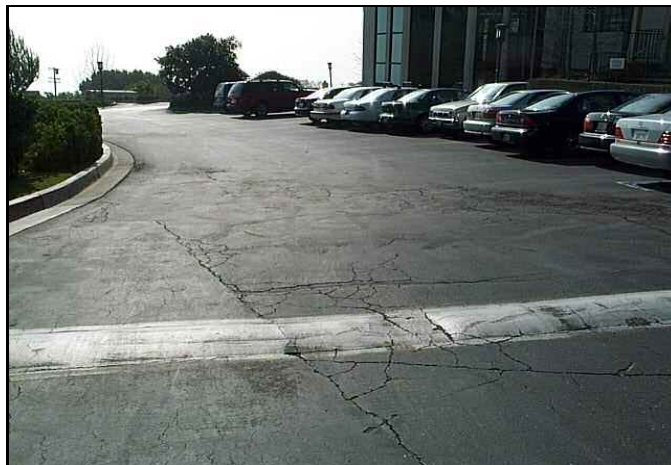
Comp #: 201 Asphalt - Resurface

Evaluation: Fair general structural condition (no unevenness or significant potholes). Local cracking throughout, some growing to significant size. Expect a full resurface with a Petromat underlayment will be required due to quantity of cracks.

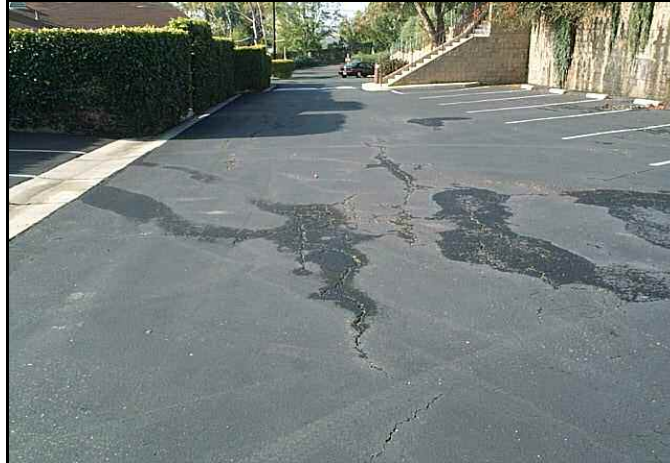
Comp #: 202 Asphalt - Seal/Repair

Evaluation: Both lower and upper lots have many cracks. Both areas in need of significant crack sealing in addition to seal coat. Significant water bleeding up through lower lot (see photo) shows surface is not watertight.

Best Case: \$4,225.00
\$.10/Sq Ft, estimate to seal coat only

Worst Case: \$6,300.00
\$.15/Sq Ft, includes minor patching & repairs

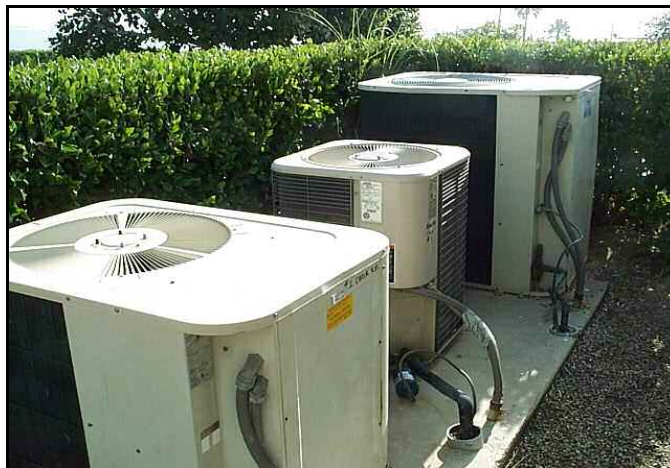
Comp #: 303 HVAC Units - Partial Replace

Evaluation: Intact and functional. One replaced in 7/97, others are of older vintages. Due to limited use and varying demands of different units, no expectancy to replace all at same time. Funding is for averaged repairs and partial replacements.

Best Case: \$8,000.00
Lower estimate for replacement of approximately two units

Worst Case: \$12,000.00
Higher estimate for additional installation

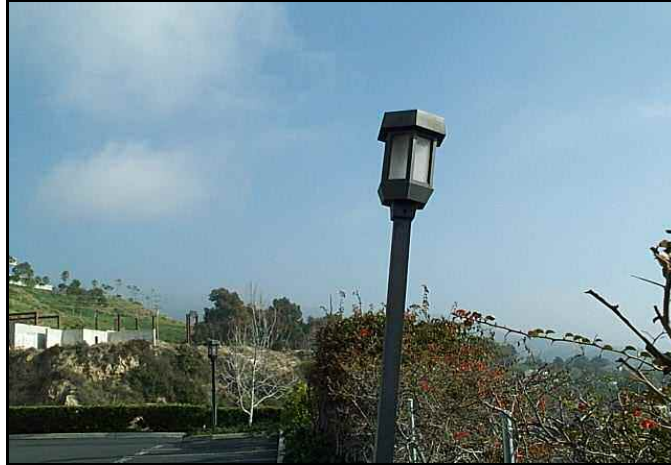
Comp #: 320 Pole Lights - Replace

Evaluation: Inspected during daylight hours, these fixtures are assumed to be functioning properly. No major problems noted at this time. Some bending and surface finish loss noted, one slightly leaning (see photo). New in approx 1986.

Best Case: \$25,300.00
\$1100/fixture; Estimate to replace with similar fixtures, installed

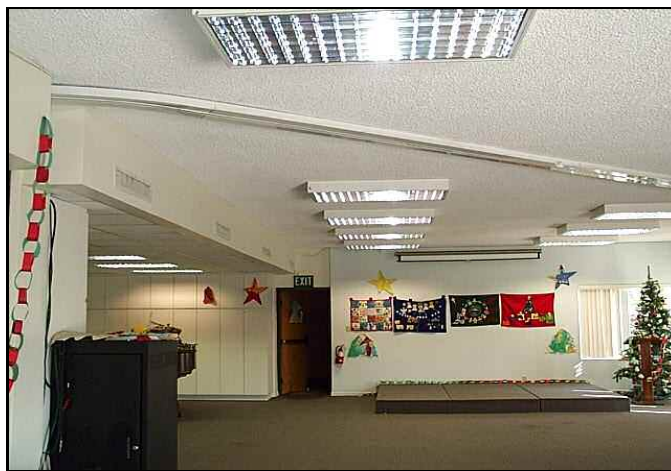
Comp #: 325 Interior Lights - Replace

Evaluation: Good, these fixtures are operating normally. If not abused, these lights have an extended useful life, no Reserve funding needed. Replace individually or in local groupings as a stylistic change.

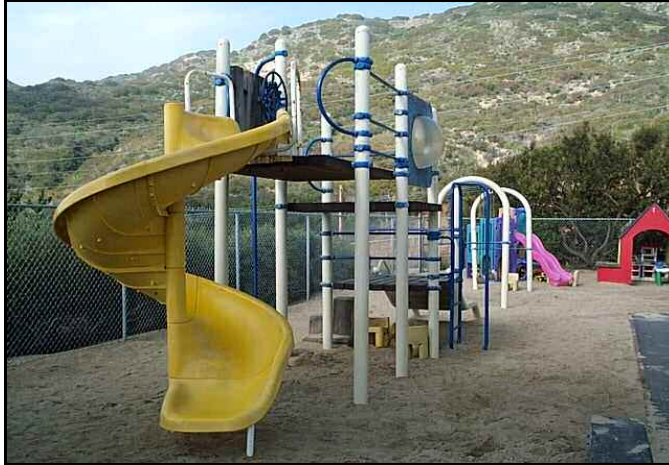
Comp #: 405 Play Equipment - Replace

Evaluation: (1) 3-level play structure with spiral and straight slide, plus one slide pole. (1) swing set with (2) swings. Minor rusting and surface finish loss due to age and outdoor exposure. Touch-up paint would help appearance.

Best Case: \$16,000.00
Estimate to replace

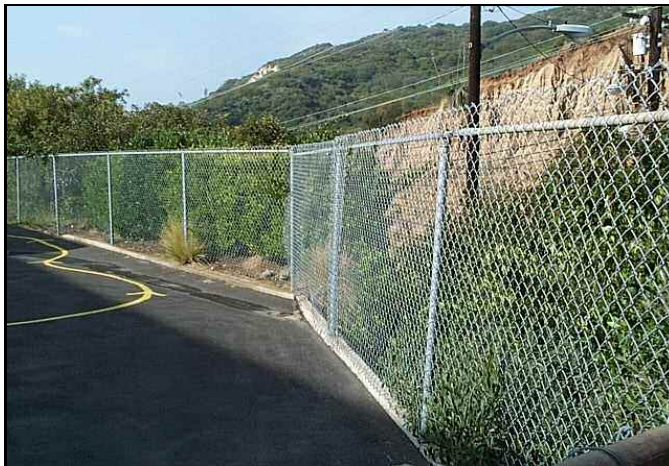
Comp #: 502 Chain Link Fence - Replace

Evaluation: Fence appears in good shape. Sturdy, no holes, no rippling, no rust or corrosion noticeable. Long life anticipated, no significant aesthetic requirements.

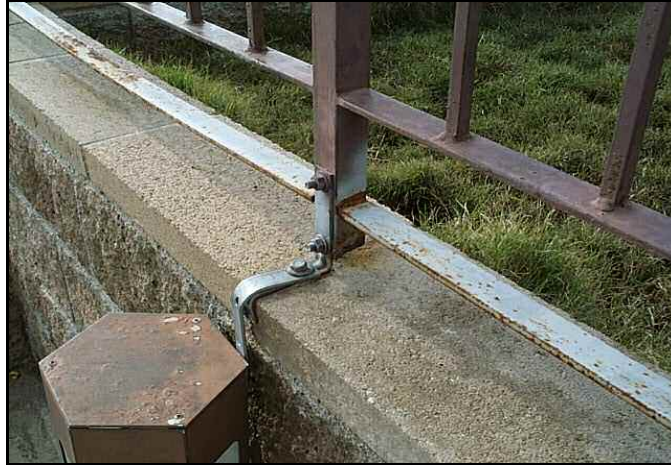
Comp #: 503 Iron Fence/Rail - Replace

Evaluation: Wobbly in areas, many repairs noted. Reportedly installed in 1986. Expect continued local repairs as required, and due to amount of repairs expect total replacement will be eventually required.

Lower estimate for replacement fence/rail,
\$30/Linear Ft

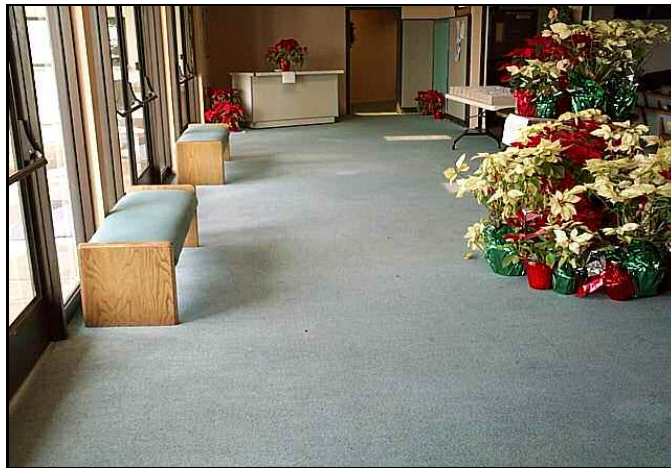
Comp #: 601 Hallway-Foyer Carpet - Replace

Evaluation: Low knap carpet. Fair to poor condition, showing some significant wear and fading. Best to coordinate with worship recarpet project.

\$25/Sq Yd, replacement carpet, installed
