# VACATION OWNERSHIP RESORT

## RESERVE STUDY

[YOUR PROPERTY NAME]

Report #: 17918-0

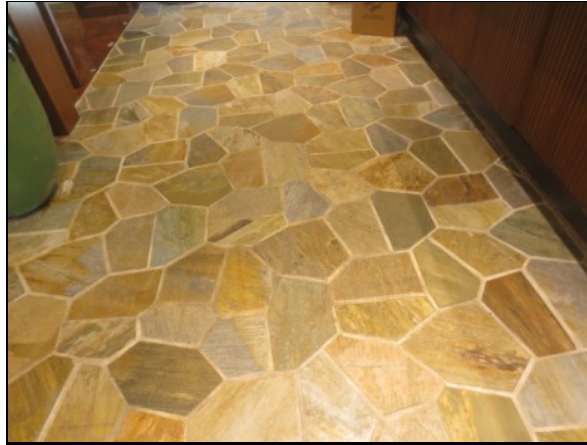
Comments: Stone surfaces looked clean and showed general traffic patterns. No cracks or significant abrasions detected. In good condition. There is no expectation for a full replacement. A funding allowance has been provided for periodic repairs.

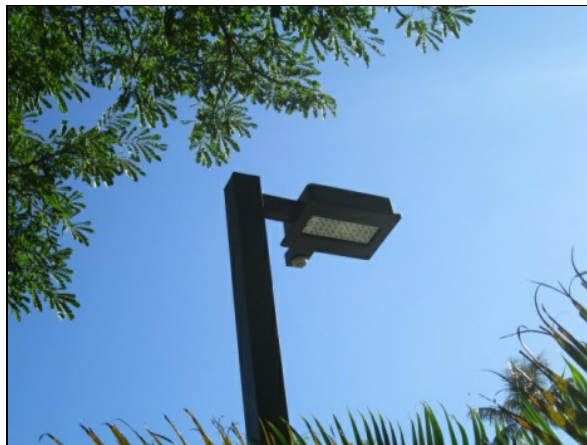
Comments: Inspected during daylight hours but assumed to be functional. Fixtures are upright stable and aging well. In good condition. It is best to eventually replace all of the pole lights at the same time to maintain a uniform appearance. Clean the fixtures on a regular basis to ensure full illumination.

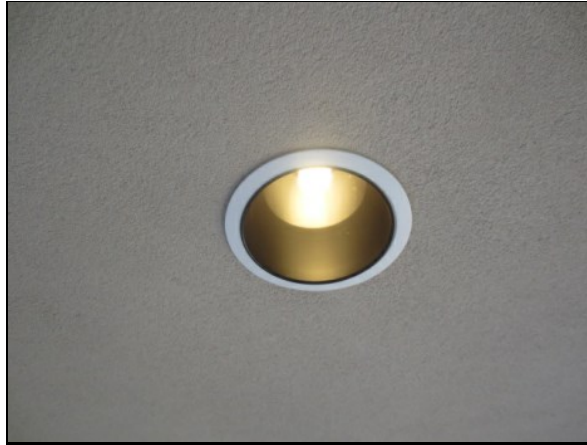
Comments: Fixtures were all in functional condition during inspection. No advanced damage or abuse noted. In good overall condition. Best to clean fixtures regularly to ensure full illumination. Plan on eventual replacement to maintain appearance.

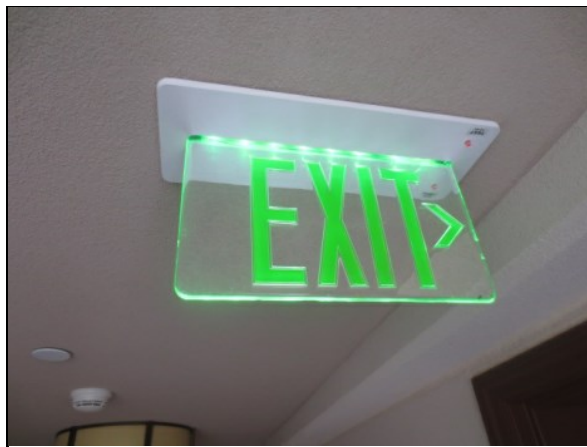
Comments: Fixtures were not tested during inspection. Exit signs were illuminated and functioning properly. No issues were reported at this time. No severe damage or abuse observed. In good condition. Plan on eventual replacement all at once to maintain a uniform appearance.

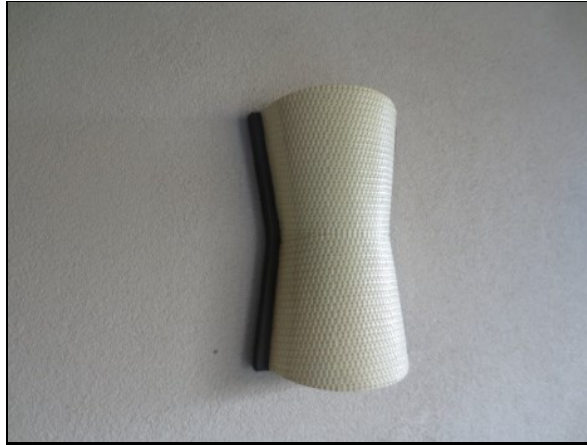
Comments: Inspected during daylight hours but assumed to be functional. Lights were intact and aging normally. No surface damage evident on any of the fixtures. In good condition. Plan on eventual full replacement to maintain a uniform appearance.

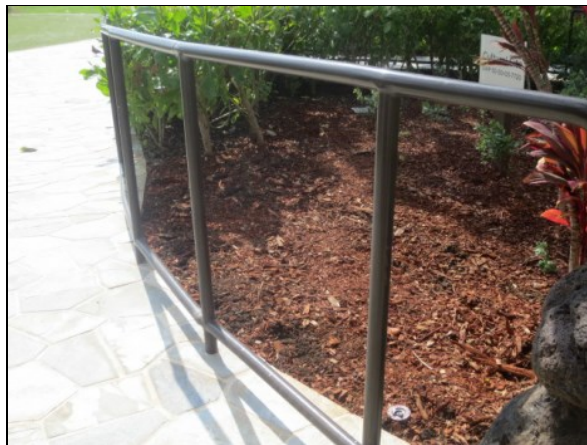
Comments: Railings were intact and in good condition. There is no expectation to replace all at once. Funding has been provided for periodic repairs/partial replacements to maintain this asset.

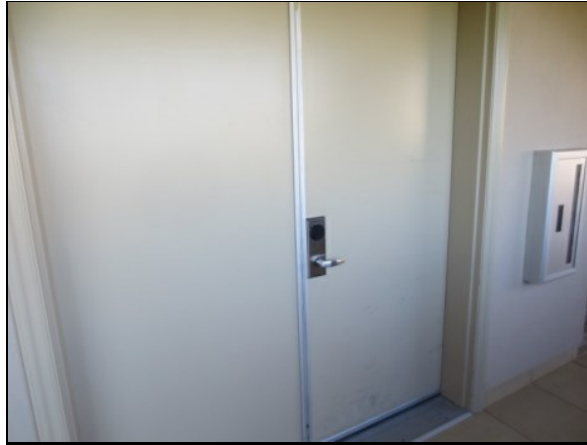
Comments: Common area doors are showing heavier signs of use compared to the unit entries. Best to repaint these doors more often to maintain a clean welcoming appearance. In fair overall condition. Plan on eventual replacement to ensure reliability.

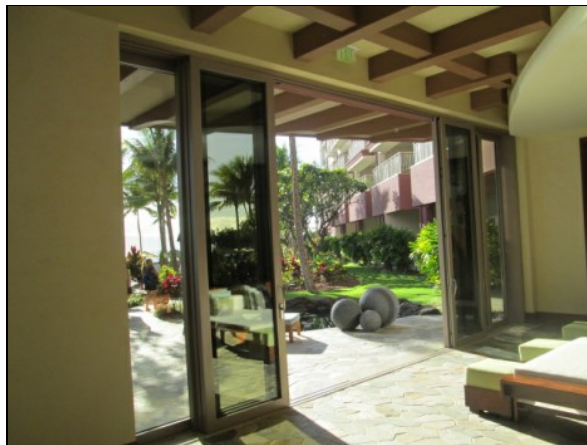
Comments: Doors were observed to be functional during inspection. Original doors were replaced due to functional issues. No significant damage was evident to the doors or their track system. In good and attractive condition. Best to have the glass cleaned regularly to maintain a welcoming appearance in the lobby area.
