# RESERVE STUDY

## MUNICIPALITIES or COMMERCIAL PROPERTIES

Report #: 17918-0

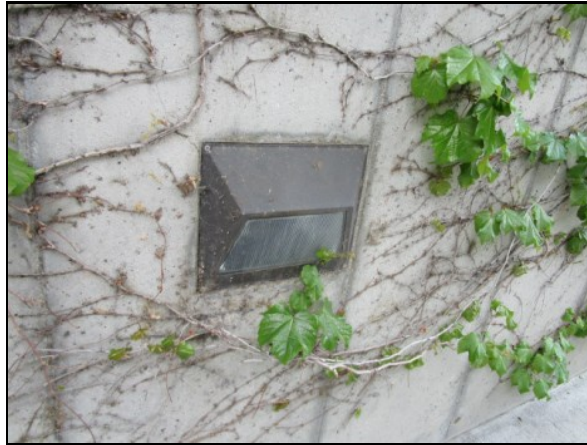
Comments: Inspected during daylight hours but assumed to be functional.

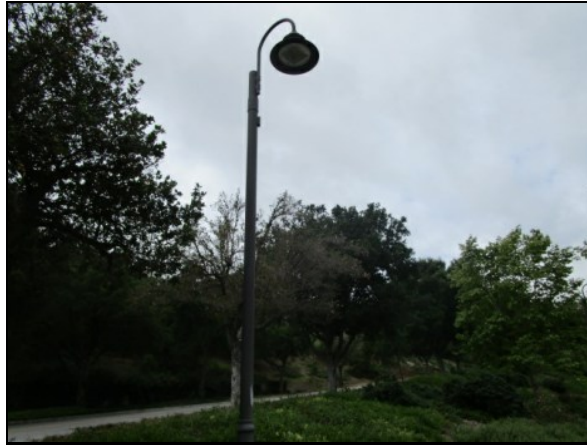
Comments: Inspected during daylight hours but assumed to be functional. Upright and sturdy with no signs of advanced damage or abuse. In fair condition. It is best to eventually replace all of the pole lights at the same time to maintain a uniform appearance. Clean the fixtures on a regular basis to ensure full illumination.

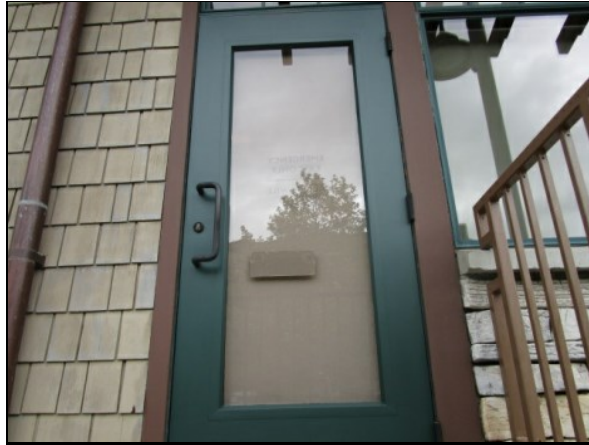
Comments: Minor wear observed but no significant deterioration witnessed at this time. Paint coverage is in good condition. Stick to repaint cycles to maintain aesthetics and to help achieve full useful lives of these assets.

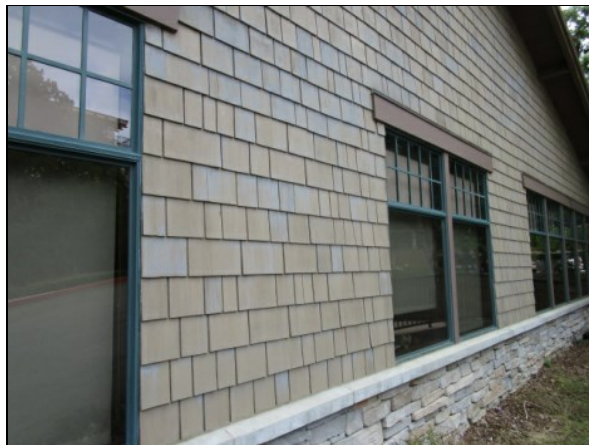
Comments: Consists of the roof perimeter's wood trim center trellis and wood shingle siding. Signs of dryness and cracking. Paint coverage is in declining condition. Regular paint cycles will help protect the wood surfaces from damaging weather elements that cause dry-rotting and warping.

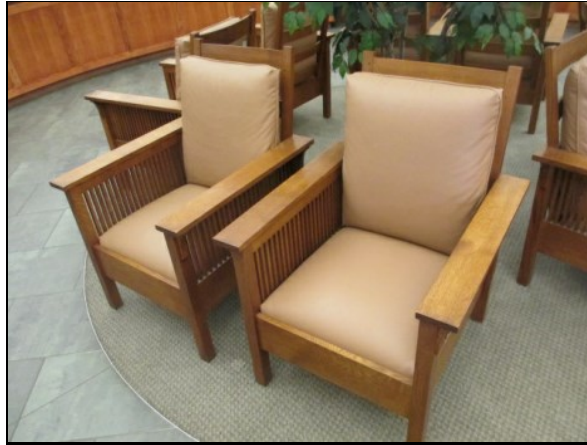
Comments: Varying styles noted but all furniture appears to be in generally good serviceable condition. Normal wear and aging noted but no widespread tearing or staining.

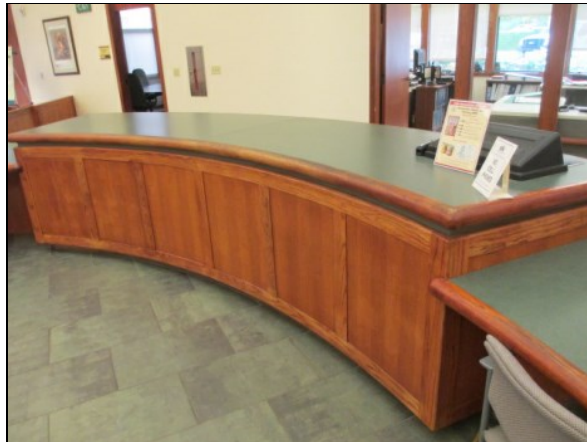
Comments: The cabinetry and counters are intact and in fair condition. Some peeling noted on the composite base cabinets located in higher traffic work areas. No severe scuffing or warping noted. In fair condition.

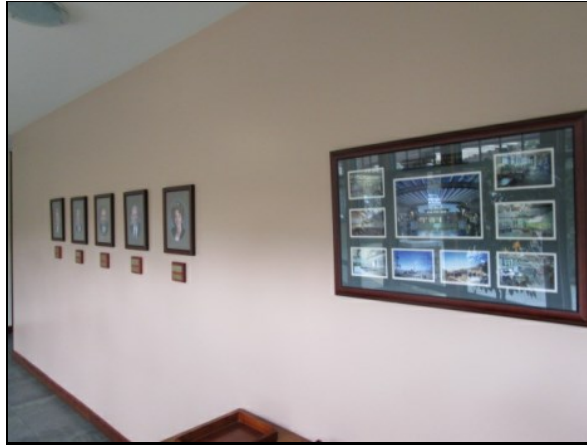
Comments: The interior surfaces are in fair condition. Normal wear and scuffing observed but no signs of any extensive discoloration or paint loss. Best to repaint regularly to ensure the surfaces remain bright and appealing.

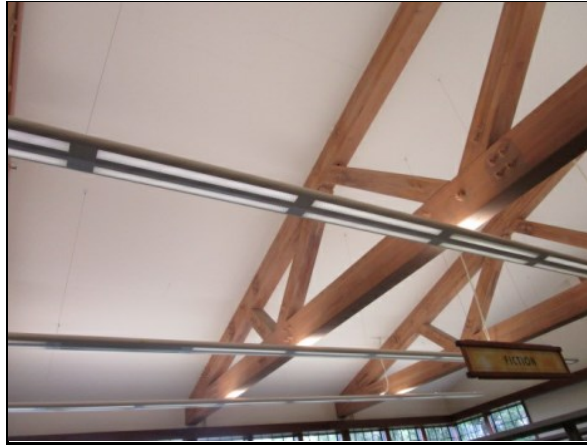
Comments: Wood is attractive and in good condition. Due to the interior location expect to repaint these surfaces on a longer cycle than the exterior wood surfaces.
