# RESERVE STUDY WORSHIP FACILITIES

[YOUR PROPERTY NAME]

Report #: 17918-0

Level of Service: **Reserve Study- FULL****July 1, 2019 through June 30, 2020****Findings & Recommendations****as of July 1, 2019**

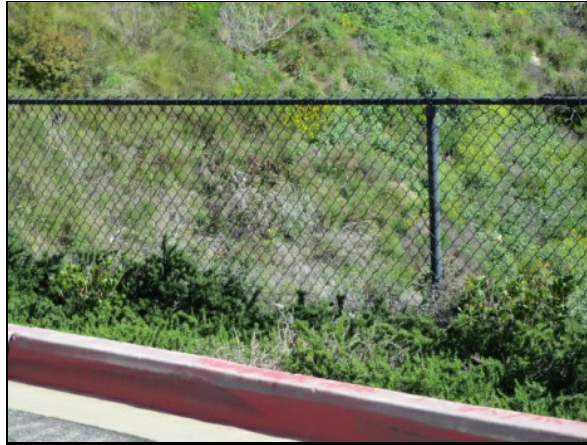
Comments: The chain link fence is aging normally. No heavy warping or leaning noted. Good apparent conditions. Chain link typically requires very little maintenance.

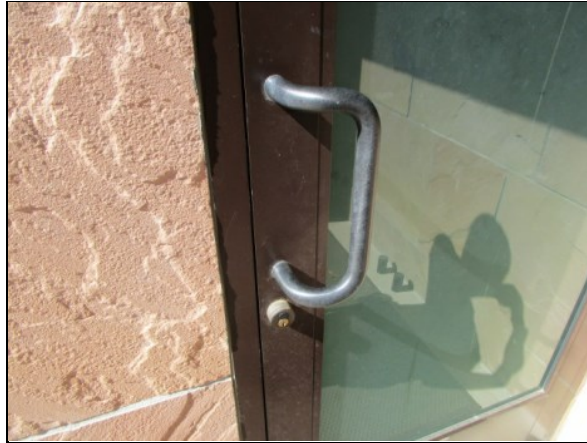
Comments: This component provides funding for periodic re-keying to ensure the site remains secure with all keys accounted for. Plan to complete any necessary door replacements alongside this project for efficiency.

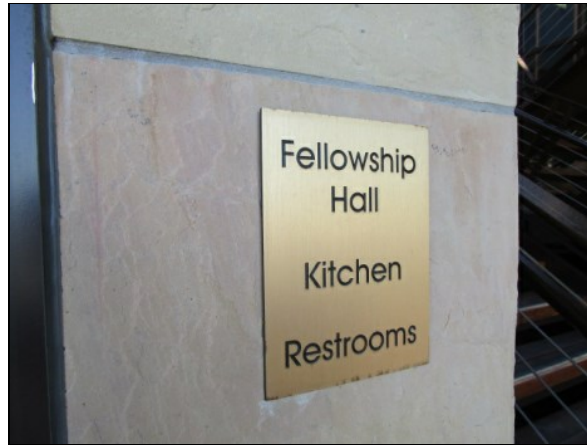
Comments: The directional signs are intact and legible. Generally attractive (presenting a good first impression). No tarnishing or abuse observed. Plan to replace all of the signs at one time to maintain the aesthetic uniformity.

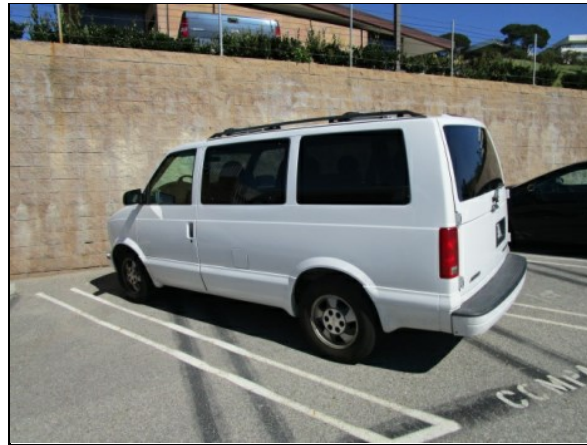
Comments: The van is older but appears to be fully serviceable. At long intervals plan to replace the van to ensure continued good operation.

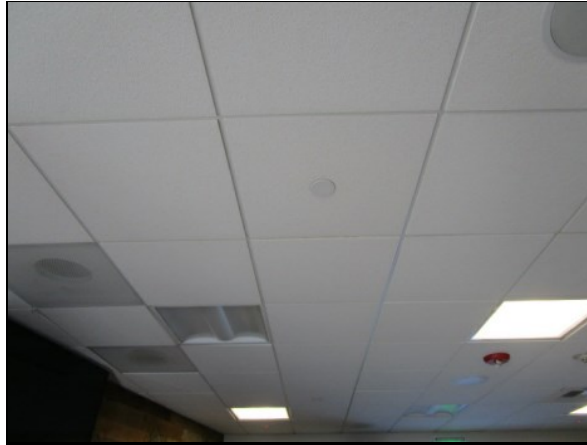
Comments: Acoustic ceiling tiles typically reach very long useful lives but eventually the fibers and materials begin to break down necessitating replacement. Due to the high cost this component provides funding for periodic replacement.

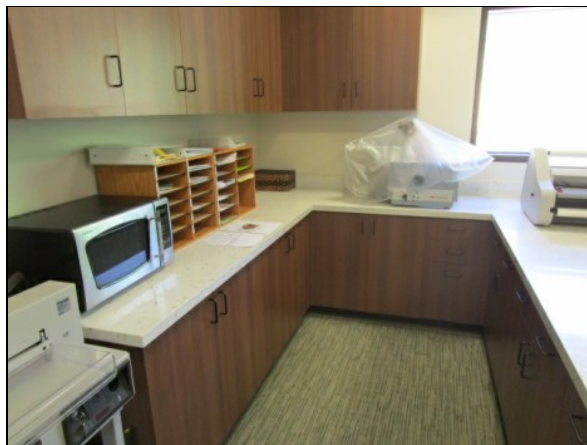
Comments: Includes approximately 57 LF of upper cabinets 128 LF of base cabinets 30 LF of floor-to-ceiling cabinets and 114 LF of counters. The surfaces vary in condition depending on level of usage but all cabinets and counters appear to be aging well. No broken or inoperable fixtures noted. As complete replacement is highly unlikely funding has been provided for regular refurbishment and repairs.
