SAMPLE  
Reserve Study

FULL

Level of Service: **Reserve Study- FULL****January 1, 2019 through December 31, 2019****Findings & Recommendations****as of January 1, 2019**

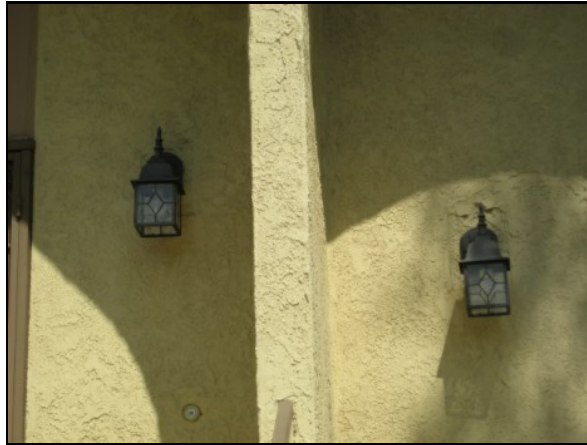
Comments: Intact and assume all are functional (inspected during daylight hours). Showing age and surface dullness but no significant deterioration. Appears to be in fair condition overall.

Useful Life:  
20 yearsRemaining Life:  
3 years

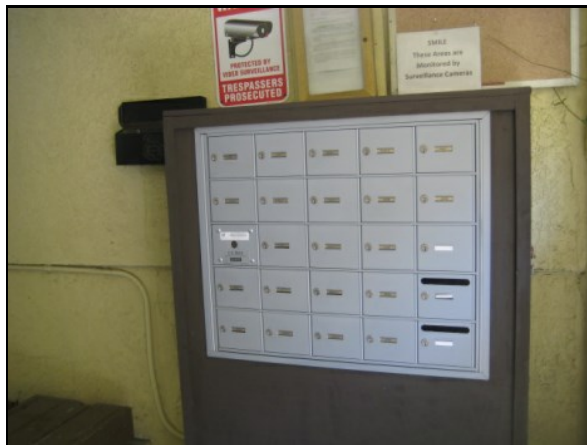
Comments: Good condition. Still in relatively new condition. No deterioration (scuffing scratching pitting) noted to structure or surface finish.

Useful Life:  
15 yearsRemaining Life:  
13 years

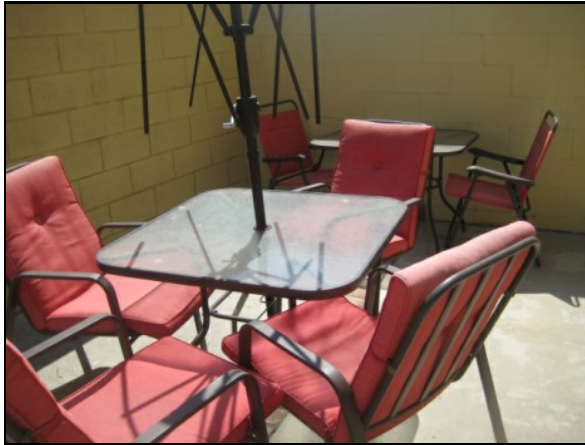
Comments: Six chair two table one sofa/lounge one coffee table. Metal frame pieces upholstered cushions. General poor &amp; faded condition.

Useful Life:  
6 yearsRemaining Life:  
0 years

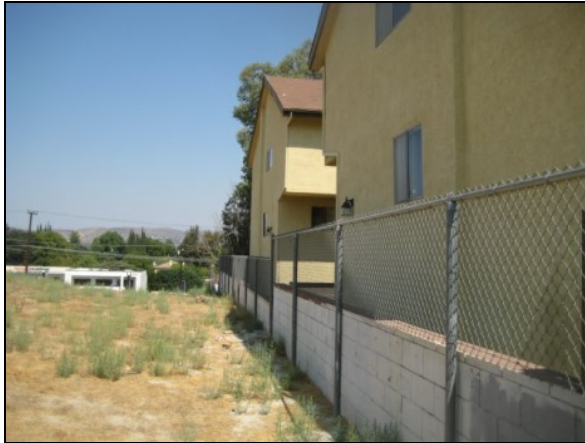
Comments: Assume to be original and association's responsibility. Fair condition. Establishes a perimeter barrier to the association. No significant aesthetic purpose. No signs of significant deterioration (stretching leaning). Expect a long useful life.

Useful Life:  
50 yearsRemaining Life:  
10 years

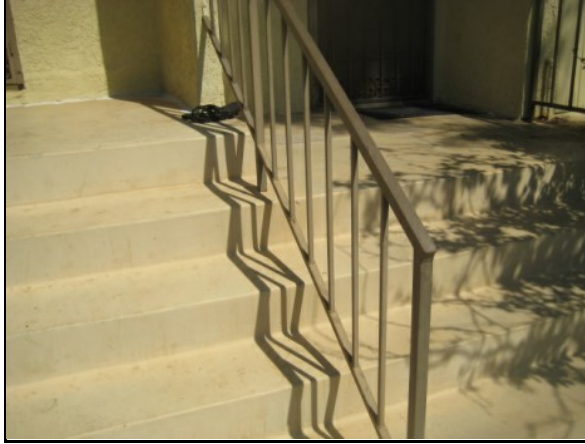
General poor older condition. Due for repaint at this time. Assoc has committed to repaint prior to end of Fiscal Year, so anticipate full Remaining Useful Life in 2019.

Useful Life:  
5 yearsRemaining Life:  
4 years

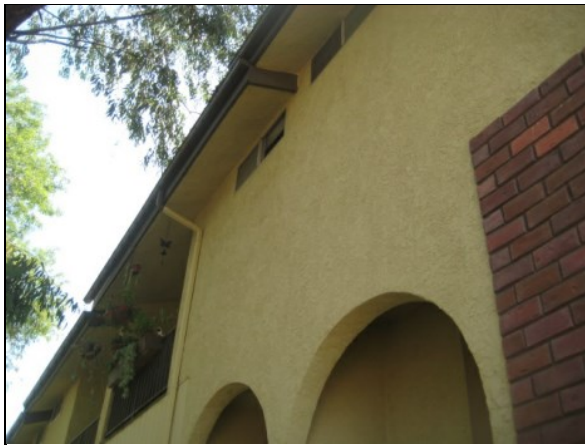
Comments: Stucco was dry and faded. Minor discoloration, and minor chalky nature. Stained in local areas due to water presence. General aged condition. Assoc plans to paint before end of this Fiscal Year, anticipate full Remaining Useful Life for 2019.

Useful Life:  
10 yearsRemaining Life:  
9 years

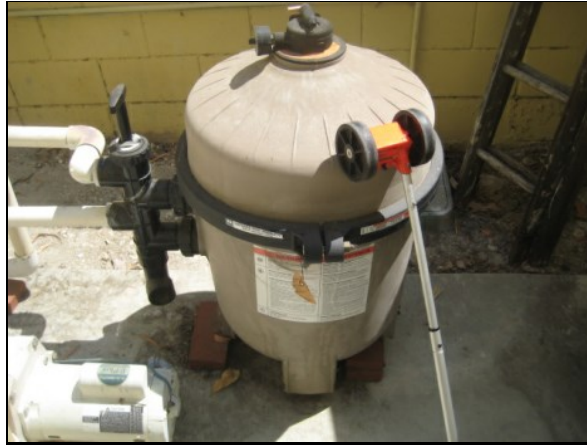
Comments: Appears to be in fair general condition. Has been unused for a number of years while spa was decommissioned. No staining no evidence of leaks no physical deterioration to note.

Useful Life:  
12 yearsRemaining Life:  
5 years

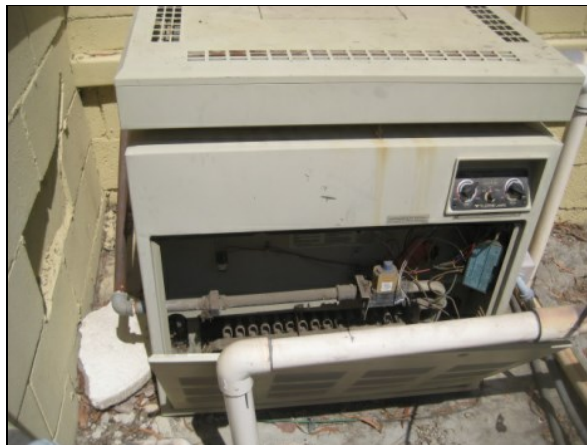
Comments: Laars 399000 BTU/hr. Serial # A99PC0310. Older unit shows neglect/age (due to years of spa being decommissioned), but no burn damage or physical damage. Expect at least some minor expenses to restore to functional condition but unit appears generally functional.

Useful Life:  
10 yearsRemaining Life:  
2 years
