# ASSOCIATION RESERVES™

SAMPLE  
Reserve Study

UPDATE - With Site Visit

Level of Service: **Update- With Site Visit (WSV)****January 1, 2019 through December 31, 2019****Findings & Recommendations****as of January 1, 2019**

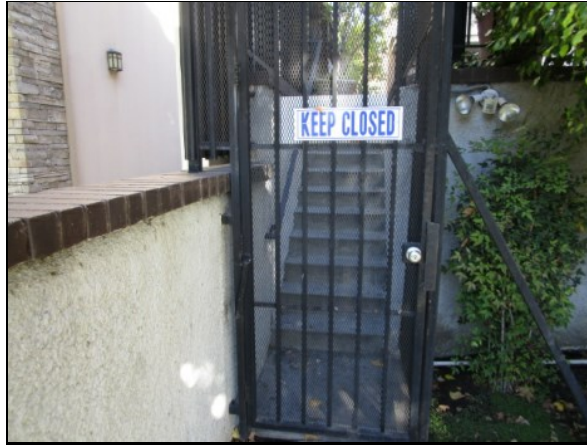
Comments: The metal gates consists of (4) vehicle and (6) pedestrian. The gates are original but are intact and functional, showing some age and general deterioration. Regular repainting projects will help extend their useful life.

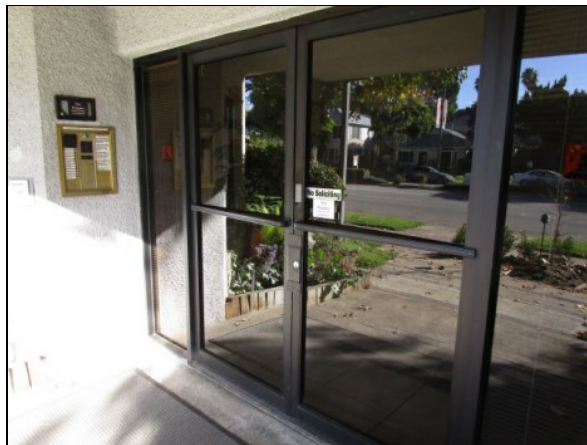
Comments: The lobby entry doors are intact and functional. No signs of damage or abuse. Minor surface wear. Funding for eventual replacement of the doors and adjacent glass panels to maintain an attractive appearance at the entry area.

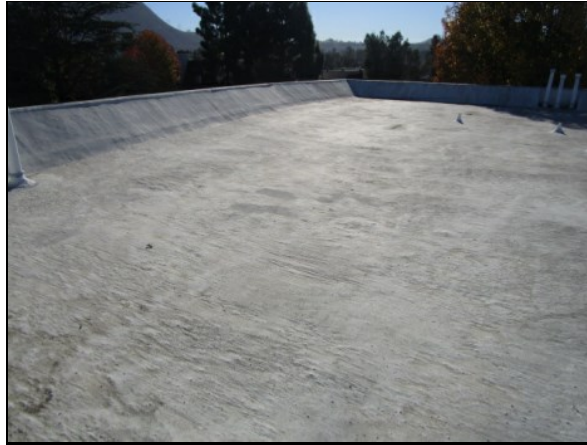
Comments: The building has a "cool roof" membrane. This type of roofing system, if regularly applied, should provide a very extended life for the roof system. No reports of current water intrusion issues. Refer to #1302 for roof repairs."

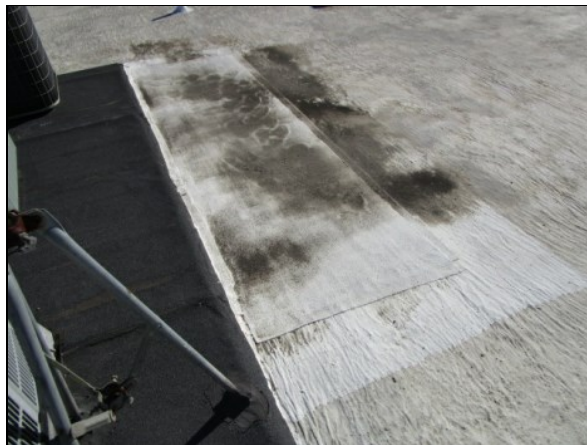
Comments: The combination of recoating and a repair project is a good pattern for this roof. Minor repairs and maintenance are being accomplished annually as an Operating expense. Funding is for future major repairs (such as the 2015 project) to help maintain the roofing system's integrity.

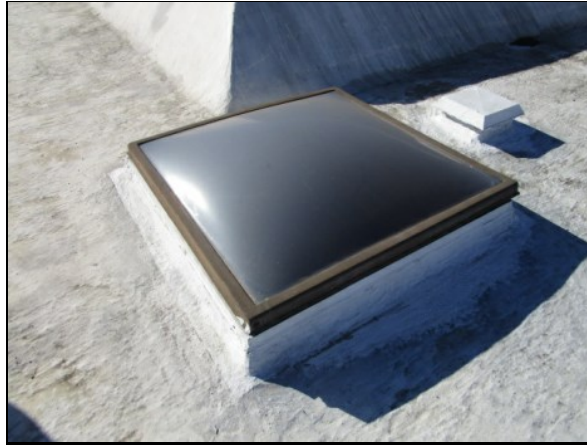
Comments: It was reported that these skylights are leaking, even though still relatively new. Note: replaced by vendor at no cost to association shortly after our site inspection.

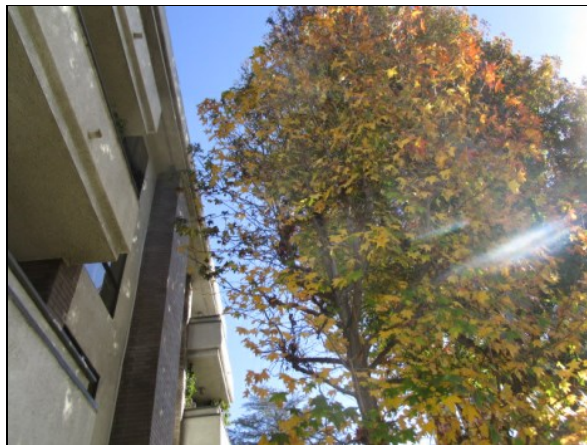
Comments: Trees are trimmed on a regular basis. Currently not touching building. Generally appearing well shaped and healthy. Anticipate to continue association's pattern of trimming on this regular schedule.

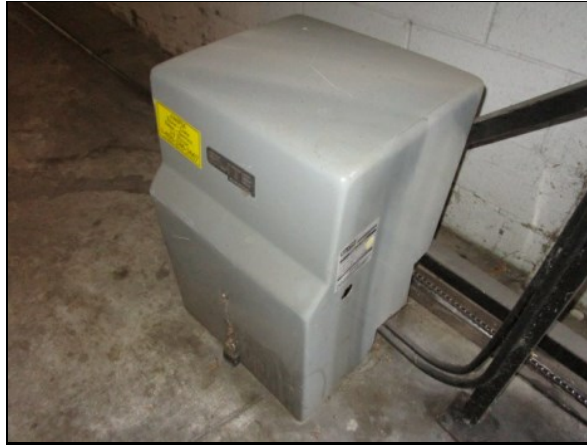
Comments: Repairs to these old operators have been expensive. Time to replace with current technology units, to reduce "down time" and minimize ongoing repair costs.

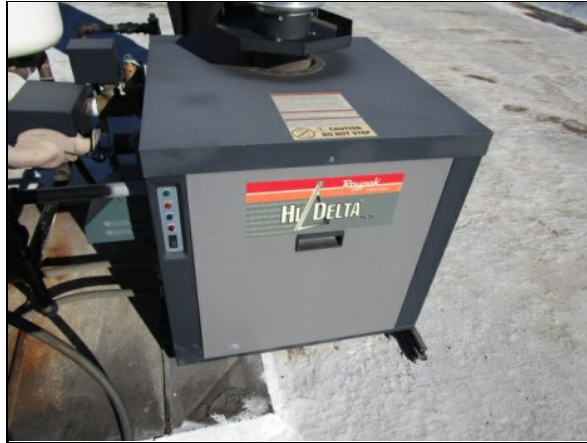
Comments: No signs of deterioration (fire damage, corrosion). No reported problems. Anticipate minor ongoing maintenance projects (as an Operating expense). All appear to be in good functional condition.

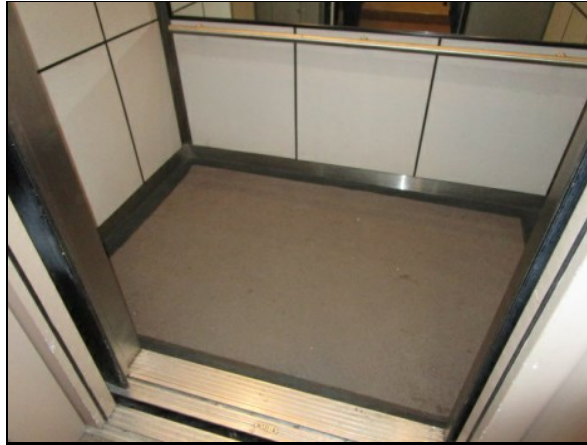
Comments: The elevator wall panels and mirror are in fair to good condition. Attractive, no scuffing or deterioration noted. Well lit, well styled

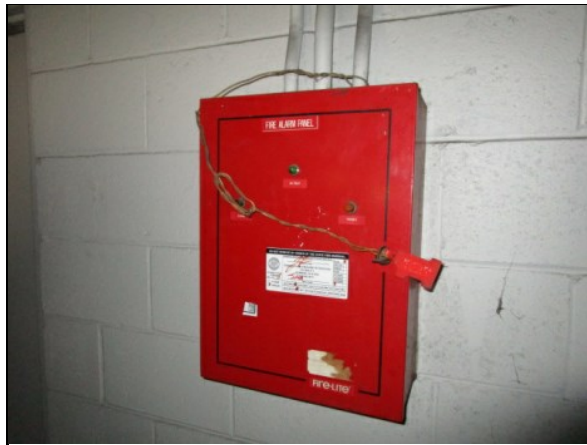
Comments: We are not licensed to inspect these systems. Fire alarm systems should be inspected and maintained on a regular basis by licensed professionals as an Operating expense. Best to fund for the eventual modernization of the system (panels fixtures etc.). Anticipate alarm system is due for modernization in near future due to age.
