# ASSOCIATION RESERVES™

## RESERVE STUDY

## PRIVATE CLUBS and RECREATION CENTERS

Report #: 17918-0

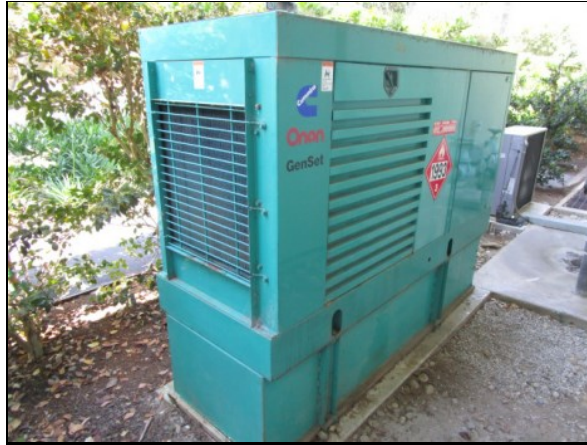
Comments: Older unit run once/wk for 30 minutes. Doing fine but older. Presume very extended life in this low use application but a professional refurbish project at this interval would be wise.

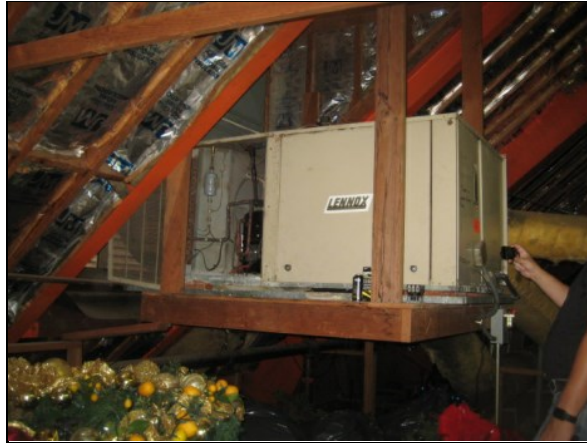
Comments: All appear generally older. All Lennox or Sterling brand. Anticipate periodic replacement on approximately this schedule.

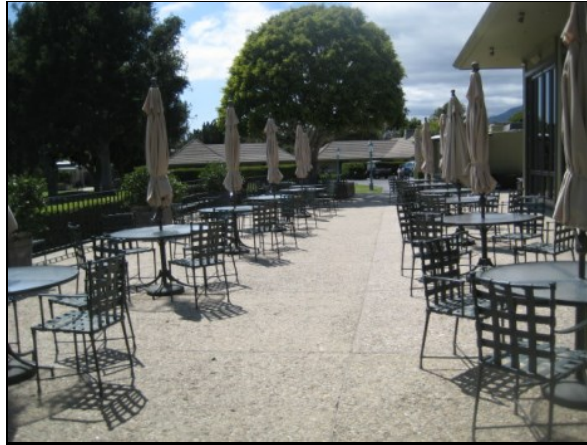
Comments: Overall good condition or fair condition, no signs of damage or wear. Subject to regular daily usage. (12) table/chair sets + (2) cushioned conversation areas. Attractive and inviting.

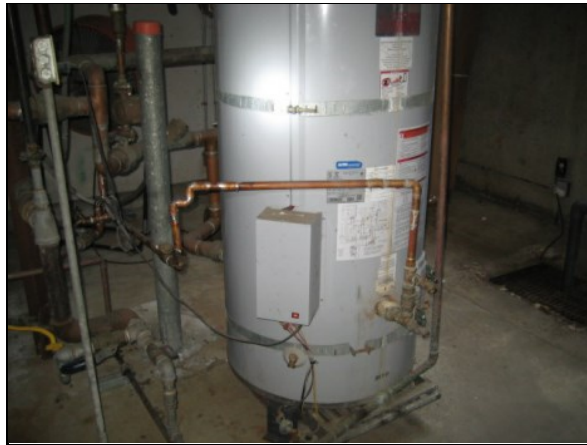
Comments: (1) American 94 gal 275000 BTU/hr. Fair general condition. Shows some minor age but no advanced deterioration at this point in time.

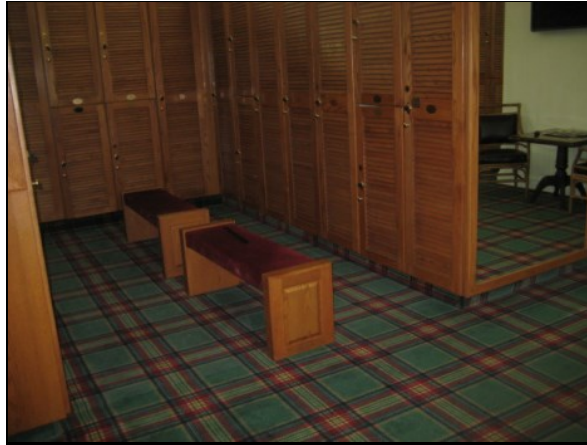
Comments: The locker room is in good condition. Furniture woodwork painted surfaces bathroom/locker facilities all still in fair or better condition. No significant deterioration or age noted.

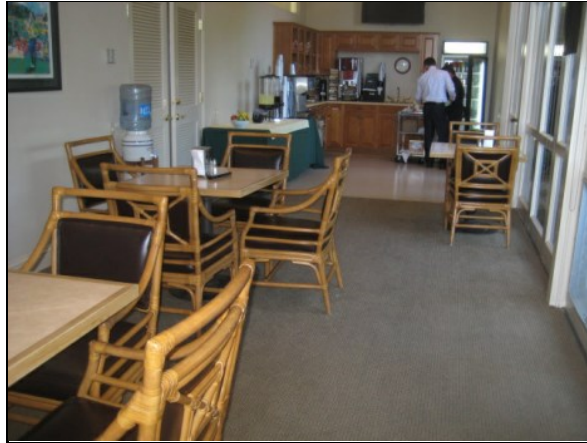
Comments: Currently a simple carpeted rm a few tables sink linoleum with cold food and cold drinks. Attractive, nicely appointed. Small grill area for freshly made food.

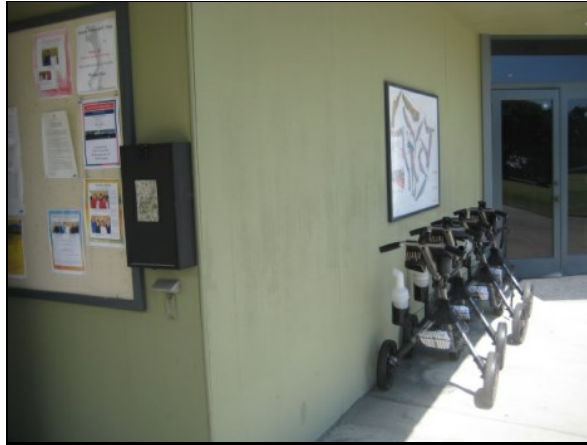
Comments: The exterior paint is in fair to good general condition. The paint color holds its age well. No staining dryness or fading. Expect to paint regularly on approximately this cycle to the building exterior surface and present an attractive exterior.

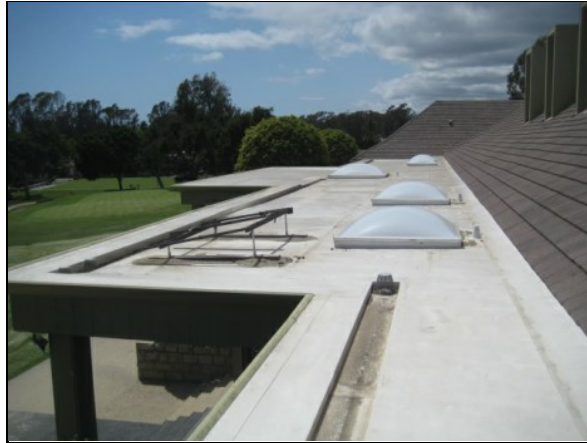
Comments: Generally intact. Single-ply roof. Minor ponding evident from evaporated puddles but no material deterioration. No seam issues.

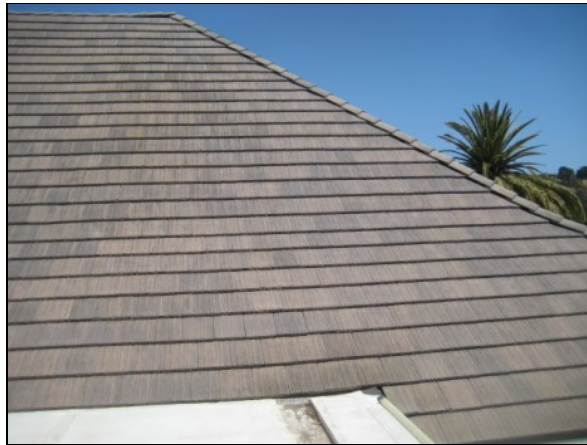
Comments: Good condition. No slipping movement or loss. Good regular pattern. No deterioration to note at this time, no leaks reported.

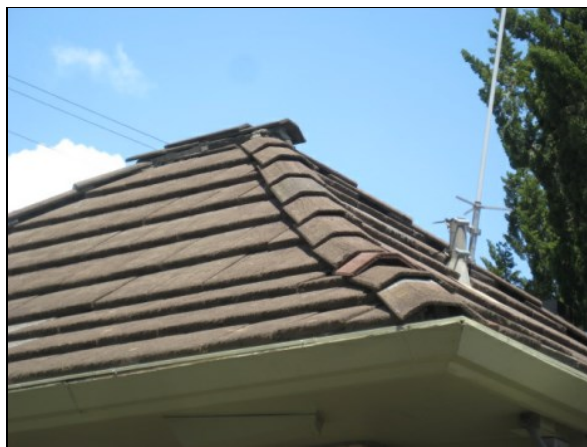
Comments: Minor to significant general age noted. Expect some issues to be resolved in upcoming renovation project. No leak reports at this time.

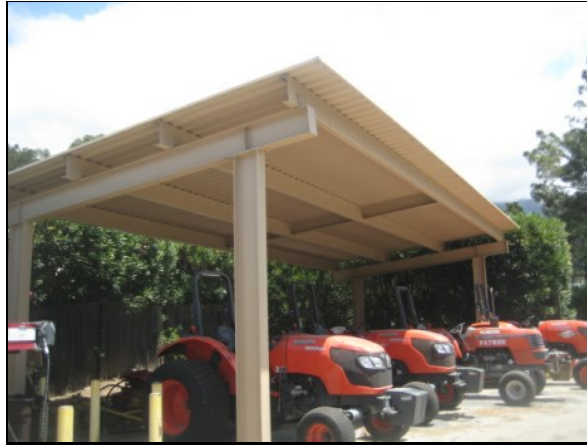
Comments: Extensive pieces. Expect annual expenses of approximately this magnitude to supplement and replenish existing equipment.

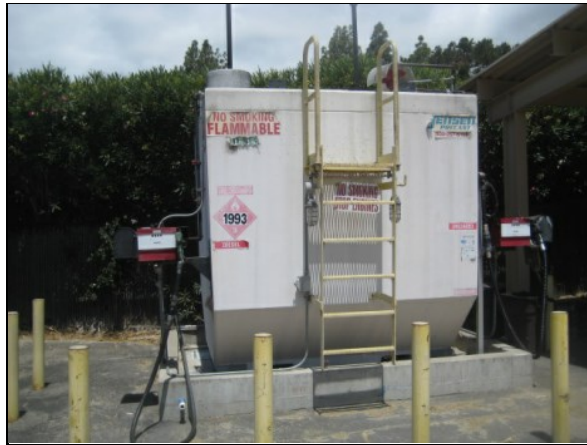
Comments: Combination 800 gal diesel and 1200 gal gasoline. Good above-ground dual-wall tanks with spill guard at base. No significant physical deterioration noted at time of site inspection other than minor cosmetic age noted.

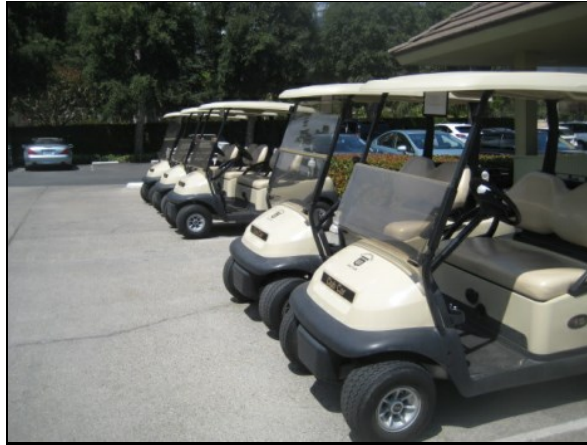
Comments: Fleet is functional but carts are getting older. Replacement fleet anticipated summer 2016 so expect a new fleet prior to Fiscal 2016/17.

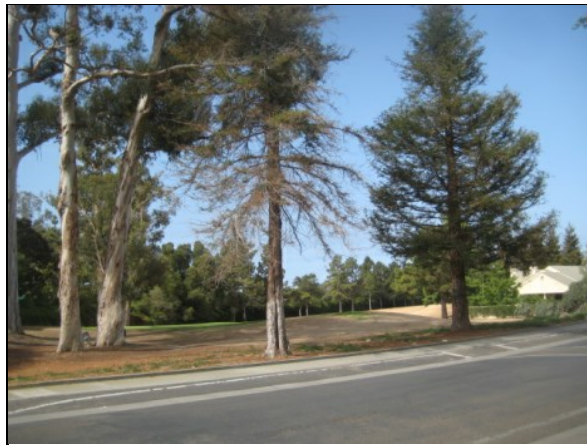
Comments: Some older trees have been undermined by age erosion and water. Some trees need replacement or have been recently replaced. Expect this pattern to continue in future years. Note: approx 26 total trees (approx \$100k) installed as part of turf conversion project. Net new trees. This included approx \$110k in individual sprinklers for each of the new trees.
