# ASSOCIATION RESERVES™

RESERVE  
STUDY

[YOUR PROPERTY NAME]

Report #: 17918-0

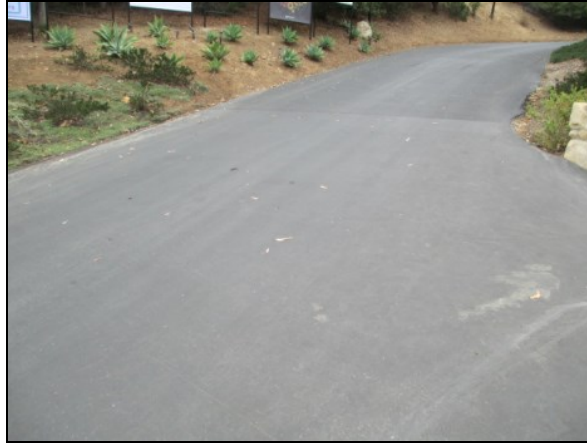
**Comp #: 201 Asphalt - Remove & Replace**

Useful Life:  
25 years

Remaining Life:  
2 years

Best Case: \$ 204,000

Worst Case: \$ 286,000

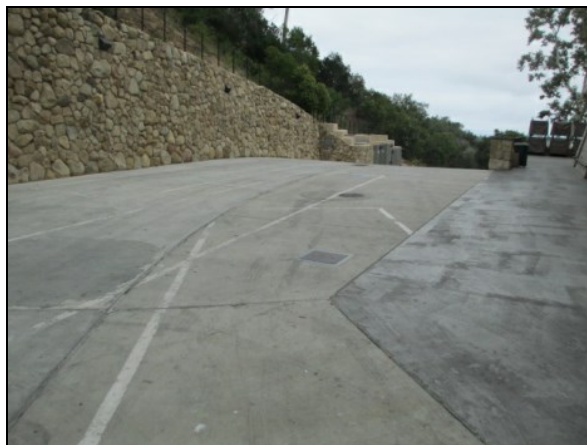
Useful Life:  
10 years

Remaining Life:  
2 years

Best Case: \$ 18,000

Worst Case: \$ 22,000

Lower estimate for repairs
