Sample High-Rise Association *Honolulu, HI*

Report #: 5101-0
Beginning: January 1, 2022
Expires: December 31, 2022

RESERVE STUDY "Full"

August 9, 2021

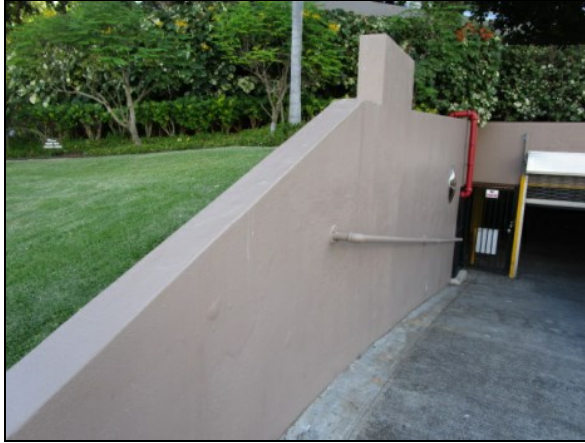
Comments: Signs of staining. The repainting of the common area walls (planter & retaining) should be included with each tower and parking structure repainting project in order to maintain a uniform appearance and to lower the overall repainting costs.

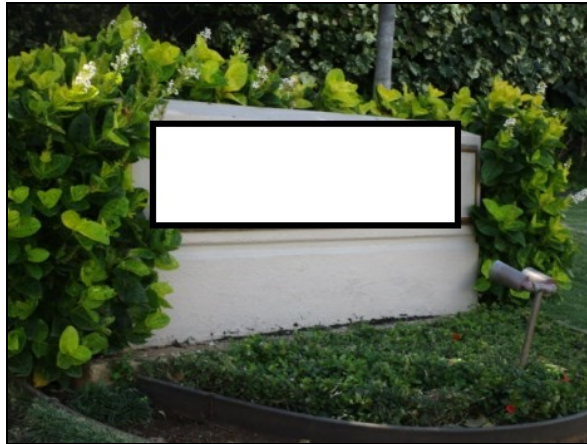
Comments: The monument sign is in fair condition. Funding for periodic replacement in order to maintain an attractive appearance.

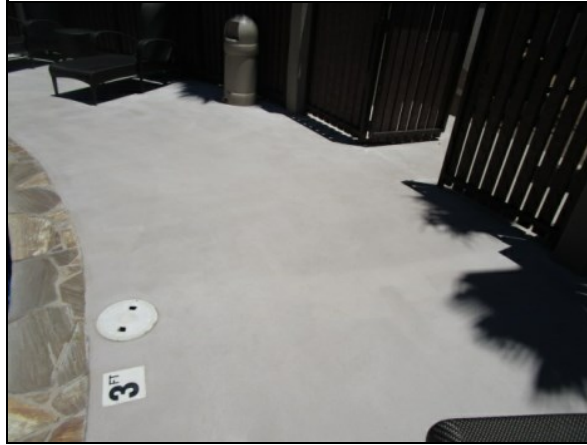
Comments: Funding for regular recoating project to maintain an attractive appearance and to extend the life of the decking membrane.

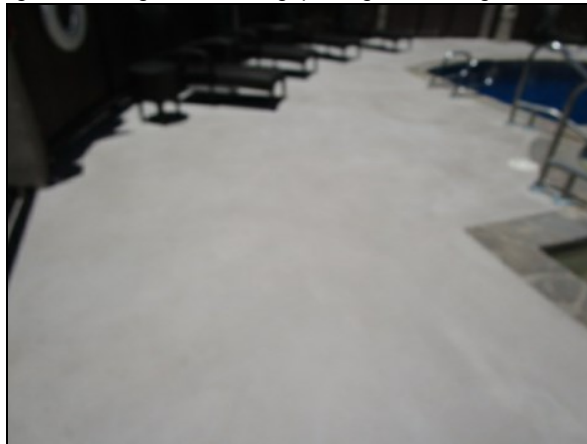
Comments: The pool deck is aging well. No signs of cracking, peeling or bubbling.

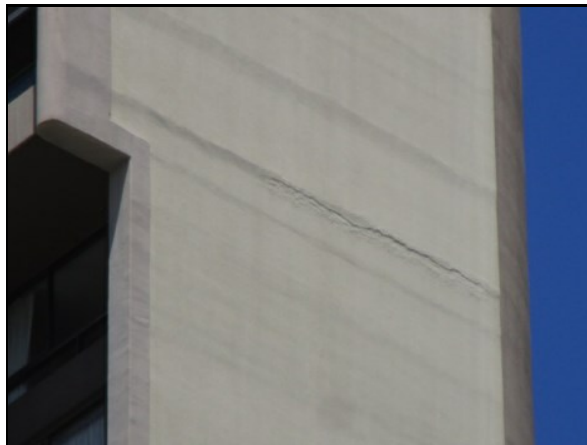
Comments: Signs of heavy staining and sections of spalling, especially on the 27th floor. Funding for ongoing repainting projects in order to maintain surface integrity and appearance. It is recommended that both towers be repainted together to maintain a uniform appearance and to lower the overall costs of repainting. The repainting of the parking garage should also be coordinated with this project (refer to #1115, Parking Structure chapter). Both repainting and window resealing projects should always be completed together to utilize the same davit crane equipment used by the crews (refer to #1119). The individual owners are responsible for the repainting of the interior walls and ceilings of their lanai decks. These surfaces are not included in this project scope of work.

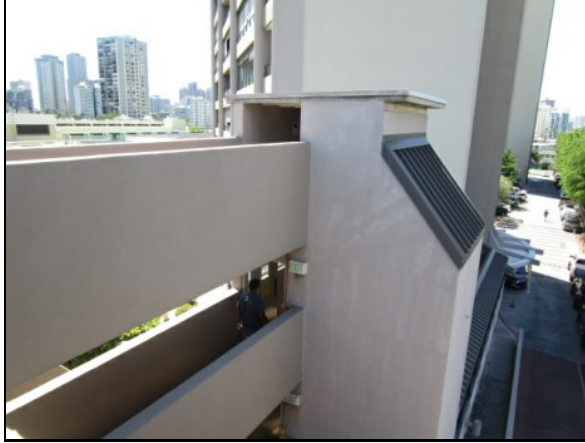
Comments: The stairwell roof is older and overdue for replacement. This project should also include repairs to the wood fascia boards.

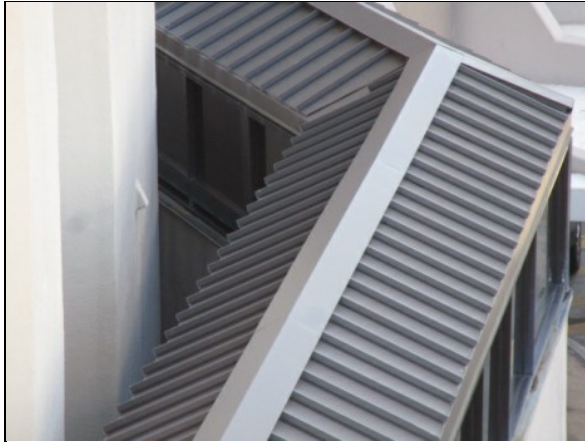
Comments: The metal roofs appears to be in good condition. No reports of water intrusion. No signs of corrosion or damage.

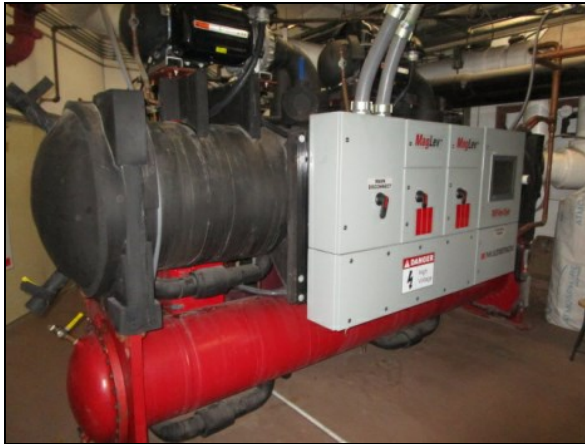
Comments: No reported problems with the liquid chiller system. Model # MS300F1L2W2HI-R134A. Serial # AA08124. This line-item includes the replacement of the chiller controller panels.

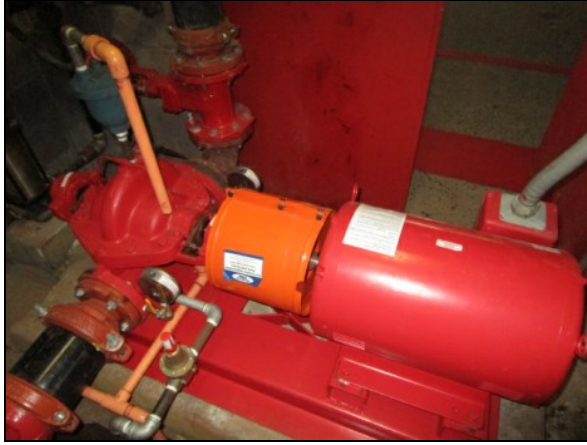
Comments: We are not licensed to test this equipment. No testing was performed during our site inspection. The fire pump and it's controller were recently replaced.

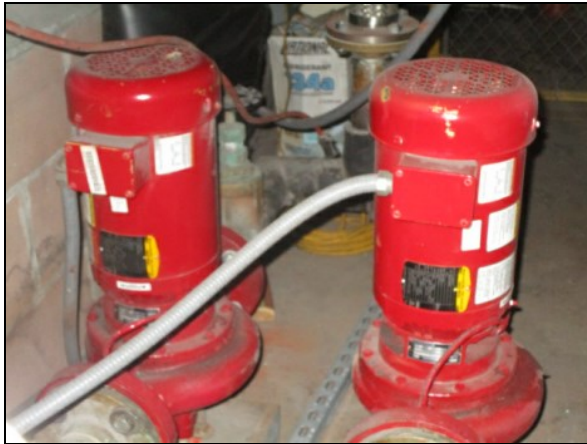
Comments: These pumps service the lower domestic heat pumps and were recently replaced. No signs of corrosion or active leakage. Good condition.
