Sample Townhome Community II
WA 2022 FY
Anytown, WA

Report #: 9999-0
Beginning: January 1, 2022
Expires: December 31, 2022

RESERVE STUDY
"Full"

July 29, 2021

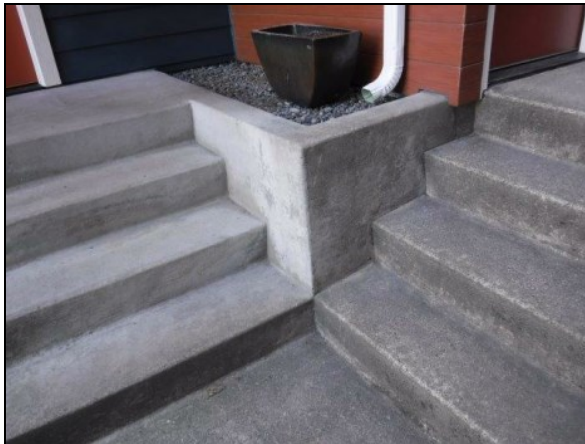
Comp #: 100 Concrete - Repair/Replace**Quantity: Moderate quantity**

Comments: The concrete appeared in generally stable condition, with no significant deterioration at this time.

In Seattle, certain parts of the public right of way (i.e. sidewalks and alley) are the adjacent property owner's (condominium) responsibility to maintain. Include these areas as part of your regular maintenance and repair. City of Seattle Property Owners' Responsibilities: <http://www.seattle.gov/transportation/projects-and-programs/programs/maintenance-and-paving/property-owners-responsibilities>

The annual repair needs are below the reserve funding threshold (1% or more of total annual expenses), and should be factored into the operating budget. In our experience, as the community ages larger repair/replacement expenses may emerge that cannot be comfortably absorbed into the operating budget. Currently, it is difficult to predict the timing, scope, and costs of larger repairs. Monitor the concrete annually and if conditions deteriorate leading to larger repair needs, funding can be included within a reserve study update.

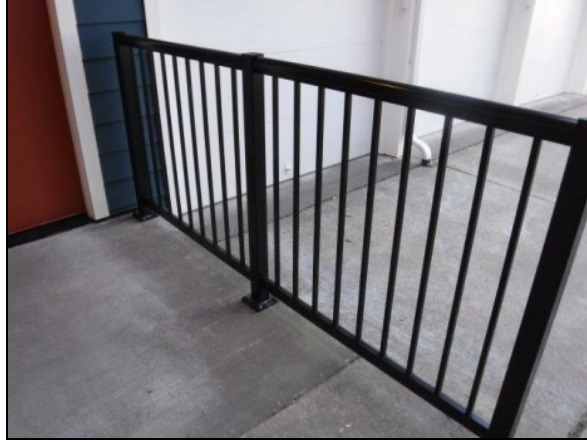
Comp #: 112 Site Rail - Repair/Replace**Quantity: ~20 LF**

History: Replaced 2020.
