**Sample Timeshare Property**

***Anywhere, XX***

Report #: 17918-1  
Beginning: January 1, 2026  
Expires: December 31, 2026

**RESERVE STUDY**  
**Update "With-Site-Visit"**

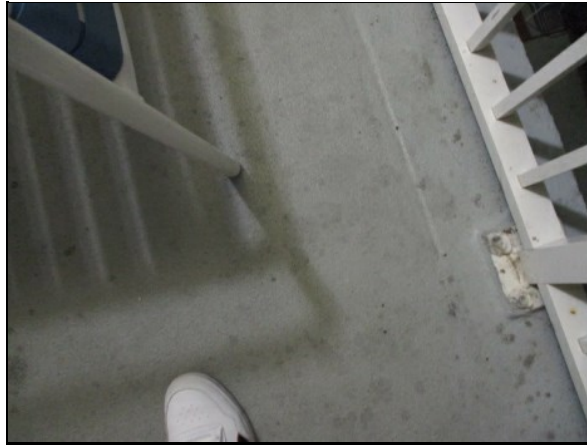
**Comp #: 23150 Decking - Coated - Walkways - Re-Coat****Approx Quantity: 4,000 GSF****Location:** Building exterior (stairwells, walkways)**Funded?:** Yes. Meets the CAI Reserve Study Standards three-part test.**History:****Comments:** \*NOTE: The remaining useful life of this component has been extended based on the recommended resurfacing of the walkway decks through component #23410.

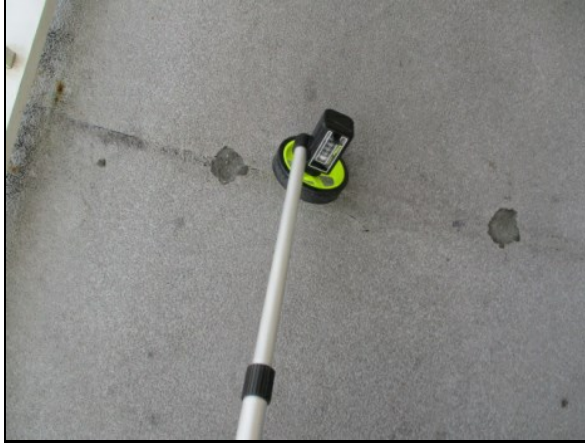
**Comp #: 23200 Flooring - Tile****Approx Quantity: 250 GSF****Location:** Building exterior (ground level)**Funded?:** Yes. Meets the CAI Reserve Study Standards three-part test.**History:****Comments:** Tile decking determined to be in fair condition may exhibit minimal, sporadic cracking and other signs of age, but is still believed to drain properly and has an acceptable appearance.
