**Sample Association**  
**Mid-Rise**  
***Anywhere, CA***

# RESERVE STUDY

## Update "With-Site-Visit"

August 5, 2026

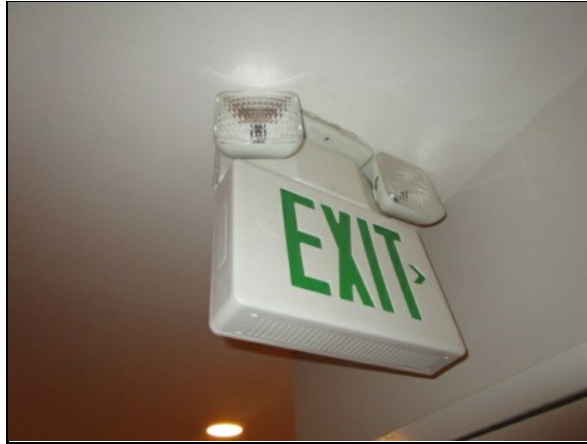
**Comp #: 326 Emergency/Exit Signs - Replace****Approx Quantity: 80 Fixtures****Location:** Building interior (hallways)**Funded?:** Yes. Meets the CAI Reserve Study Standards three-part test.**History:****Comments:** Replace individual damaged fixtures as needed as an Operating expense. Funding for periodic complete replacement projects to ensure reliability, and to maintain a uniform appearance throughout the common areas.**Useful Life:**  
20 years**Remaining Life:**  
2 years

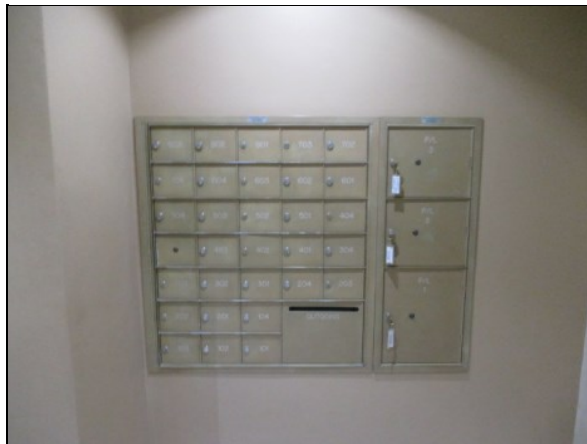
The mailboxes are intact and functional. No signs of advanced deterioration or abuse. Funding for periodic replacements to maintain security and reliability.

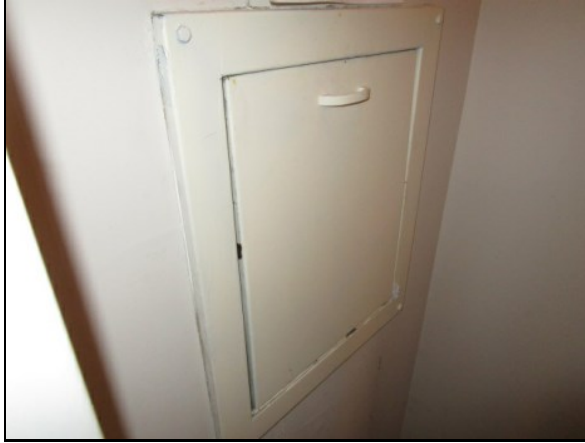
**Comp #: 713 Trash Chutes - Replace****Approx Quantity: 4 Chutes****Location:** Trash rooms**Funded?:** No. Meets the CAI Reserve Study Standards three-part test.**History:** Presumed to be original to the construction of the property (1985, per information provided)**Comments:** The trash chutes were located at the interior of the building in a protected location. Minimal wear/deterioration evident at the time of inspection. As such, funding has been deemed too indeterminate for Reserve designation at this time.**Useful Life:****Remaining Life:**

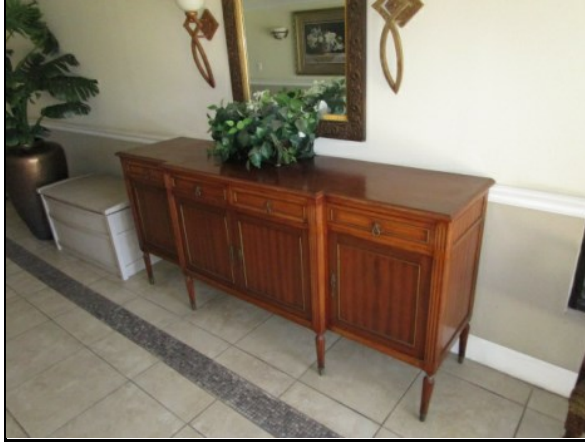
Still in fair or better condition. Heavy traffic through this area, but furniture is just for appearance. Last remodel included new flooring, wallcovering, paint, and furniture. Expect to remodel approx every-other hallway renovation project. .

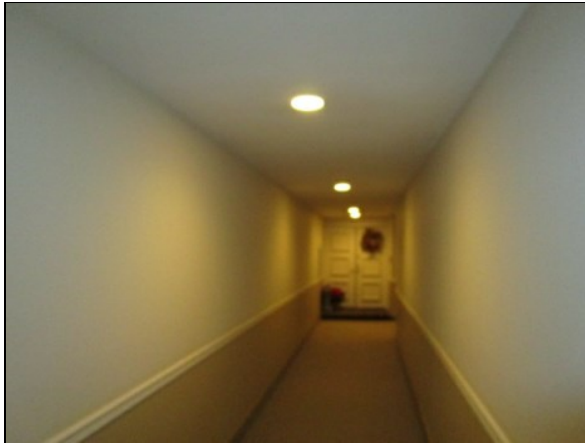
**Comp #: 1110 Interior Surfaces - Repaint****Approx Quantity: 74,000 GSF****Location:** Hallway and lobby walls/trim**Funded?:** Yes. Meets the CAI Reserve Study Standards three-part test.**History:** Hallway remodeling project completed in 2019 (per information provided)**Comments:** Funding for the periodic repainting of the interior common area surfaces to maintain an attractive appearance throughout. These projects should always be coordinated with floor replacement projects whenever possible. Repainting should always be completed before the floor replacement projects to avoid damaging new surfaces. Any minor touch-up repainting projects should be handled as an Operating expense.**Useful Life:**  
10 years**Remaining Life:**  
2 years

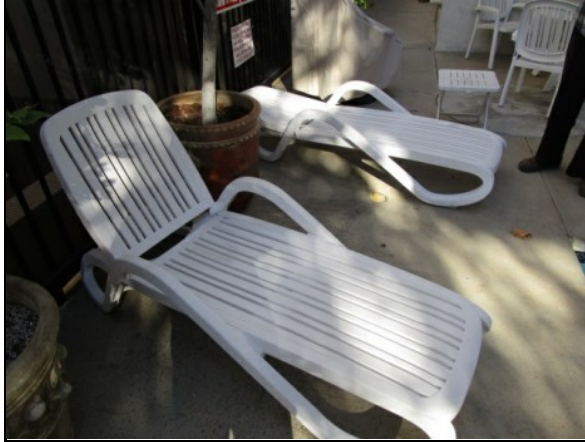
**Comp #: 404 Pool Furniture - Replace****Approx Quantity: 20 Pieces****Location:** Pool perimeter**Funded?:** No. Partial replacements expected - Cost estimates too small for Reserve designation.**History:****Comments:** The furniture pieces vary in age, style, and condition. It was reported that the furniture pieces are replaced on an as-needed basis as an Operating expense. There is no expectation for complete replacement. No Reserve funding is required.**Useful Life:****Remaining Life:**
