# VACATION OWNERSHIP RESORT

## RESERVE STUDY

## Site Inspection Notes

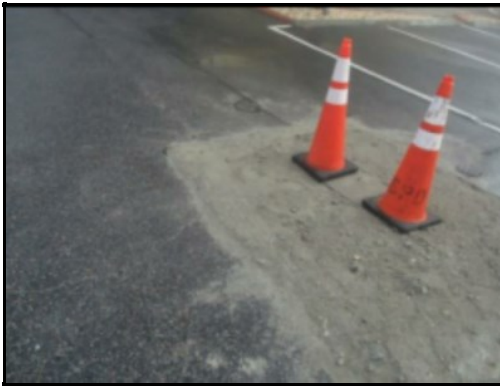
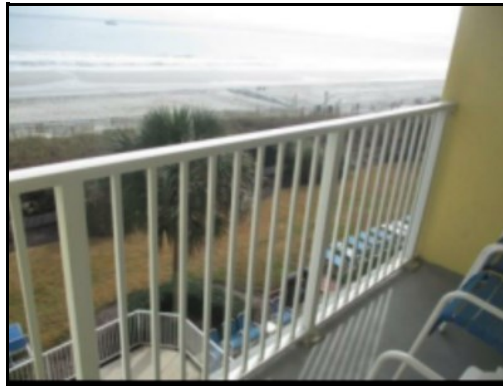
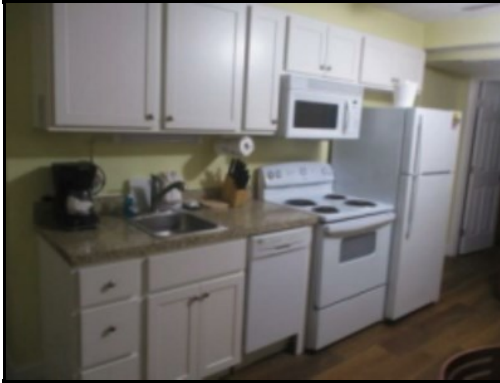
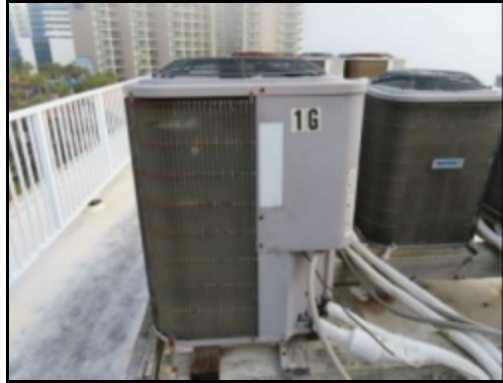
During our site visit on 8/5/2026, we started with a brief meeting with property management and maintenance representatives. We thank them for their assistance and input during this process. During our inspection, we visually inspected all common areas, amenities, and other components that are the responsibility of the Client. We also entered three different units, made available by on-site staff for measurements, condition assessments, and pictures taken. Please refer to the Component Details section at the end of this document for additional photos, observations and other information regarding each component.

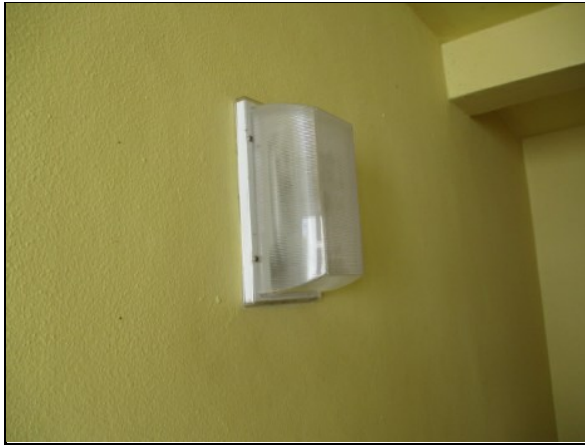
Observed during daylight hours but assumed to be in functional, operating condition. As routine maintenance, clean by wiping down with an appropriate cleaner, change bulbs and repair as needed. Individual replacements should be considered an Operating expense. If available, an extra supply of replacement fixtures should be kept on-site to allow for prompt individual replacements. Best practice is to plan for total replacement to periodically restore an attractive aesthetic standard within the property's common areas. Based on evident conditions and repair/replacement history provided by the Client during this engagement, we recommend financially preparing for comprehensive replacement at the approximate time frame below. Unless otherwise noted, costs shown here are based on replacement with comparable quantity and style of lights as existing. We recommend consideration of LED fixtures or other energy-saving options whenever possible.

**Useful Life:**  
20 years**Remaining Life:**  
14 years

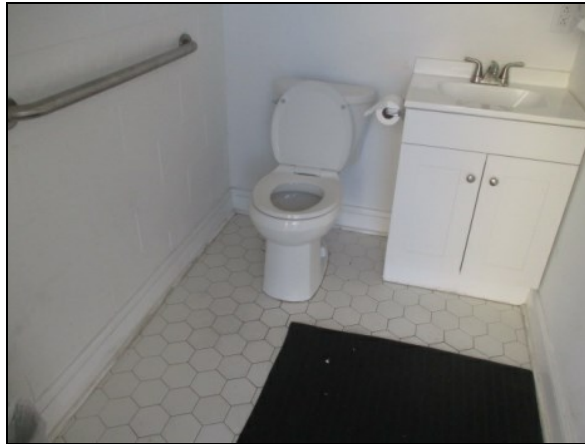
**Useful Life:**  
20 years**Remaining Life:**  
3 years

As routine maintenance, inspect regularly and perform any needed repairs promptly utilizing general Operating funds. Typical remodeling project can include some or all of the following: replacement of plumbing fixtures, partitions, countertops, lighting, flooring, ventilation fans, accessories, décor, etc. Best practice is to coordinate this project with other amenity areas, such as kitchens or other amenity rooms. Remaining useful life is based on consideration of materials, evident conditions, and/or remodeling/renovation history provided during the engagement. Costs can significantly vary based on an anticipated scope of work as well as materials chosen for remodeling/renovation. Unless otherwise noted, estimates shown are based primarily on light to moderate cosmetic remodeling, not complete "gut" remodel projects.

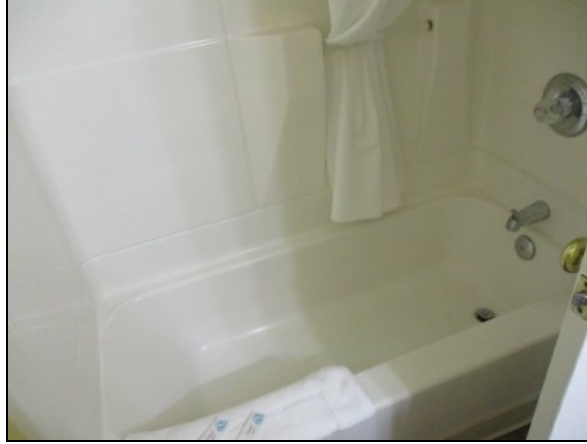
Useful life and remaining useful life figures shown below take past project history the client's anticipated renovation cycles/intervals and the visual condition evident at the time of inspection into account. Costs shown below are intended to be with comparable pieces in style and quality.

**Useful Life:**  
28 years**Remaining Life:**  
10 years

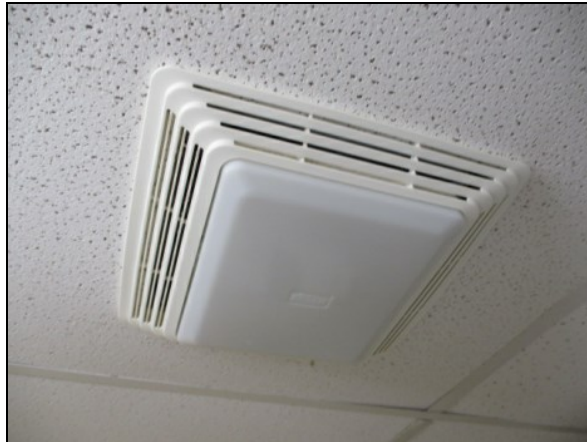
Useful life and remaining useful life figures shown below take past project history the client's anticipated renovation cycles/intervals and the visual condition evident at the time of inspection into account. Costs shown below are intended to be with comparable pieces in style and quality.

**Useful Life:**  
14 years**Remaining Life:**  
10 years
