**Sample Reserve Study
HOA/POA
*Anywhere, FL***

Report #: 35269-0
Beginning: January 1, 2022
Expires: December 31, 2022

RESERVE STUDY
"Full"

July 27, 2021

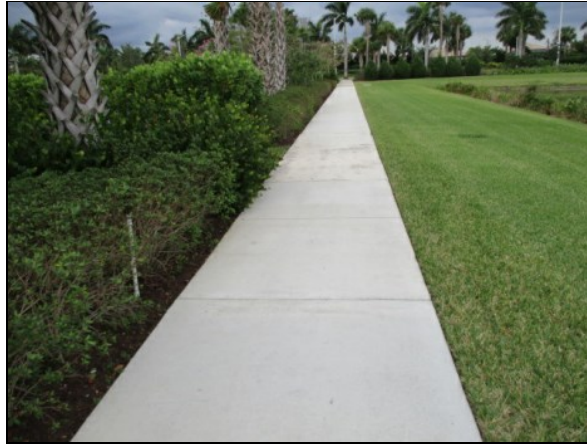
Comp #: 2107 Concrete Sidewalks - Repair**Quantity: Approx 230,700 GSF**

Useful Life:
4 years

Remaining Life:
0 years

Lower allowance to repair

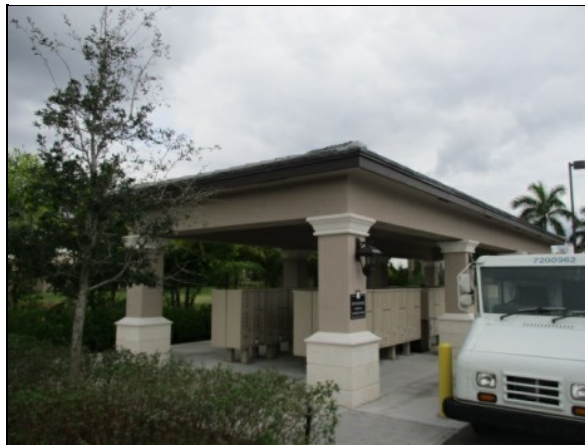
Comments: All kiosks inspected included (16) mailboxes and (2) parcel lockers. Good condition: Mailbox kiosks determined to be in good condition typically exhibit a uniform appearance without much surface wear. Hardware appears to be in good condition, and boxes/panels appear to close and lock properly. Appearance and style are consistent with the aesthetic standards of the development. Inspect regularly and clean by wiping down exterior surfaces. If necessary, change lock cylinders, lubricate hinges and repair as an Operating expense. Best to plan for total replacement at roughly the time frame below due to constant exposure, usage and wear over time.

Useful Life:
20 yearsRemaining Life:
15 years

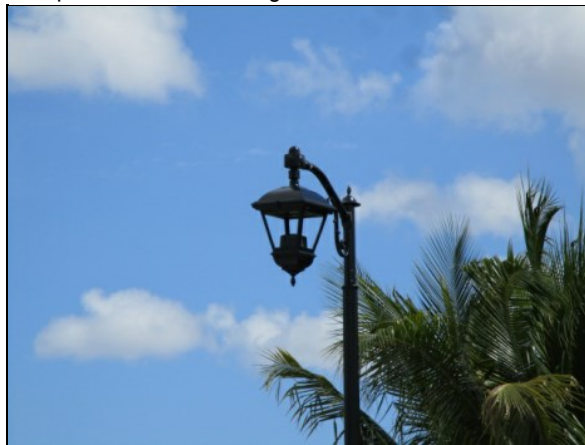
Comments: Includes (38) pole lights at clubhouse parking lot, (4) pole lights at north entry, and (16) more decorative pole lights at main entry. Good condition: Pole lights determined to be in good condition typically exhibit good surface finishes with only minor, normal signs of wear. Fixtures are intact and clear with no unusual signs of age. Style is consistent and appropriate for local aesthetic standards. Observed during daylight hours; assumed to be in functional operating condition. As routine maintenance, inspect, repair/change bulbs as needed. Best to plan for large scale replacement at roughly the time frame below for cost efficiency and consistent quality/appearance throughout Association. Replacement costs can vary greatly; estimates shown here are based on replacement with a comparable size and design, unless otherwise noted.

Useful Life:
25 yearsRemaining Life:
20 years

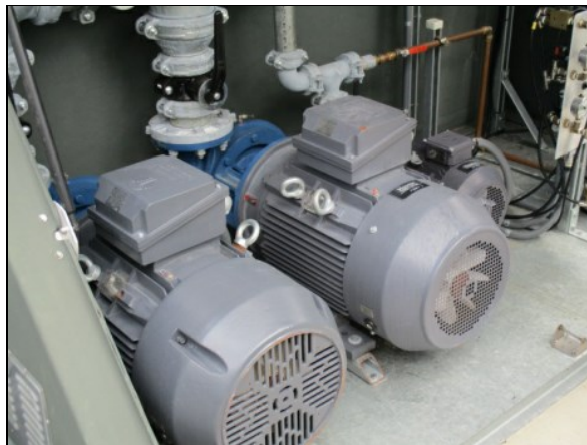
Minimal or no subjective/aesthetic value for this component. Useful life is based primarily on normal expectations for service/performance life in this location. Unless otherwise noted, remaining useful life expectancy is based primarily on original installation or last replacement/purchase date, our experience with similar systems/components, and assuming normal amount of usage and good preventive maintenance.

Useful Life:
20 yearsRemaining Life:
15 years
