**Sample Association  
Low-Rise Condominium  
*Anywhere, TX***

Report #: 17918-0  
Beginning: January 1, 2027  
Expires: December 31, 2027

**RESERVE STUDY**  
**"Full"**

August 5, 2026

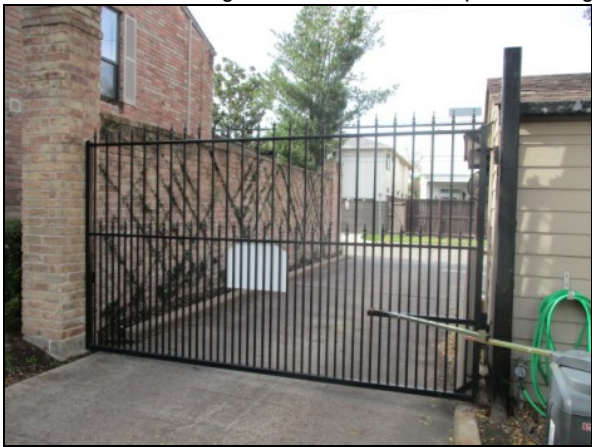
**Comp #: 704 Gates - Vehicular (Resident) - Replace**

**Useful Life:**  
30 years

**Remaining Life:**  
25 years

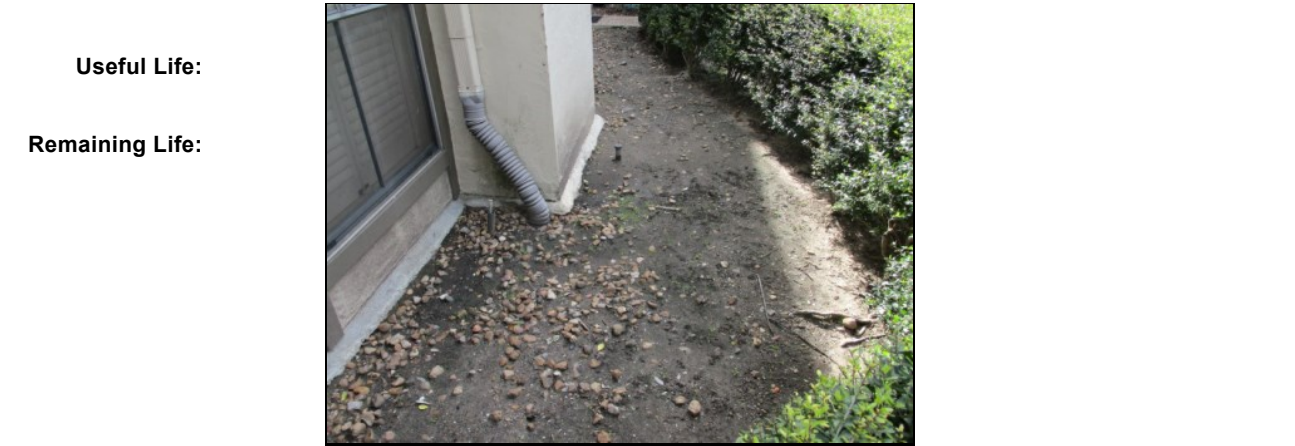
**Comments:** Routine landscaping is expected to be included within the Client's landscaping contract or otherwise reflected in the annual Operating budget. We recommend consulting with a qualified landscaping professional to create a long term plan for the care and management of the landscaping within the community. Based on correspondence with the Client and/or other information provided during this engagement, all potential landscaping refurbishment projects are expected to be handled through the Client's Operating budget. However, this component should be re-evaluated during future Reserve Study updates and funding incorporated (if necessary) based on the most current information available at that time.

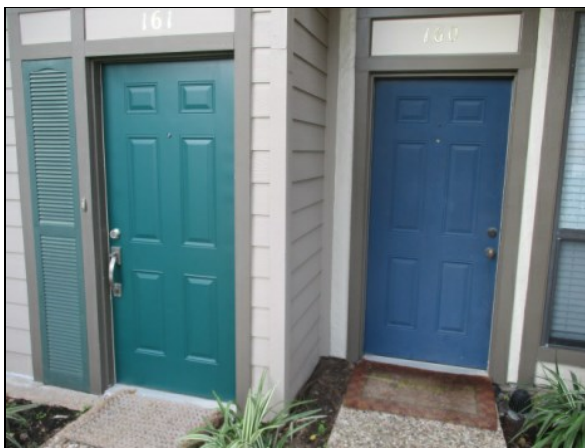
**Comp #: 701 Doors - Units - Replace****Approx Quantity: 150 Doors****Location:** Building exteriors (unit entrances)**Funded?:** No. Per information provided - Client/Association not responsible.**History:****Comments:** Based on limited review of the Association's governing documents, individual owners are believed to be responsible for front door replacement. However, our review is not intended to be a professional legal opinion and we reserve the right to revise this component if the Association is otherwise found to be responsible for replacement. No recommendation for Reserve funding at this time.**Useful Life:****Remaining Life:**

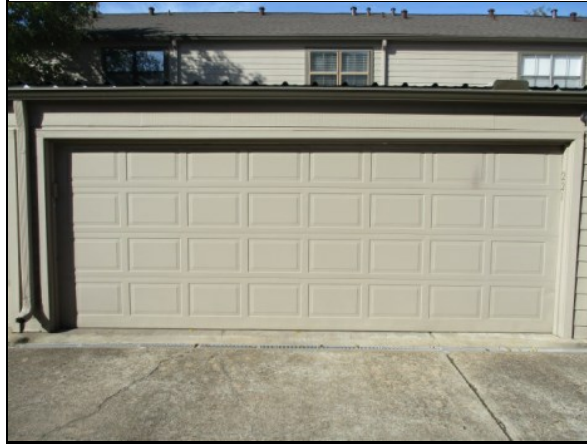
**Comments:** Based on limited review of the Association's governing documents, individual owners are believed to be responsible for garage door replacement. However, our review is not intended to be a professional legal opinion and we reserve the right to revise this component if the Association is otherwise found to be responsible for replacement. No recommendation for Reserve funding at this time.

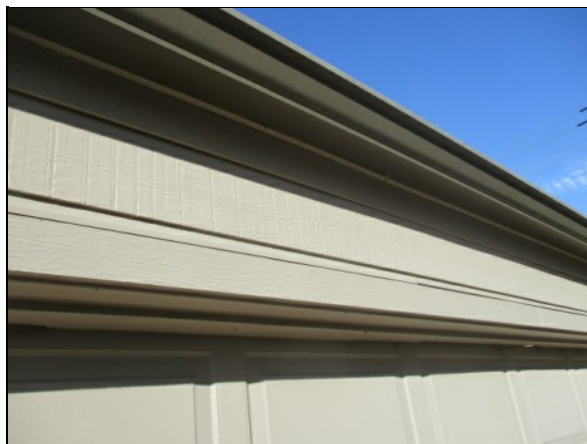
**Comments:** Two beams have reportedly been replaced over the past several years due to roof leaks, which prompted replacement of the garage roofing (component #1305). In accordance with industry standards, a Reserve Study is based only on a visual inspection. As such, future repairs and replacements of garage beams is considered too indeterminate for Reserve designation based on a visual inspection alone. If the client has further concerns related to the beams, we recommend consultation with a qualified professional (engineer/contractor) to determine the best plan of action for future repairs/replacements. This component can then be re-evaluated during future Reserve Study updates based on the most current information available at that time.
