# ASSOCIATION RESERVES™

## RESERVE STUDY

[YOUR PROPERTY NAME]

Report #: 17918-0

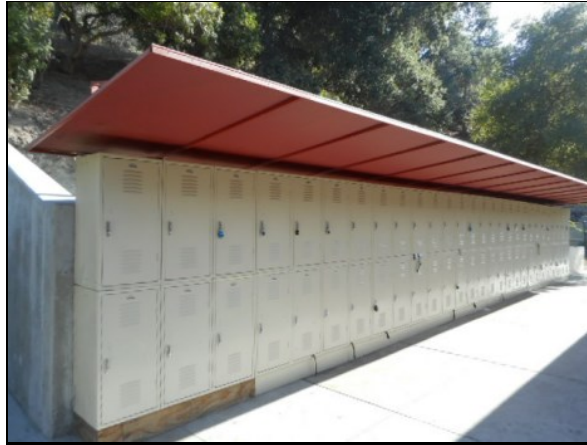
Comments: The lockers varied in condition throughout the property. Minor denting and wear observed on the exterior surfaces of the oldest. None showing significant damage. Expect to continue replacement in approx four phases on this interval.

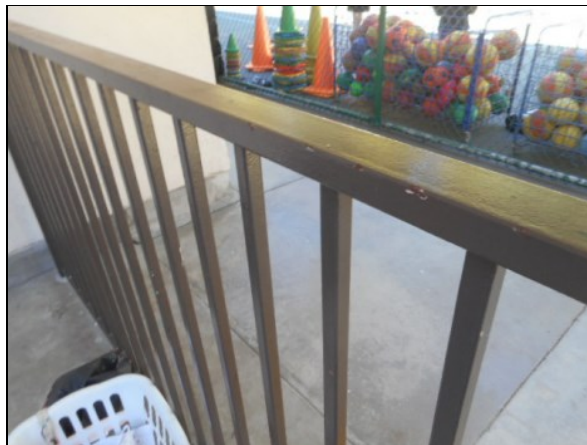
Comments: The metal surfaces appear to be in fair condition. Minor scuffs beginning to show but no serious lack of paint coverage noted. Regular paint cycles will help protect the ironwork from damaging weather and irrigation elements while maintaining an attractive appearance.

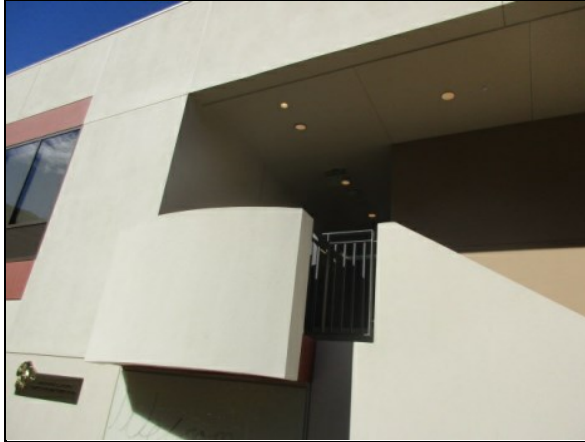
Comments: Varying conditions observed throughout. The buildings were constructed in different years; as such complete repainting will likely not be needed. Funding provided for partial painting cycles.

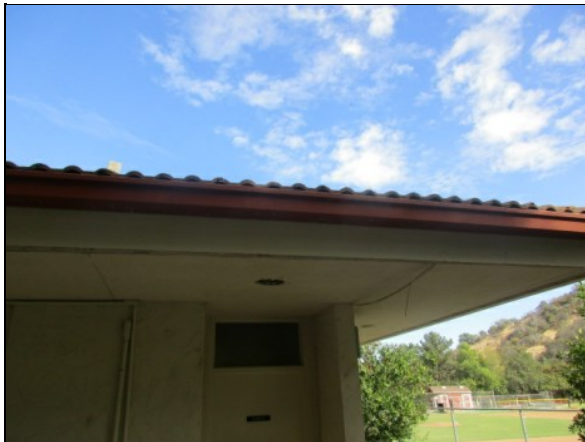
Comments: No access to closely inspect. Based on the age of the roof it is assumed to have reached an extended useful life. Although no major problems have been reported it is best to replace before failure occurs.

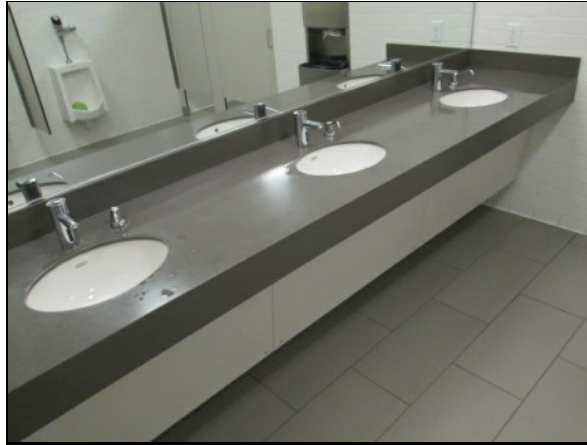
Comments: The bathrooms vary in location depending on location. There is no expectation to refurbish all at the same time. Funding has been provided for periodic partial refurbishments to maintain appearances and cleanliness.

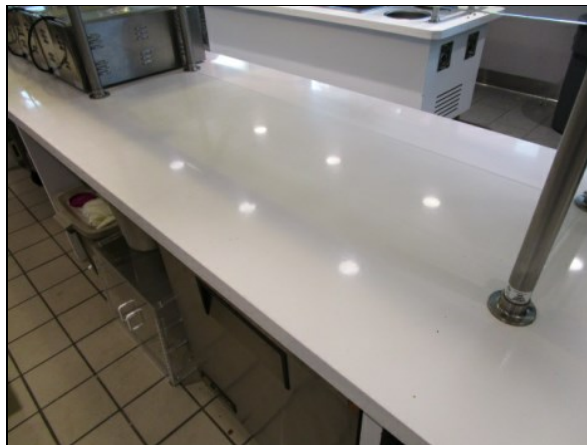
Comments: Includes kitchen area and 20 LF of wall shelves, 16 LF of counters, and 8 LF of built-in hot bar. The cafeteria was reportedly refurbished and restored in recent years. No signs of abuse or vandalism. Good conditions.

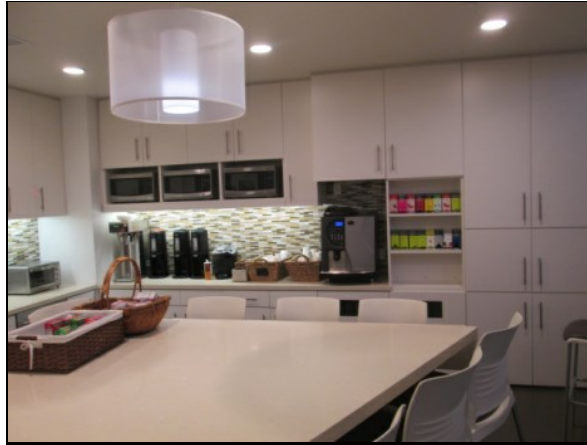
Comments: The room is attractive and aging well. In good condition. Includes (2) GE fridges (1) toaster oven (1) GE oven (5) microwaves (2) dishwashers 70 LF of cabinets/counters and assorted furniture.

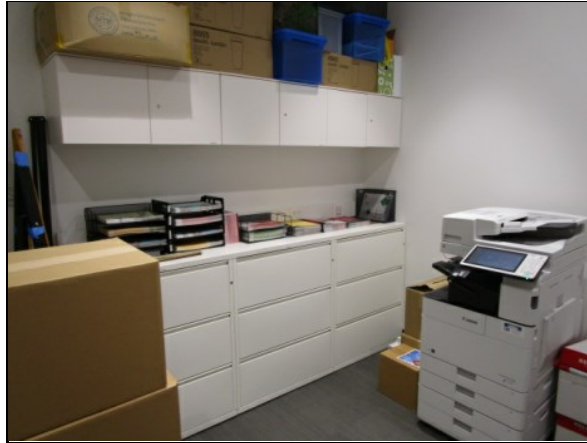
Comments: The admin building cabinetry appeared to be in good condition during the inspection. No serious deterioration noted. Expect a full service life.

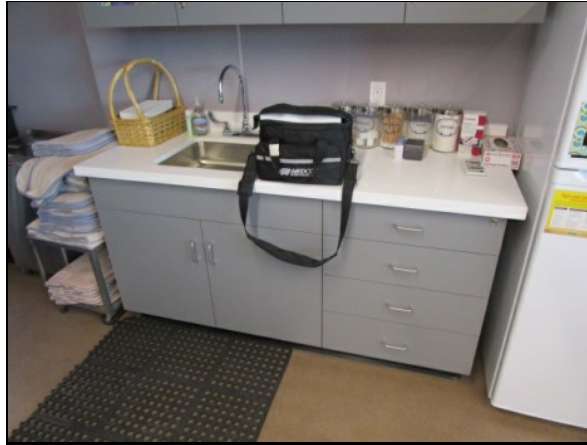
Comments: The areas of cabinetry appear to be in generally good, near-new condition. No abnormal wear or abuse noted. With regular maintenance these materials should reach long useful lives.

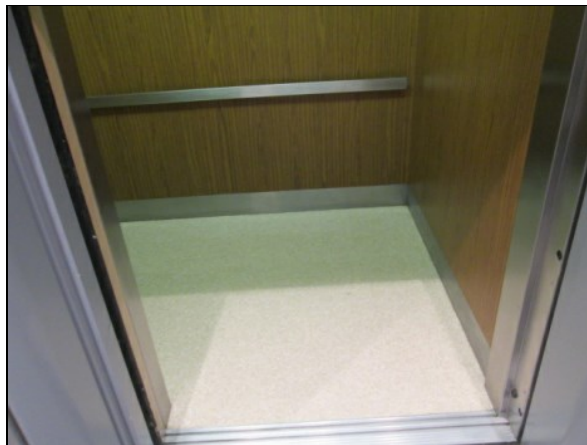
Comments: The cab appears to be in good condition. No heavy abuse or damage noted. Best to remodel at regular intervals to preserve the school's aesthetic standards.

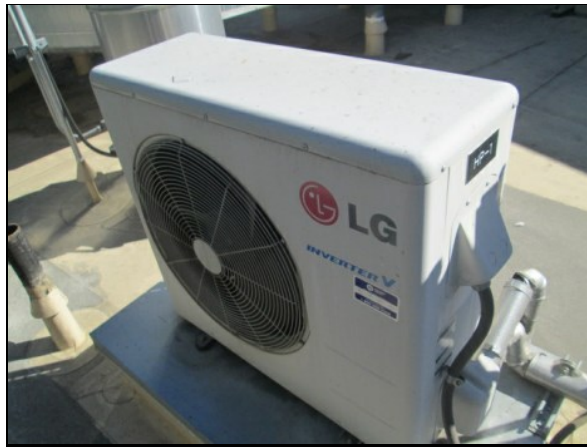
Comments: The units show minor wear and usage at this time. No rust or other forms of severe damage detected. In good general condition.

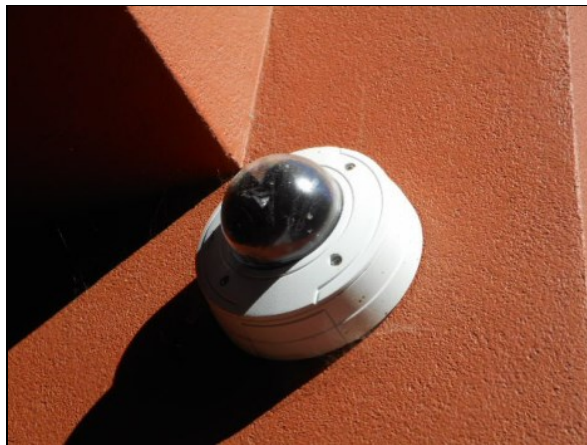
Comments: This component provides for new or additional cameras recording equipment and software upgrades as deemed necessary by the Board. Equipment was not tested during the site inspection. Best to have the system inspected and tested on a regular basis by your service provider.

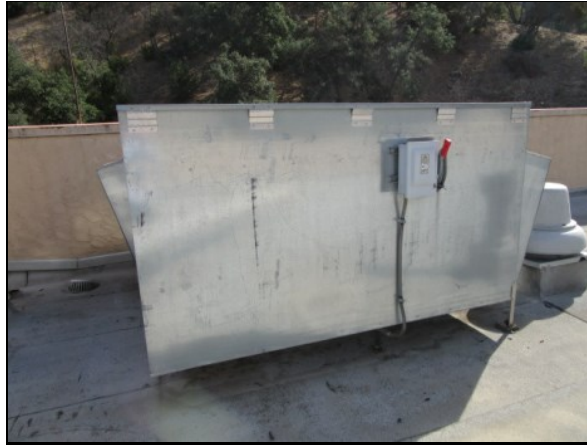
Comments: The air handlers are reportedly functional but have reached extended useful lives. No problems reported but the school should fund with the expectation that failure could occur at anytime.

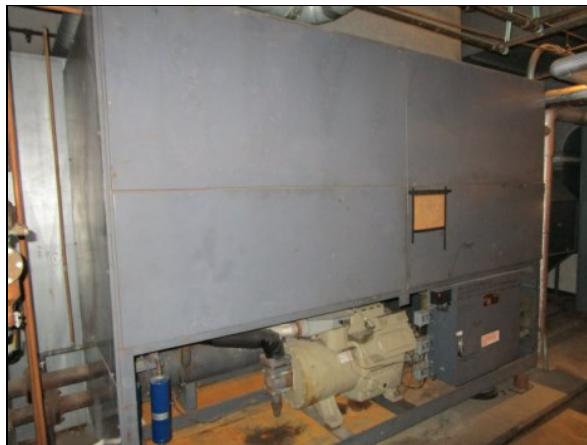
Comments: Old. Unknown vintage. While immediate replacement may not be needed it is best to fund with the expectation that failure could occur at anytime.

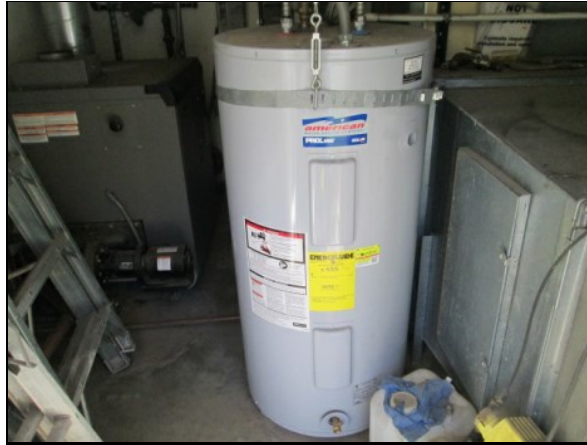
Model #: E62-30L-045D Serial #: 1325T470227.

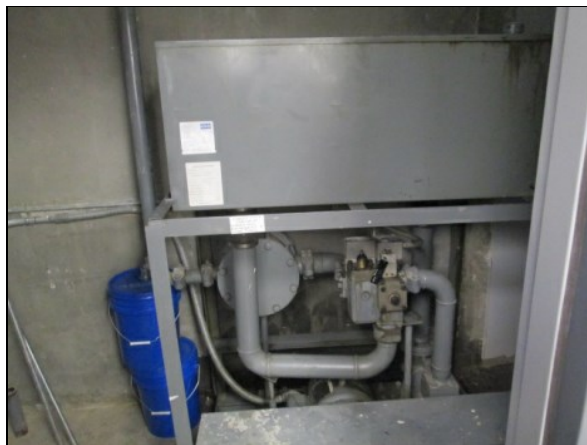
Comments: Refurbished in last few years. Reportedly in good functional condition, minimal repair calls. We are not licensed to inspect these systems. Not tested during inspection but found to be operational. Anticipate the need to modernize a hydraulic elevator every 20-30 years. Modernization consists primarily of replacing the controller door operator pumping unit valve tank push-button fixtures &amp; indicator fixtures.
