SAMPLE
Reserve Study

UPDATE - No Site Visit

[YOUR PROPERTY NAME]

Report #: 17918-15

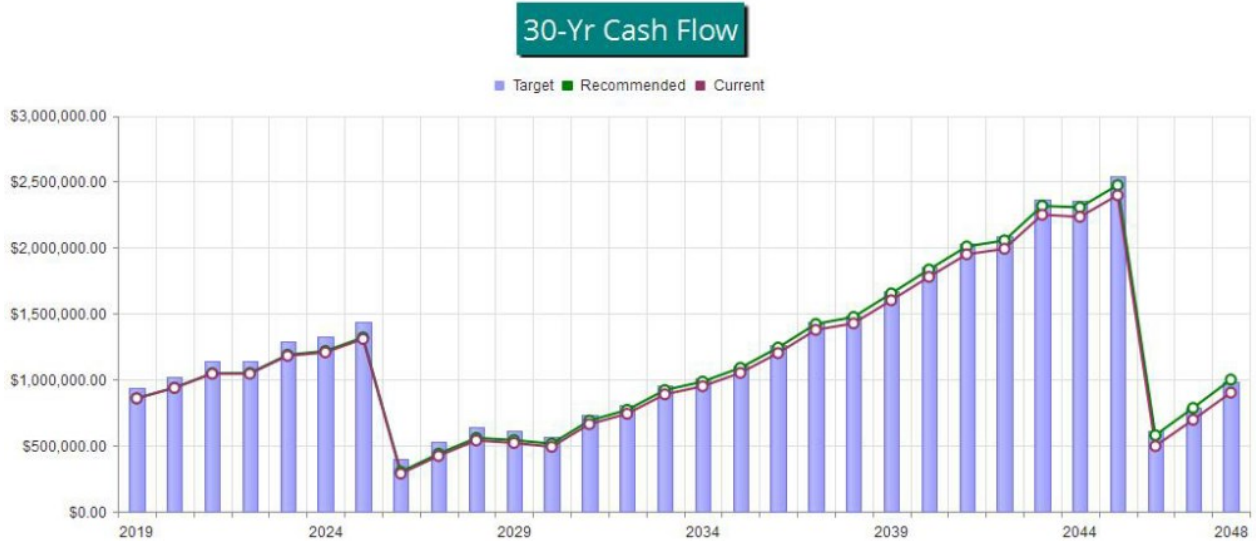
Figure 3

The following chart shows your Reserve balance under our recommended Full Funding Plan and at your current budgeted contribution rate, compared to your always-changing Fully Funded Balance target. Note that while your asphalt project is very expensive, your Reserve Fund is projected to be sufficient to handle that expense.

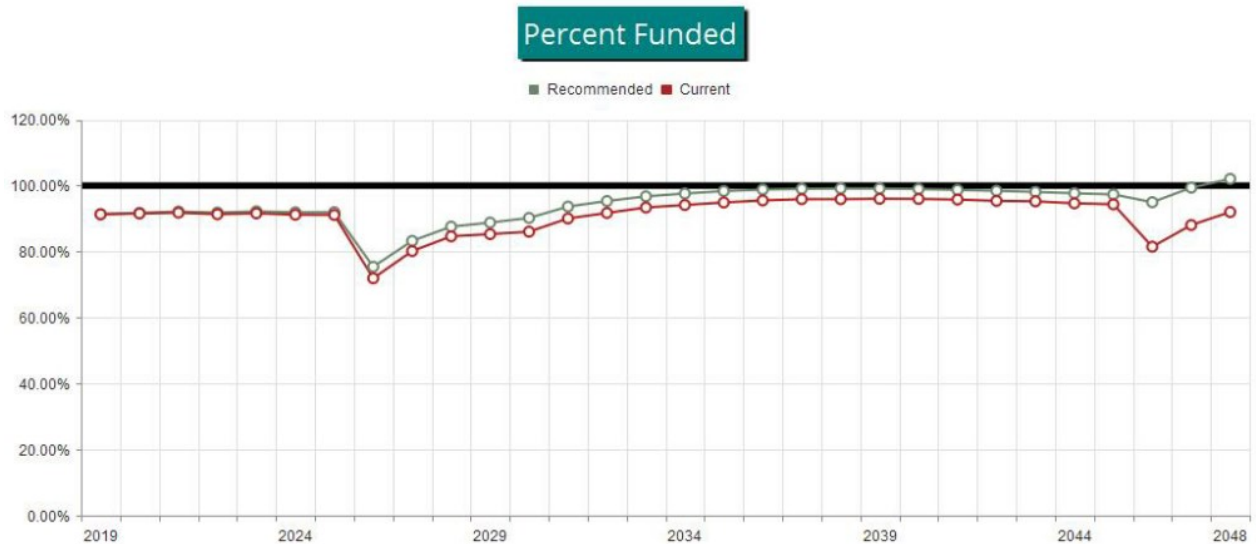
Figure 4

This figure shows the same information plotted on a Percent Funded scale. It is clear here to see how your Reserve Fund strength approaches the 100% Funded level under our recommended multi-yr Funding Plan. Being well funded provides some margin should your asphalt project occur earlier or more expensive than anticipated.
