# **AVOID THE STICKER HEART ATTACK OF REPAIRS**

by Elliott Meier  
Project Manager  
Bethco Builders  
[www.BethcoBuilders.com](http://www.BethcoBuilders.com)

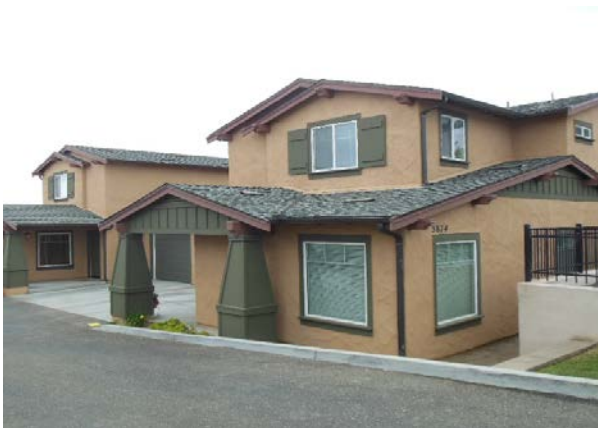
**BUILDING A**

Let's take a look at two different buildings and the result of performing routine maintenance and deferring maintenance. In the photos above, building "A" has undergone periodic maintenance to keep the wood trim sealed and water tight. There may be some areas where paint is peeling or flaking, but the overall condition of the materials are in good shape. The cost to make the minor repairs and apply a new coat of paint, while expensive, is certainly within budget. Building "B" has not undergone periodic maintenance; instead no maintenance has occurred for many years. The paint and sealant has failed and peeling off, exposing the raw wood to the elements. The lack of useful paint and sealant allows water to penetrate the wood and start the deterioration process. Since no work has occurred for some time, the wood has started deteriorating. The costs involved with making these repairs are much more significant; not only does the deteriorated wood itself need to be replaced, but the surrounding stucco needs to be removed in order to replace the wood. The size and scope of the repair for building "B" has doubled or tripled in size compared to building "A." The cost for repairing building "B" could not only result in a sticker heart attack for the board of directors, but also for the residents of the community when they receive the unexpected special assessment letter in the mail.

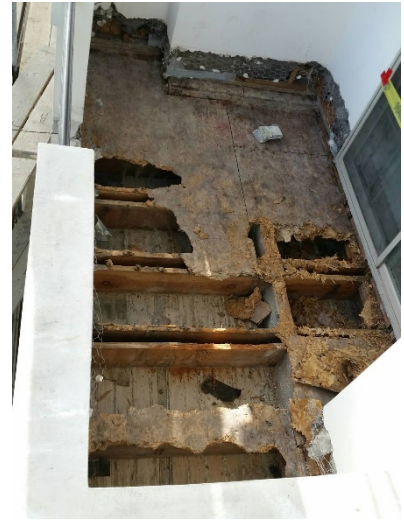
**INVASIVE REPAIRS DUE TO LACK OF MAINTENANCE**

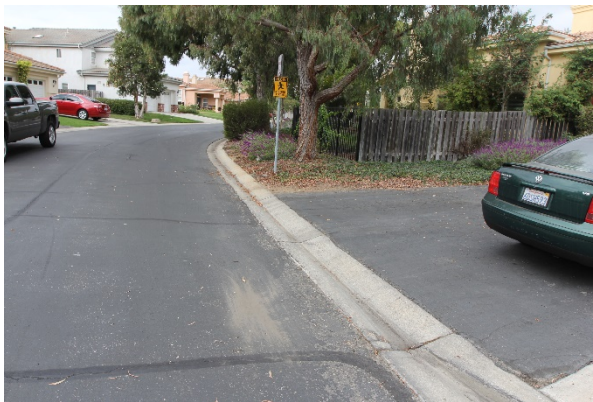
**STREET A**

In the photos above, street “A” has some minor cracking in the asphalt, but nothing appears to be too major. Street “B” on the other hand has large cracks crisscrossing the asphalt, in a pattern commonly referred to as “alligator cracking.” Alligator cracking is the result of water seeping through cracks in the asphalt, saturating the underlying material (known as base), resulting in the asphalt moving more than it was designed to move.

If caught soon enough, like in Street “A”, the crack can be filled with a tar-like material and the entire street can be covered with a “slurry seal” that will protect the asphalt from water seepage and maintain the elasticity of the asphalt. The result of Street “B”, however, will be a full removal and replacement of the asphalt and base material (as can be seen in the adjacent photograph), providing another source of sticker heart attack for the board of directors and source of inconvenience for the residents when they cannot access their driveways for days at a time due to the streets being torn up.

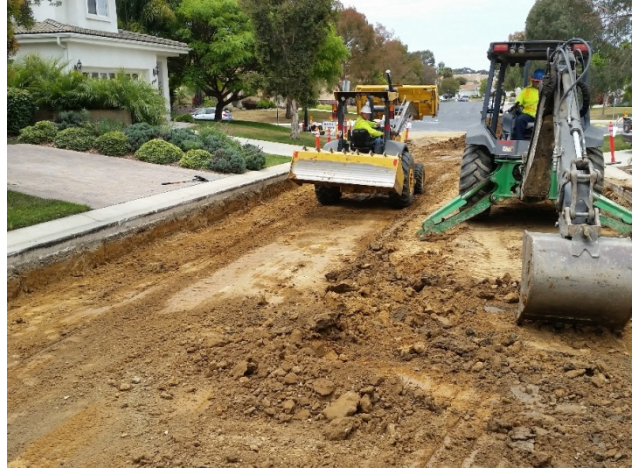
**THE RESULT OF POOR MAINTENANCE**
