Sample Property
Private Club
Anywhere, CA

Report #: 17918-1
Beginning: January 1, 2026
Expires: December 31, 2026

RESERVE STUDY
Update "With-Site-Visit"

February 16, 2026

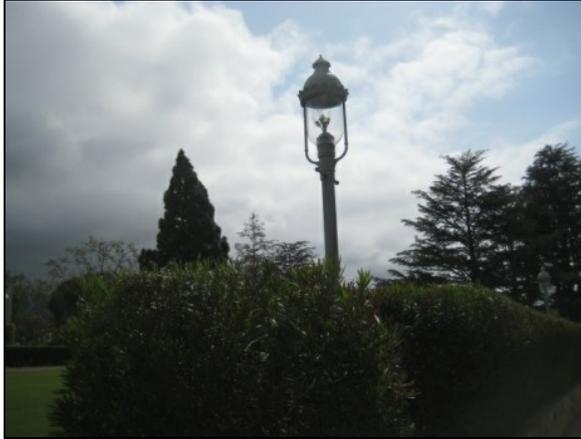
Remaining Life:

5 years

**Lower Estimate:**

\$ 27,000

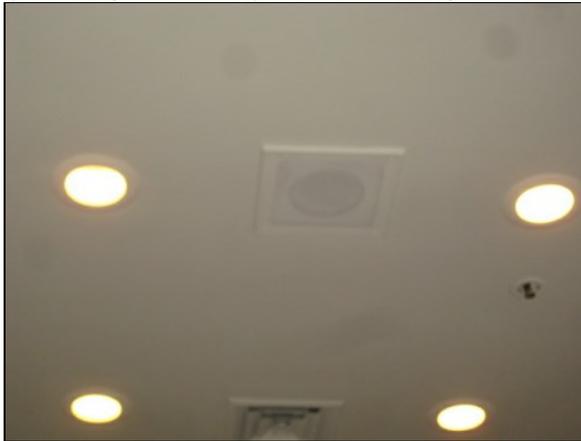
Remaining Life:

0 years

**Lower Estimate:**

\$ 6,750

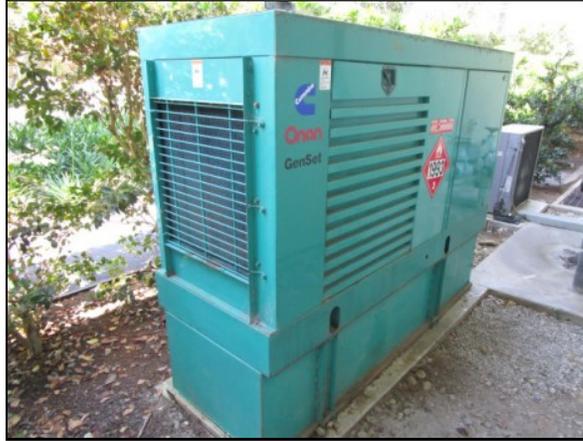
Useful Life:
10 years

Remaining Life:
3 years

Lower Estimate:

\$ 18,000

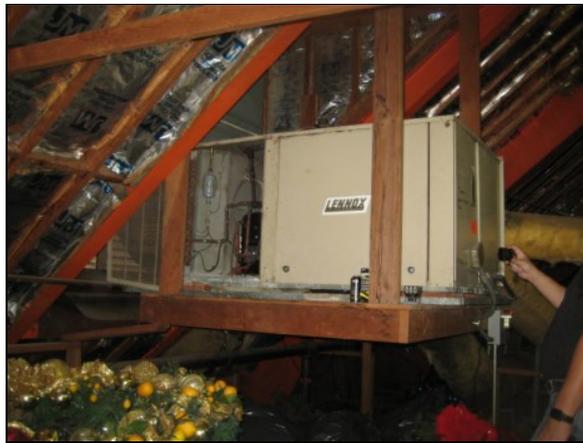
Comp #: 330 Clubhouse HVAC - 1/6 Replace

History: Unknown age. Last unit was replaced in 2012

Useful Life:
4 years

Remaining Life:
0 years

Lower Estimate:

\$ 14,900

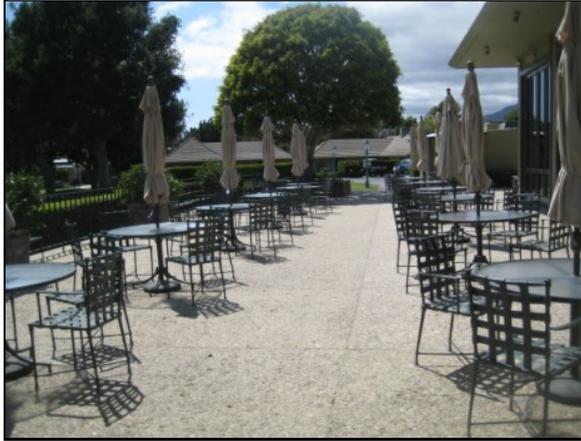
Comp #: 404 Terrace Patio Furniture - Replace

Useful Life:
10 years

Remaining Life:
3 years

Lower Estimate:

\$ 31,500

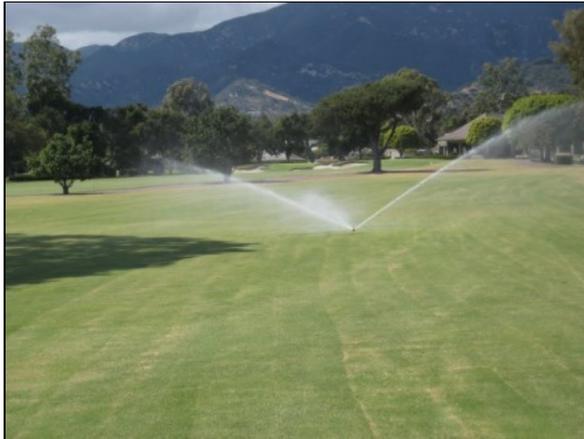
Useful Life:
15 years

Remaining Life:
12 years

Lower Estimate: \$ 698,000 **Higher Estimate:** \$ 854,000

Cost Source: Client Cost History

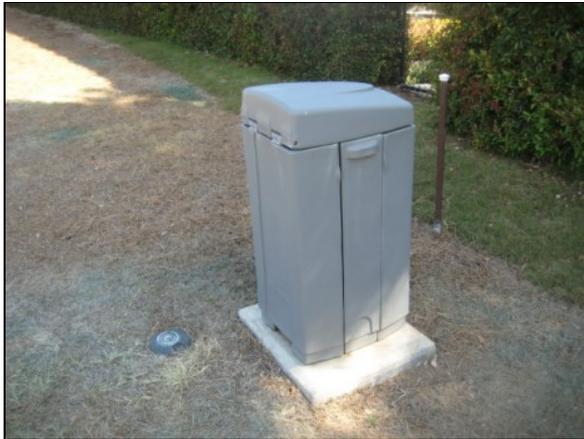
Useful Life:
20 years

Remaining Life:
19 years

Lower Estimate: \$ 304,000 **Higher Estimate:** \$ 371,000

Cost Source: Research with local vendor
