# ASSOCIATION RESERVES®

## RESERVE STUDY

## PRIVATE CLUBS and RECREATION CENTERS

Level of Service: **Update "With-Site-Visit"****January 1, 2027 through December 31, 2027****Findings & Recommendations****as of January 1, 2027**

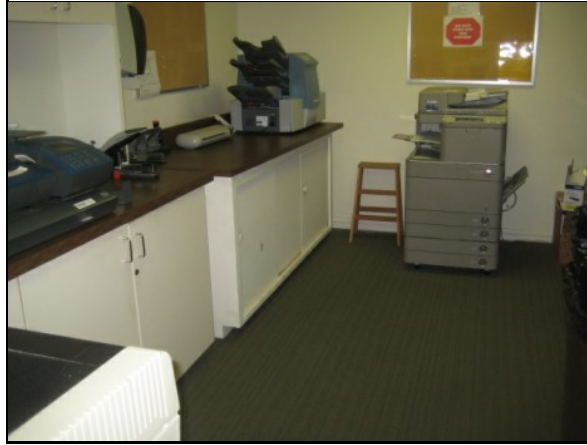
**Comp #: 917 Office Eqp - Replace****Approx Quantity: 1 Extensive pieces****Location:** Office/admin areas of clubhouse**Funded?:** No. Numerous small pieces, all replaced as needed as an ongoing operational expense, not Reserves.**History:****Comments:** Fair condition, all pieces functional. Range of newer and older pieces. Some of the larger pieces leased (copier, mail machine).**Useful Life:****Remaining Life:**
