# VACATION OWNERSHIP RESORT

## RESERVE STUDY

[YOUR PROPERTY NAME]

Report #: 17918-0

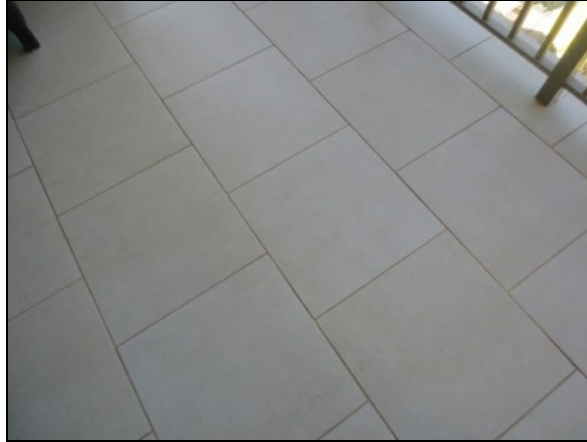
### Comp #: 104 Balcony Decks - Seal/Repair

Lower estimate to seal/repair, \$2/GSF

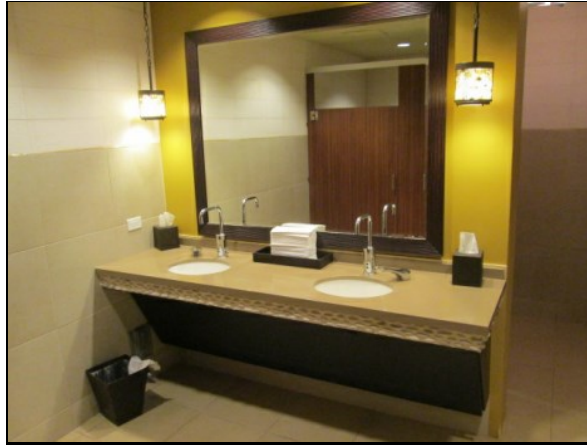
Comments: Bathrooms show minor wear and tear at this time. No advanced deterioration or abuse detected. In good and attractive condition.

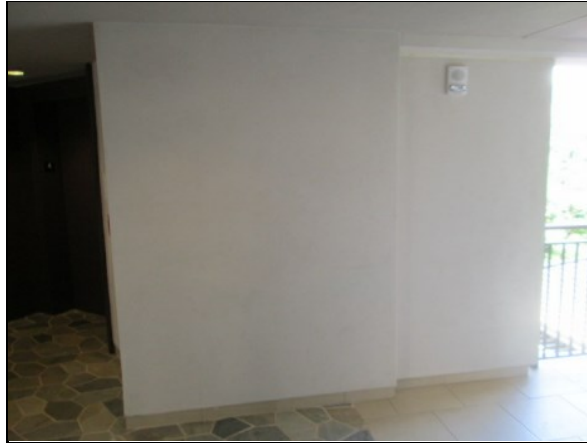
Comments: Surfaces show minor marks and scuffs at this time. No advanced discoloration or wear noted. Paint coverage is in good condition. Stick to repaint cycles to maintain appearance.

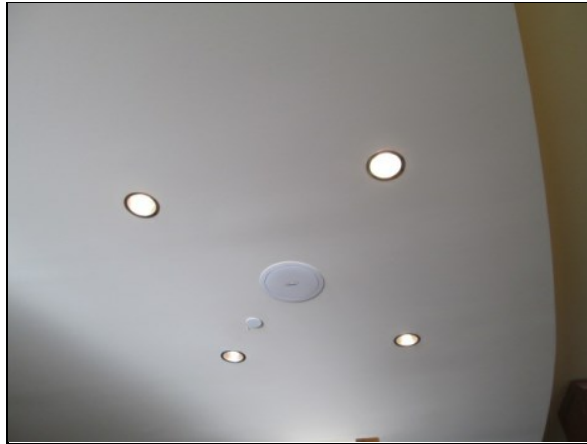
Comments: All are intact and observed to be functional. General wear/tear and aging evident. In good condition. Lights include: (12) recessed and (8) spot lights

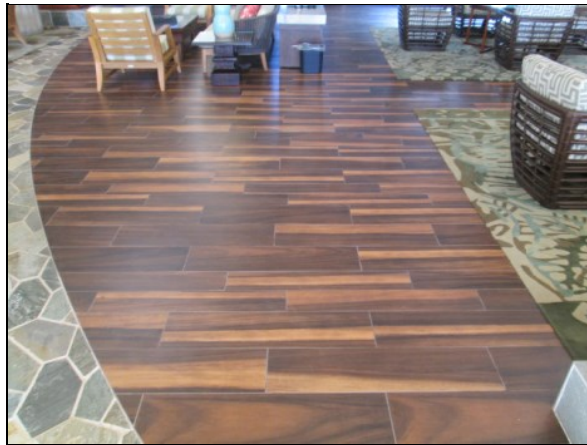
Comments: Wood floor surfaces looked to be in good condition. All surfaces looked clean and are well kept. Daily cleaning and sweeping of wood floors was observed. There is no expectation for a full replacement within the scope of this report. Plan on periodic refinishing to maintain this asset.

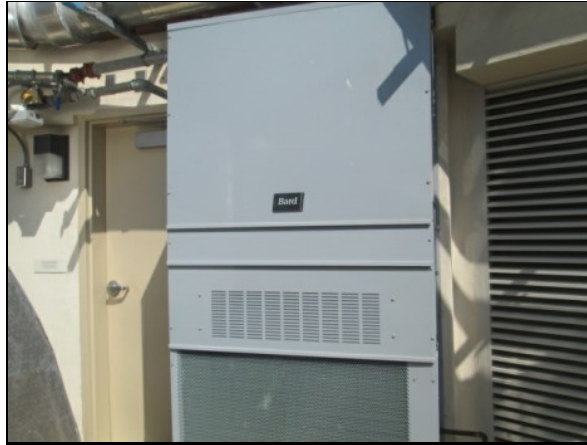
Comments: The elevator room units are aging well at this time. General grime and wear observed during inspection. No service problems reported and no advanced damage witnessed. In good condition. Model: WA4S3-C0ZBP4XXJ S/N: 384B143099811-02.

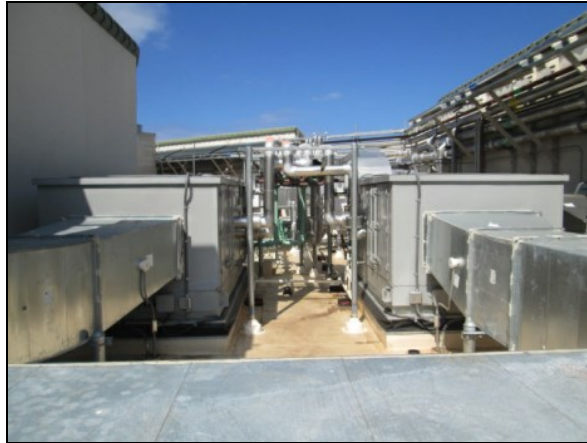
Comments: These units show minor wear and are reported to be functional. No significant aging or abuse witnessed at this time. In good condition. Model: CSAA017UBG00 (1) S/N: K14A00885 (2) S/N: K14A00893.

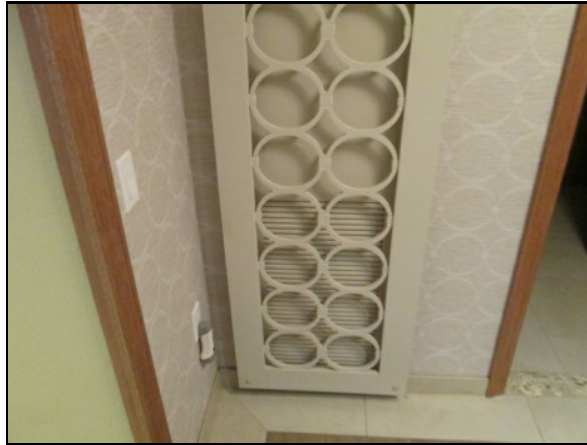
**Comp #: 303 Room HVAC Units - Replace****Quantity: (131) Units**

Comments: HVAC systems are all reported to be functional with no service related issues at this time. Minor wear noted. In good condition.

Lower estimate to replace with similar units,  
\$6000 ea

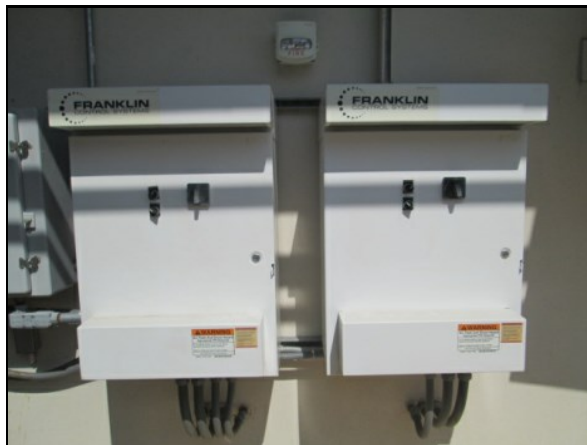
**Comp #: 304 Cooling Tower VFD's - Replace****Quantity: (2) 7.5 HP Franklin**

Comments: Units appear to be aging normally with no advanced forms of deterioration evident. Both are reported to be functional with no issues. In good condition.

Lower estimate to replace

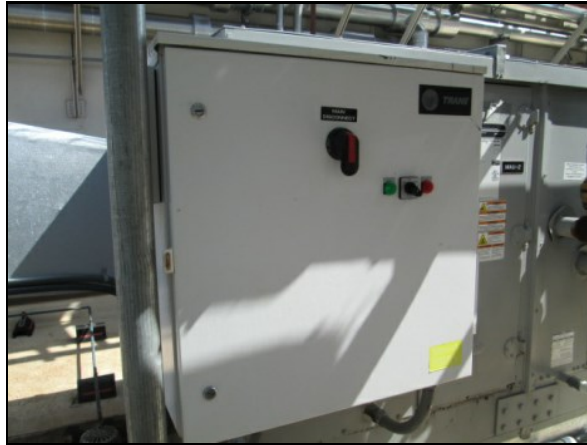
**Comp #: 304 Make-Up Air VFD's - Replace****Quantity: (2) 10 HP Trane**

Comments: Units are aging well at this time. No reports of service related issues. No rust or other forms of advanced deterioration observed. In good condition. (1) S/N: 787404Y024 (1) S/N: 787304Y024.

Lower estimate to replace, installed

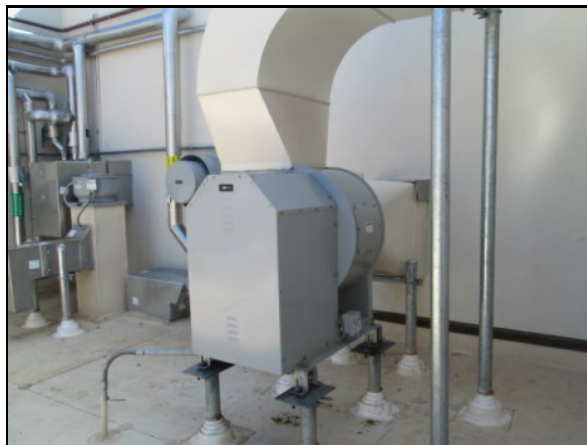
**Comp #: 306 Exhaust Fans - Replace****Quantity: (35) Greenheck**

Comments: Systems not tested during inspection. These fans are designed to ensure safe air quality levels in the guest units. No reports of service related issues at this time. General wear and tear due to outdoor exposure, but no rust or damage observed. In good condition.

Lower estimate for replacement units,  
installed

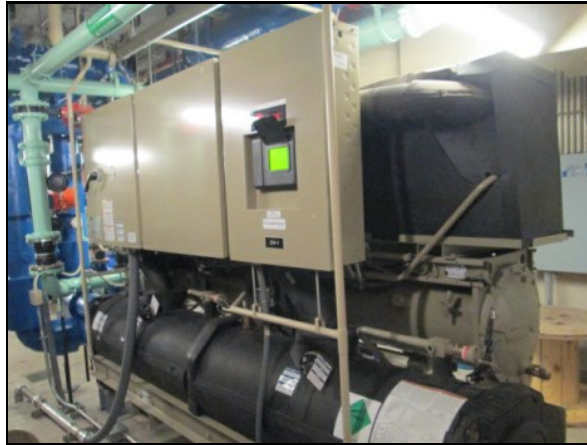
**Comp #: 309 Chillers - Replace****Quantity: (2) Trane 130T**

Comments: These water cooled chillers are reported to be functional. Both units appear to be aging well at this time. No severe damage or abuse evident. In good condition. Model: RTWD130F (1) S/N: U14A08346 (1) S/N: U14A08345.

Lower estimate for replacement unit, installed

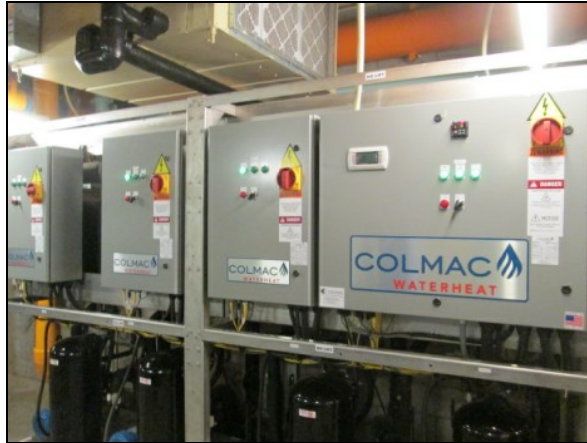
**Comp #: 310 Heat Pumps - Replace****Quantity: (4) Colmac Units**

Comments: Heat pumps are reported to be functional. General wear noted but all appear to be aging normally. In good condition. Each unit has (1) 15 ton compressor and (1) 2 HP circulating pump. Heat Pumps include: Model: HPW60M-D-PLC.

Lower estimate for replacement units,  
installed

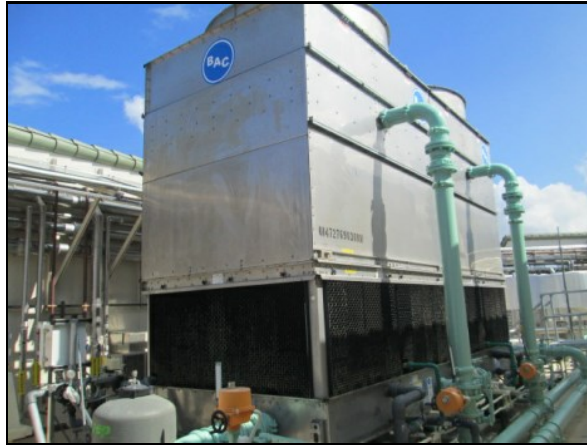
Comments: Funding has been provided for periodic refurbishment of the cooling tower, at approx halfway point of unit's life. Estimated work includes blade and fan assembly repairs.

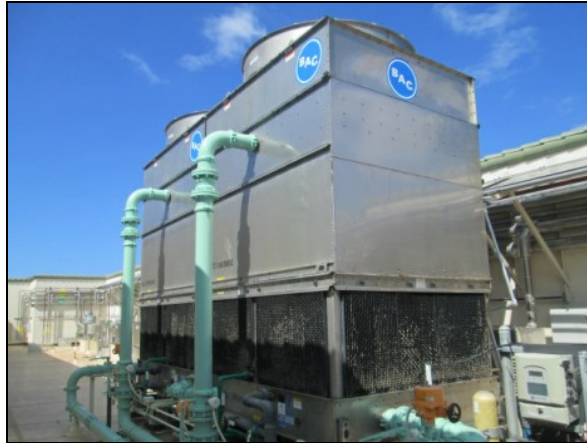
**Comp #: 312 Cooling Tower - Replace****Quantity: (1) BAC PT2 282 Ton**

Comments: Cooling tower is aging well and reported to be functional. General wear observed but no advanced deterioration witnessed. In good condition. Model: PT2-0709A-3J2.

Lower estimate for replacement unit, installed

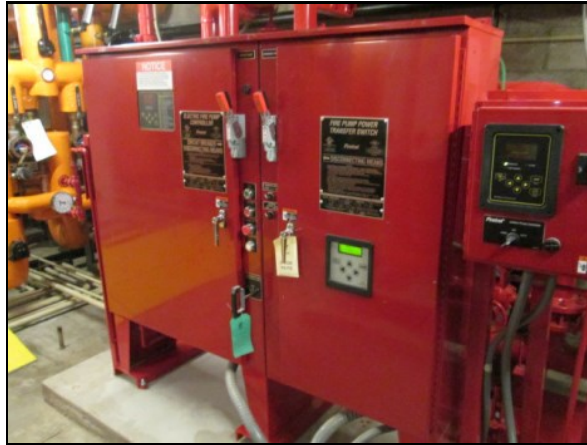
**Comp #: 314 Fire System Controller - Replace****Quantity: (1) Firetrol Controller**

Comments: System not tested during inspection. Reported to be functional at this time. No physical deterioration observed. Observed to be aging well. In good condition. Includes: (1) transfer switch.

Lower estimate for replacement controller,  
installed

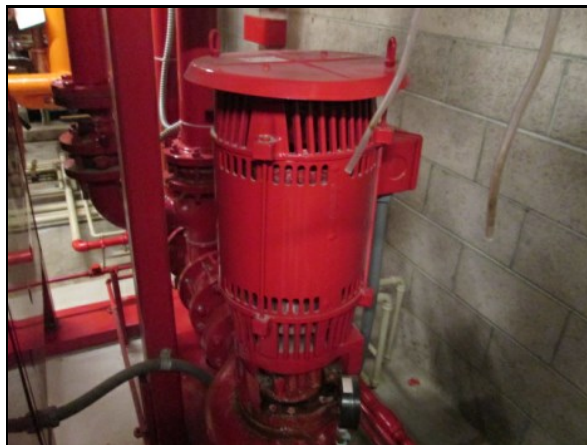
**Comp #: 316 Booster Pumps - Replace****Quantity: (2) 20 HP Pumps**

History: Replaced in 2017

Comments: Pumps are reported to be functional at this time (original pumps had a problem). No significant damage or abuse evident during inspection. In good condition. Plan on periodic replacement to ensure reliability.

Lower estimate for replacement pumps,  
installed

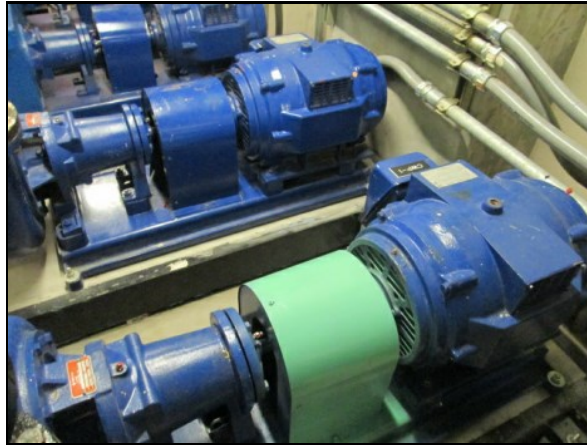
**Comp #: 316 Chilled Water Pumps - Replace****Quantity: (2) Marathon Pumps**

Comments: Pumps are aging normally at this time. No observable deterioration. No reports of service issues or signs of advanced deterioration evident. In good condition. Model: 286TTDCA6026 HP: 30 and 284TTDCA6026 HP: 25.

Lower estimate to replace

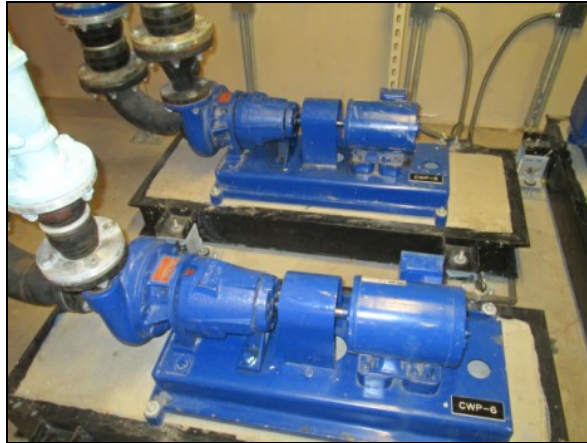
**Comp #: 316 Condensor Water Pumps - Replace****Quantity: (4) Pumps**

Comments: Pumps exhibit minor deterioration and usage (some grime buildup). No reports of problems at this time. In good and functional condition. Includes: (2) 30 HP and (2) 1 HP.

Lower estimate to replace

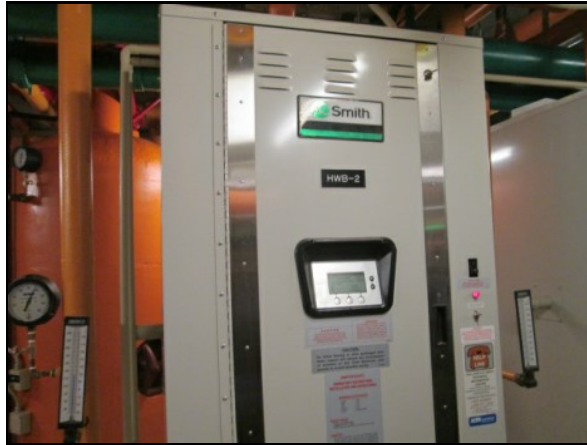
**Comp #: 801 Boilers - Replace****Quantity: (2) 140 Gal. A.O. Smith**

Comments: These service the hot water system. Both are aging well and reported to be functional. No observable deterioration at this time. In good condition. Model: DVE140A (1) S/N: 1418R000047 (1) S/N: 1418R000046.

Lower estimate to replace with similar units,  
installed

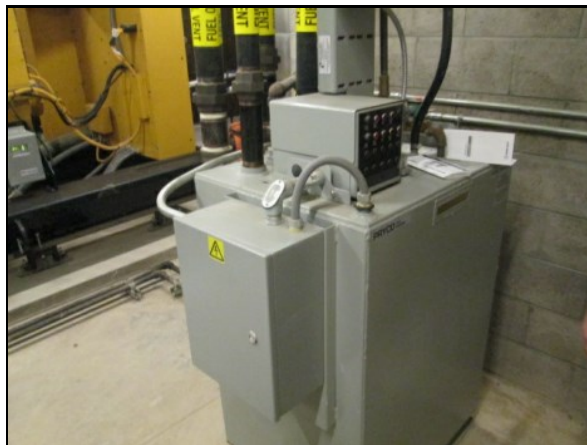
**Comp #: 802 Fuel Tank - Replace****Quantity: (1) Pryco Tank**

Comments: Minor wear and usage evident during inspection. Also includes (1) transfer switch and (1) Veeder Root fuel panel. No advanced damage or abuse noted at this time. In good condition.

Lower estimate to replace with similar above-  
ground tank

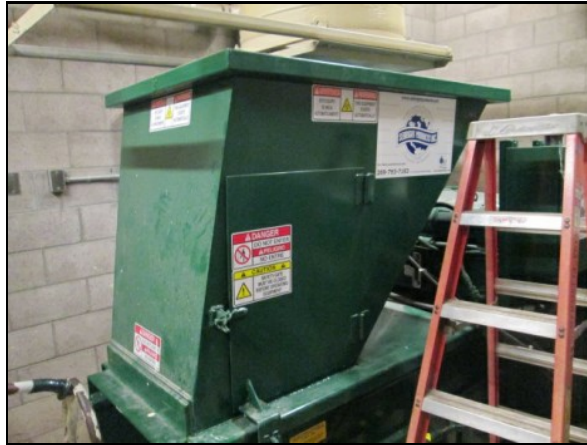
**Comp #: 807 Trash Compactor - Replace****Quantity: (1) Sebright**

Comments: Minor wear/tear and usage evident, normal due to a few years of use. No severe damage or abuse noted during inspection. In good functional condition. Model: AP2424 S/N: 141111230.

Lower estimate for replacement unit, installed

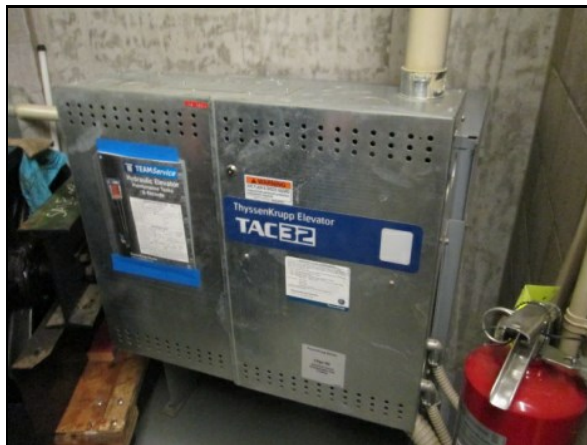
Comments: Appears clean, no hydraulic fluid leakage. We are not licensed to inspect these systems. Not tested during inspection but found to be operational. Anticipate the need to modernize a hydraulic elevator every 20-30 years. Modernization consists primarily of replacing the controller door operator and push-button fixtures.

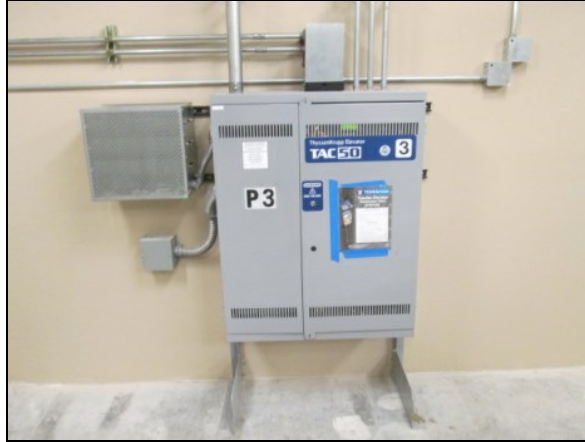
Comments: We are not licensed to inspect these systems. Not tested during inspection but found to be operational. Anticipate the need to modernize a traction elevator every 20-30 years. Modernization consists primarily of replacing the controller door operator and push-button fixtures.

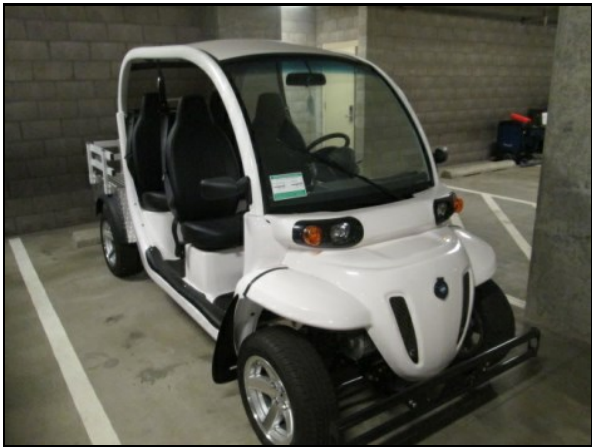
**Comp #: 1810 Utility Vehicle - Replace**

Location: Mechanical room  
Funded?: Yes. Meets National Reserve Study Standards four-part test  
History: New earlier this year in 2018  
Comments: This electric vehicle shows minor wear and usage. No advanced deterioration or abuse witnessed. In good functional condition.

Lower estimate to replace with similar vehicle

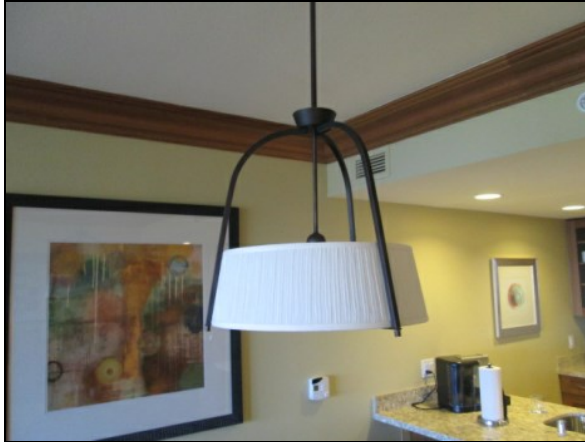
### Comp #: 325 Interior Lights - Replace

Comments: Fixtures are aging well at this time. No severe damage or abuse detected during inspection. In good and attractive condition.

Lower estimate to replace, \$150 ea on average

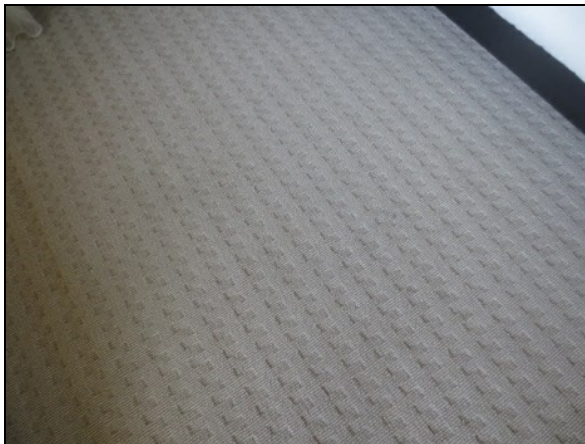
### Comp #: 601 Carpet - Replace

Comments: Carpet was clean and had an attractive appearance. No fraying or staining was observed, no wear patterns. In good overall condition.

Lower estimate to replace, \$50/GSY

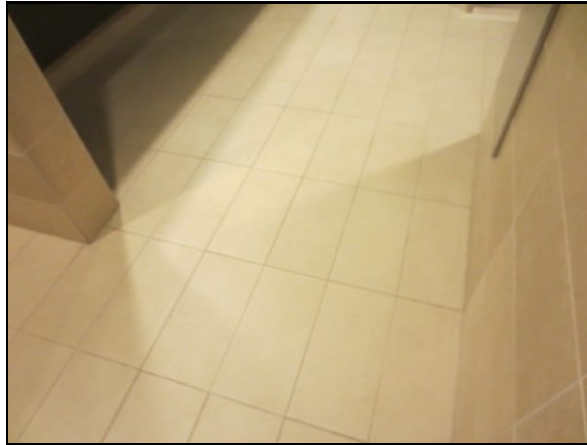
**Comp #: 603 Tile Floor - Replace****Quantity: Approx 92500 GSF**

Comments: Floors were intact and aging normally. No cracks or significant grime build-up evident. In good overall condition. Plan on eventual replacement to maintain appearance.

Lower estimate to replace, \$12/GSF

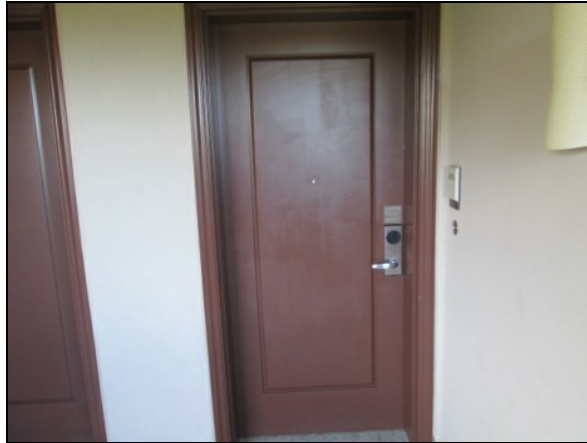
**Comp #: 701 Front Doors - Replace****Quantity: (131) Doors**

Comments: These metal doors are intact and functional, appearing to be heavy-duty. General wear and usage observed but no advanced damage or abuse detected during inspection. In good condition.

Lower estimate to replace, \$1000 ea, installed

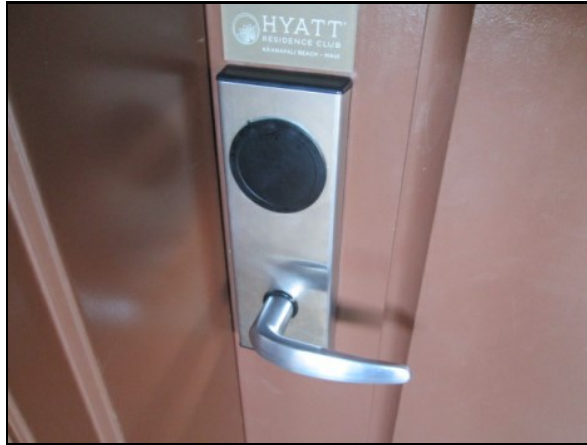
**Comp #: 709 FOB Entry System - Replace****Quantity: (131) Units**

Comments: System and FOBs worked successfully at every opportunity during our inspection. System should be tested and maintained on a regular basis. Observed to be fully functional at this time. Best to fund for periodic replacement.

Lower estimate to replace, \$380 ea

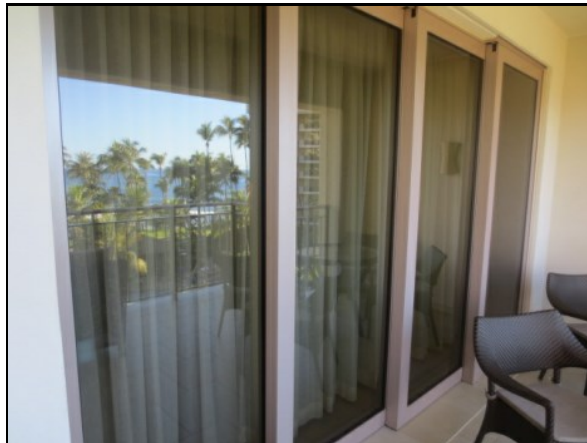
**Comp #: 710 Balcony Glass Sliding Drs - Replace****Quantity: (262) Sliding Doors**

Comments: The doors that were tested were in working condition with no issues. Doors opened and closed very smoothly and locked securely. No damage or issues were reported. In good condition. Expect salt-air environment will reduce life expectancy under 20 yrs.

Lower estimate to replace, installed, \$1900 ea

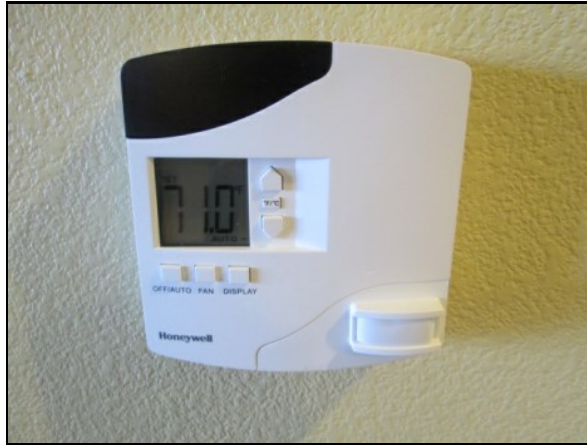
**Comp #: 900 Thermostats - Replace****Quantity: (131) Units**

Comments: Thermostats were observed to be functional during inspection. No reports of service issues at this time. No severe deterioration noted. In good overall condition.

Lower estimate to replace with similar units,  
\$150 ea

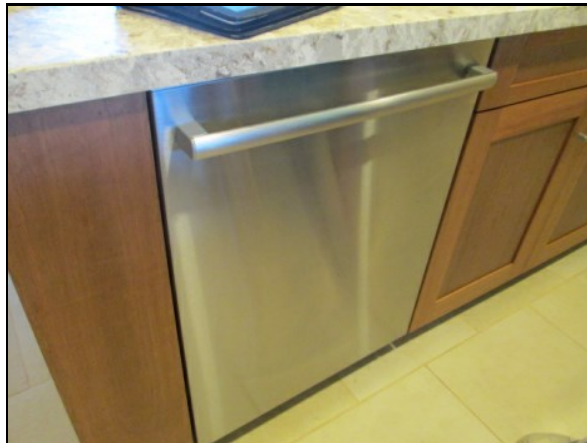
**Comp #: 901 DW, MW, Oven - Replace****Quantity: (131) sets**

Comments: Minor signs of usage evident during inspection. No significant deterioration or wear witnessed at this time. In good condition. Expect some minor replacements, but plan to replace majority on this interval.

Lower estimate to replace, installed

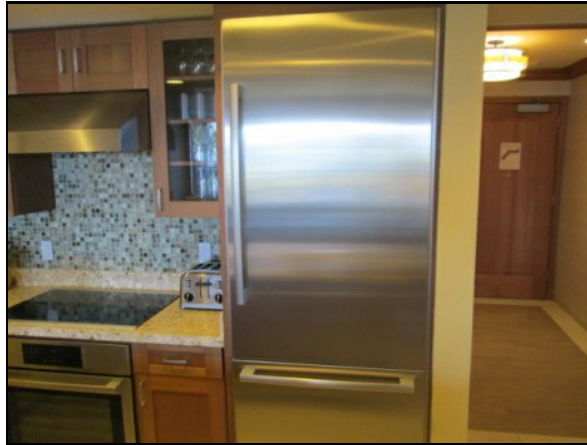
**Comp #: 901 Refrigerators - Replace****Quantity: (131) Refrigerators**

Comments: The refrigerators are high end bottom freezer units with glass shelves and LED interior lights. All are aging well with no advanced deterioration or abuse evident at this time. In good condition.

Lower estimate to replace, \$6000 ea

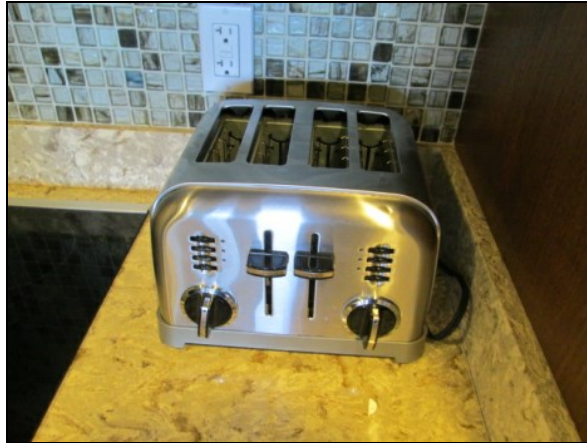
**Comp #: 901 Small Appliances - Replace****Quantity: (262) Assorted Appliances**

Comments: This is made up of Cuisinart toasters and single serve coffee machines. The appliances exhibit minor wear and are aging normally at this time. In good condition.

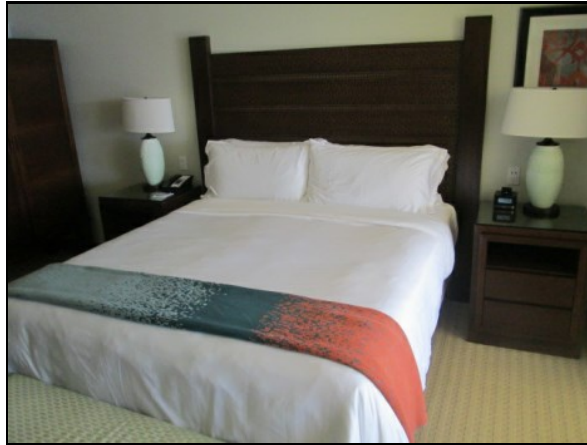
**Comp #: 902 Mattress Sets - Replace****Quantity: (255) Mattress Sets**

Comments: Mattress sets are high quality and attractive. No severe damage or abuse noted at this time. In good overall condition. Plan on frequent replacement to maintain comfort and appearance.

Lower estimate to replace, \$7000 ea

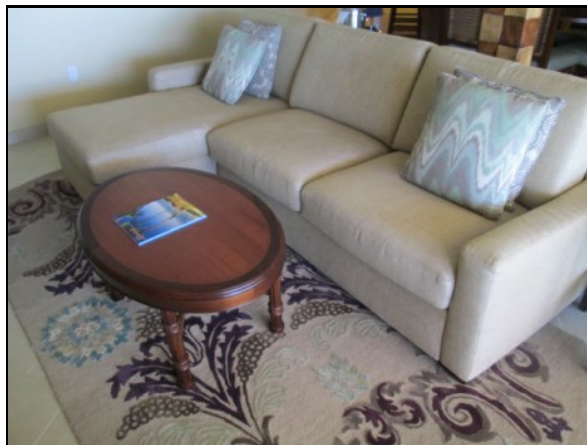
**Comp #: 903 Soft Good Furniture - Replace****Quantity: (131) Units**

Comments: Furniture was in good condition overall. No scuffing tearing or chipping was observed on any of the surfaces. Plan on periodic replacement to maintain appearance. Pieces include: (255) loveseats (131) couches (131) upholstered chairs (772) table lamps (255) floor lamps and (131) area rugs.

Lower estimate to replace, \$5900/unit

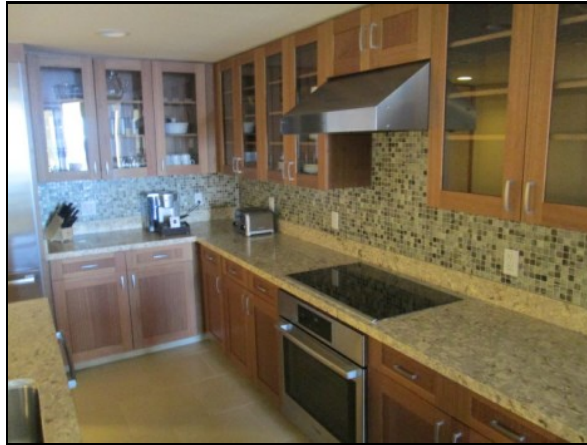
Comments: Kitchens are modern high end and attractive. Cabinets counters and back-splashes are all aging well at this time. In good condition. Plan on periodic refurbishment to maintain aesthetics.

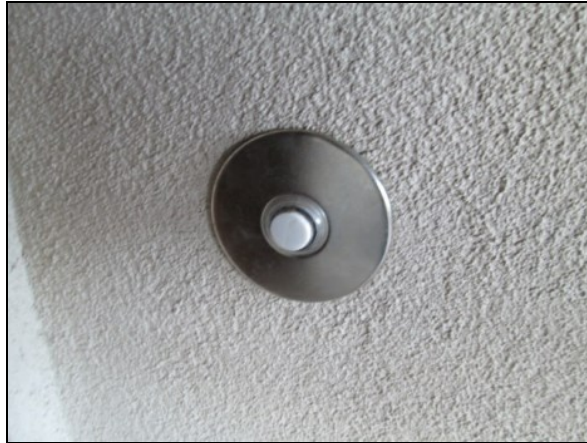
**Comp #: 905 Doorbells - Replace****Quantity: (131) Door Bells**

Comments: The door bells were observed to be functional during inspection. All are intact and aging normally. No advanced deterioration noted. In good condition.

Lower estimate to replace, installed @ \$400  
ea

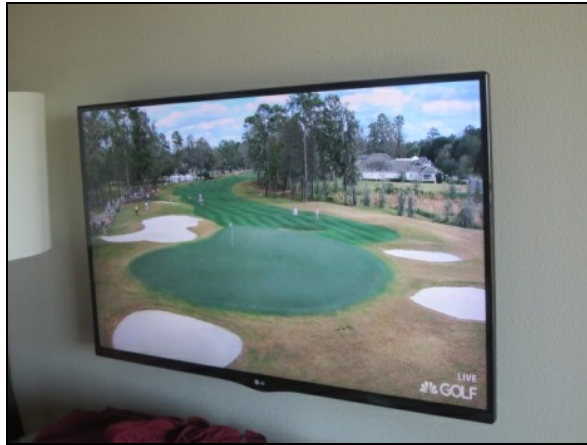
**Comp #: 906 TV and Entertainment - Replace****Quantity: (131) Units**

Comments: This component includes all the televisions and any supporting equipment (speaker system Blu-ray players and TV input panel). All equipment that was tested was in working condition. TVs were in good condition with no distortion and a very clear picture. Good quality, but low Useful Life due to being technologically dependent.

Lower estimate to replace, \$5300/unit (avg)

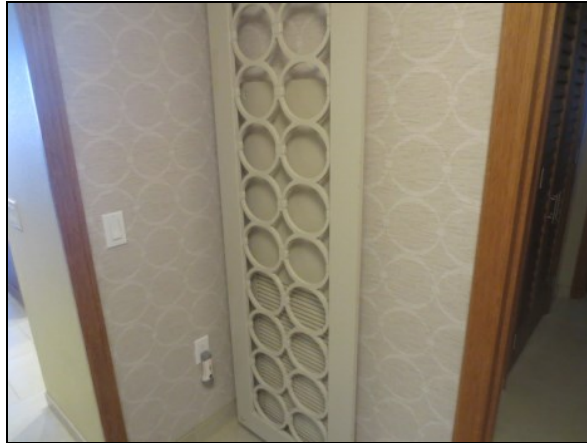
**Comp #: 907 Wallcovering - Replace****Quantity: Approx 27600 GSF**

Comments: Wallpaper was clean and had a very high quality look. No peeling or fraying was observed. In good overall condition.

Lower estimate to replace, \$5/GSF

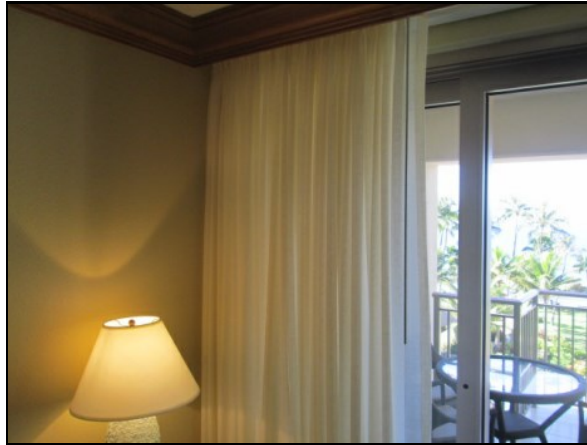
**Comp #: 908 Window Treatments - Replace****Quantity: Approx (275) Curtains**

Comments: Curtains were clean and were lacking any signs of significant deterioration. Some of the rods were reported to break when they are pulled in a forcible manner. In good overall condition. Best to replace rods as needed as an operating expense.

Lower estimate for replacements,  
\$400/location

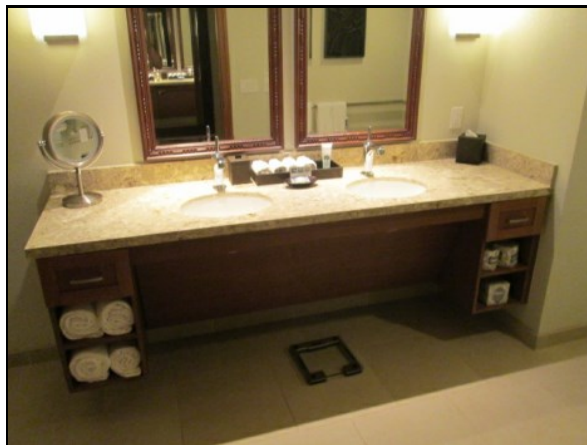
Comments: Bathrooms are attractive and exhibit current styling. Fixtures show minor wear and usage but no advanced deterioration detected. In good condition.

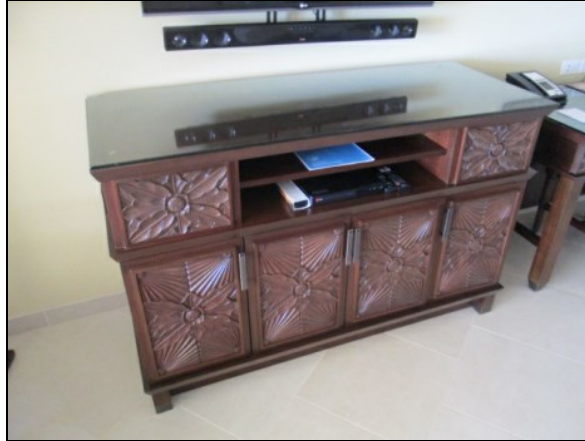
**Comp #: 910 Case Good Furniture - Replace****Quantity: (131) Units**

Comments: Furniture is sturdy attractive and high quality. Minor light use noted but no significant aging or deterioration witnessed. In good condition. Plan on periodic replacement to maintain appearance. Pieces include: (131) dining tables (131) desks (810) dining chairs (12) console tables (510) nightstands (255) dressers (386) mirrors (131) coffee tables (131) built-in hutches (262) end tables and (36) bar stools.

Lower estimate to replace, \$15,250/unit

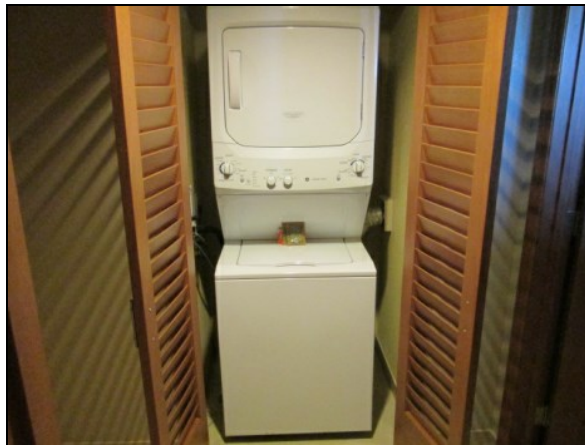
**Comp #: 915 Washers/Dryers - Replace****Quantity: (131) Stacked Sets**

Comments: The laundry machines exhibit minor signs of wear and usage. No severe damage or abuse detected at this time. In good overall condition.

Lower estimate to replace, \$1300 ea

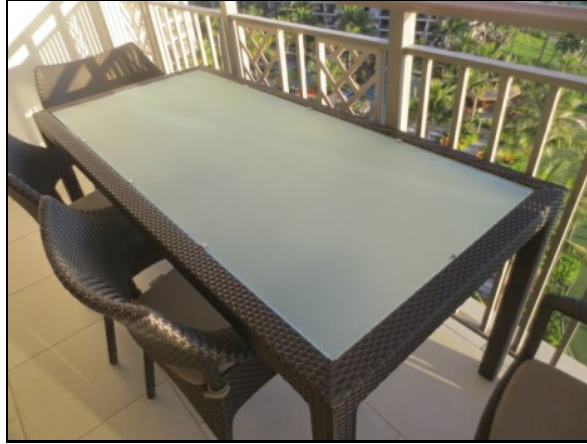
**Comp #: 918 Balcony Furniture - Replace****Quantity: (1310) Assorted Pieces**

Comments: Furniture was all uniform and high quality. No scuffing or deterioration was observed on any of the pieces inspected. In good condition. Best to replace pieces at the same time to maintain a uniform appearance. Furniture includes: (524) chairs (262) cushioned chairs (131) tables (131) drink tables (131) ottomans (131) lounge chairs and assorted pillows.

Lower estimate for replacement pieces,  
\$7000/villa

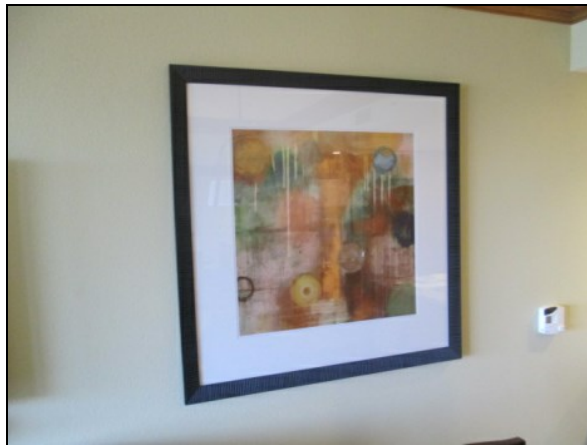
**Comp #: 920 Interior Artwork/DÃ©cor - Replace****Quantity: (131) Units**

Comments: Artwork/decor varies depending on room layout. All pieces are intact and attractive. In good condition. Plan on periodic replacement to maintain appearance.

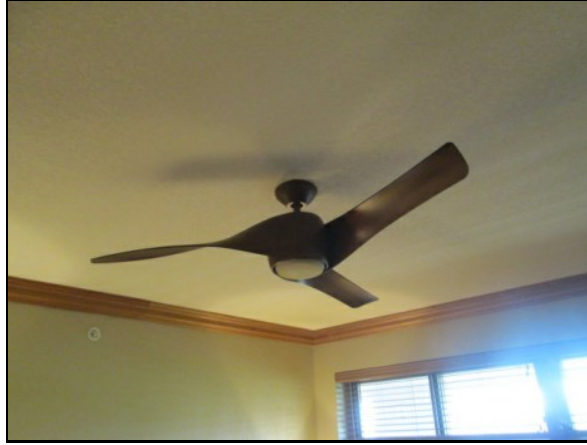
**Comp #: 922 Ceiling Fans - Replace****Quantity: (386) Fans**

Comments: Ceiling fans exhibit minor wear and tear. No advanced damage or abuse witnessed at this time. In good condition.

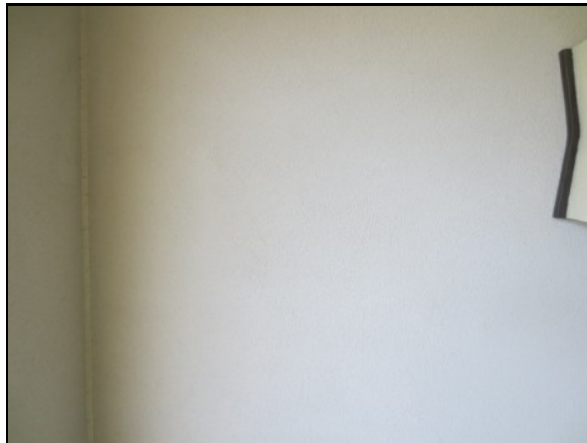
Comments: Walls were very clean with no advanced deterioration. There was no scuffing or any damage to any of the walls that were inspected. Paint coverage is in good condition. Expect minor touchup projects as necessary as an ongoing maintenance project, but anticipate a repaint project on this cycle to restore appearance and provide an opportunity for color change.
