# RESERVE STUDY

## MUNICIPALITIES or COMMERCIAL PROPERTIES

Report #: 17918-0

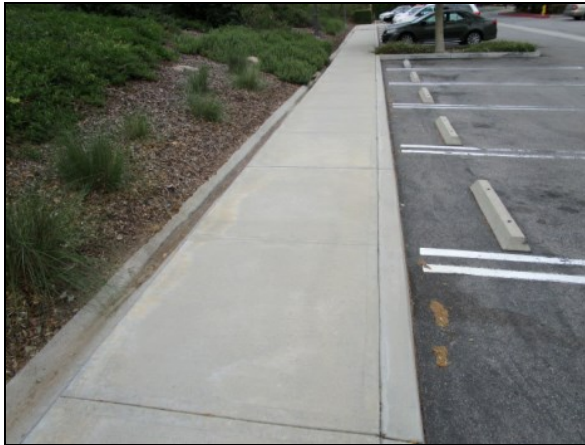
**Comp #: 103 Concrete Walk - Repair****Quantity: Extensive GSF**

Useful Life:  
0 years

Remaining Life:  
0 years

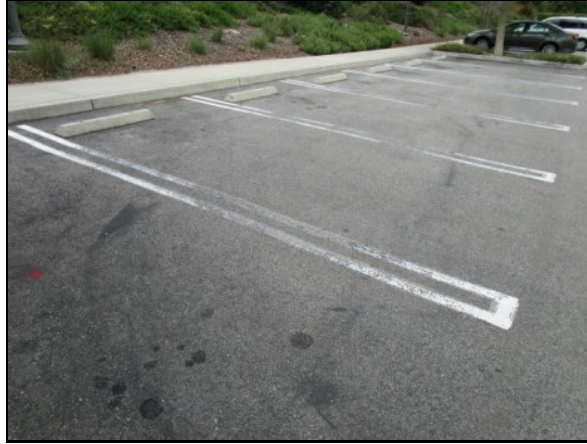
**Comp #: 202 Asphalt - Seal/Repair****Quantity: Approx 63100 GSF**

Useful Life:  
5 years

Remaining Life:  
0 years

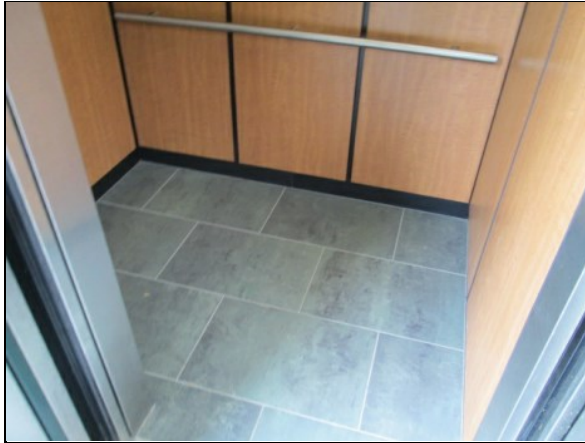
Comments: Consists of tile floor and wood panels. Minor deterioration observed but no significant aging noted. In fair condition.

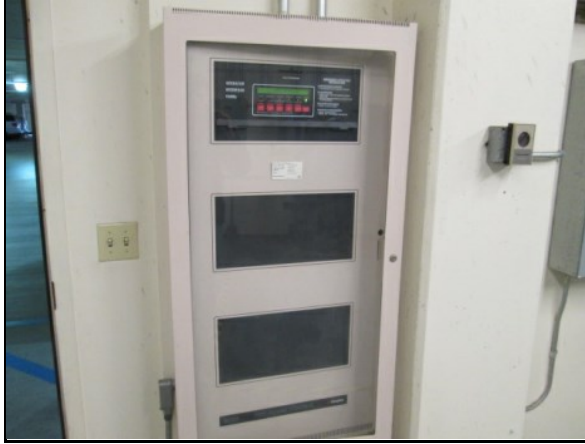
**Comp #: 1803 Fire Alarm Panels - Replace**

Comments: We are not licensed to inspect these systems. Fire alarm systems should be inspected and maintained on a regular basis by licensed professionals as an Operating expense. Best to fund for the eventual replacement of the panels. Panels include: (1) Model 4020 and (1) Model 4010.
