# RESERVE STUDY WORSHIP FACILITIES

[YOUR PROPERTY NAME]

Report #: 17918-0

Level of Service: **Reserve Study- FULL****July 1, 2019 through June 30, 2020****Findings & Recommendations****as of July 1, 2019**

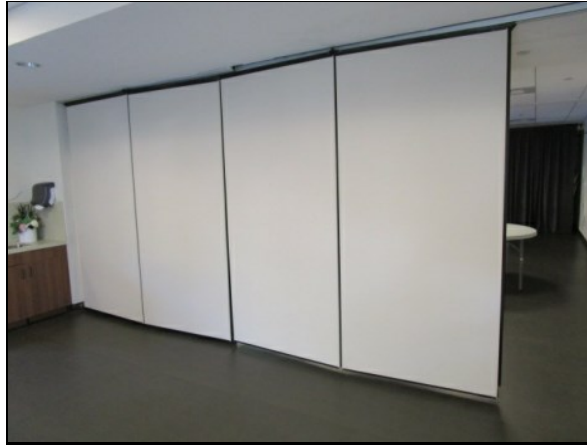
**Comp #: 920 Retractable Divider Walls - Replace****Quantity: (2) 20 LF 5-Panel Walls**

Comments: The divider walls are in good functional condition. No heavy markings or abrasions observed. Periodic replacement will ensure continued reliable operation.

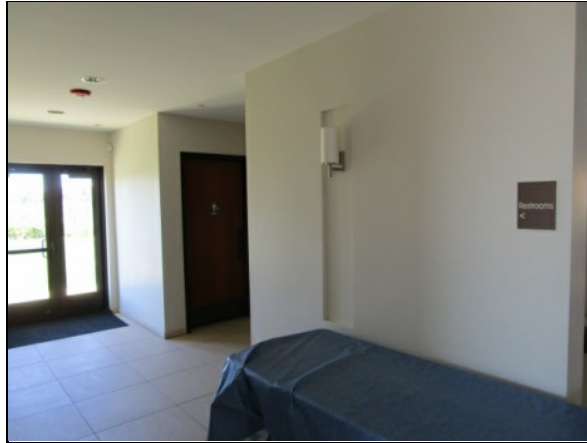
Comments: The interior surfaces are aging normally. Minor scuffing noted but no signs of any major staining or cracking. Plan to repaint periodically to ensure the interiors remain attractive and inviting.

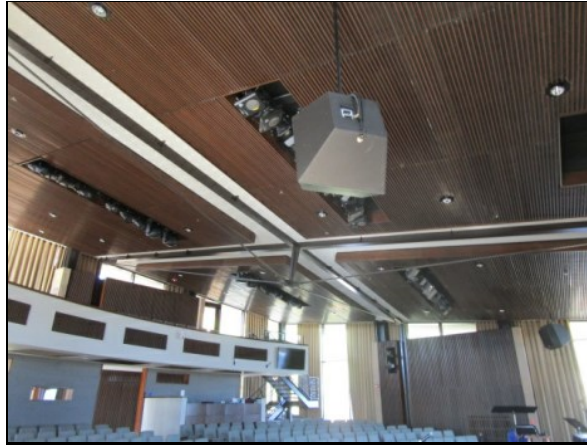
Comments: The interior surfaces are in good condition. No fading or staining noted. All surfaces are clean and aesthetically pleasing.

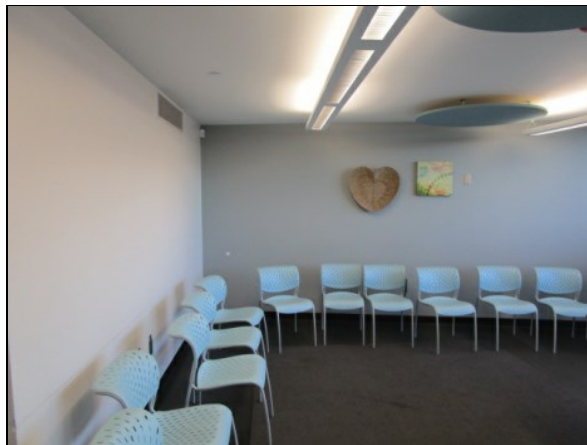
Comments: The Sunday School surfaces are clean and smooth. No heavy scuffing or damage noted except for isolated areas which were damaged by water intrusion. Assuming the damaged areas will be addressed in the immediate future as an Operating expense overall good conditions.

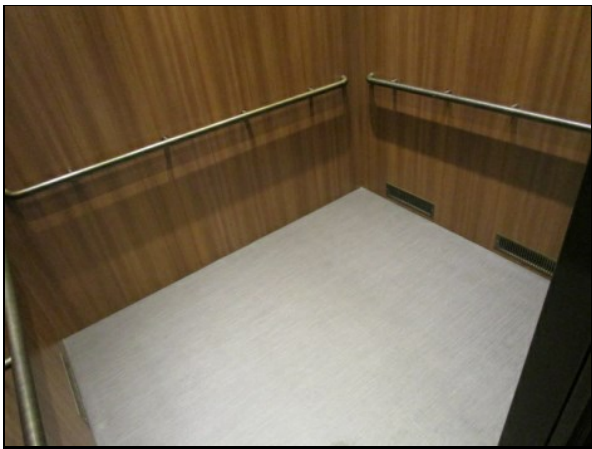
Location: Core of building  
Funded?: Yes. Meets National Reserve Study Standards four-part test  
History: New in 2010  
Comments: The elevator cab is in good condition. No heavy scuffing or marring noted. All surfaces are clean and attractive. Plan to remodel periodically to maintain the quality aesthetics.

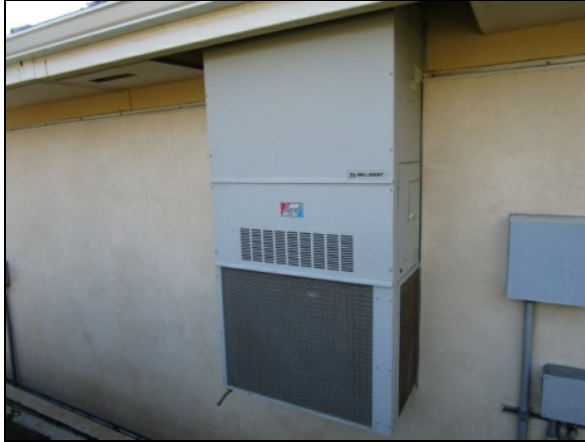
### Comp #: 303 Packaged HVAC Units - Replace

Comments: The HVAC units are assumed to be fully functional. No abnormal exterior wear observed. With regular maintenance these units should reach full useful lives. Model #: WH483-A04VP4XXX EHW04-A04 Serial #: 236P072439524-02 236P072439529-02 236P072439531-02.

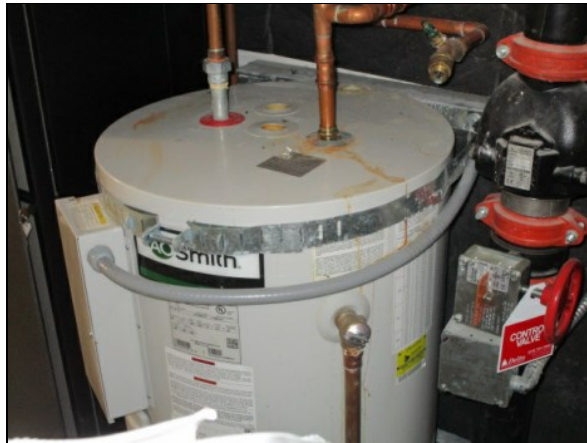
**Comp #: 803 Water Heater/Tank - Replace****Quantity: (1) AO Smith 30 Gallon**

Comments: The water heater appears to be fully functional. No evidence of staining or corrosion. No problems reported. Expect a full useful life.

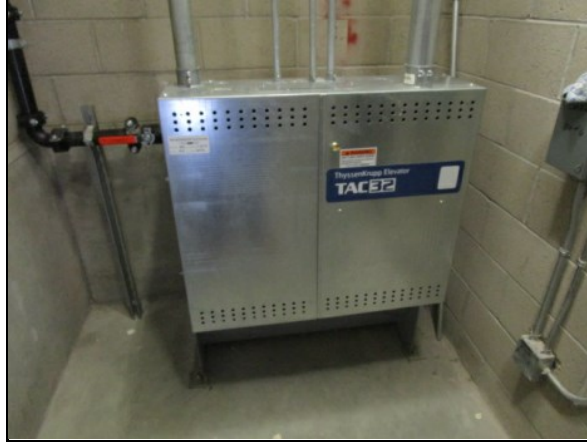
Comments: Reported to be in good functional condition. Used on a daily basis. Modernization is typically required at longer intervals and consists primarily of replacing the controller door operator and push-button fixtures as well as any other code changes or upgrades required. Delaying or deferring this project can lead to unexpected failures and lengthy shut-down periods as replacement parts are ordered. Scheduling this project ahead of time will minimize down" period of the elevator and allow for optimal planning. State #: 161952."

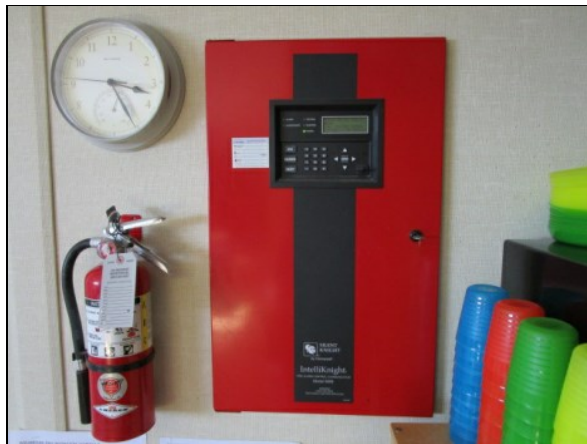
**Comp #: 1803 Fire Alarm Panels - Replace****Quantity: (1) Silent Knight System**

Comments: Appeared clean, indicator lights on. We are not licensed to inspect these panels. Fire alarm panels should be inspected and maintained on a regular basis by licensed professionals as an Operating expense. Best to fund for eventual replacement with newer code-compliant technology.

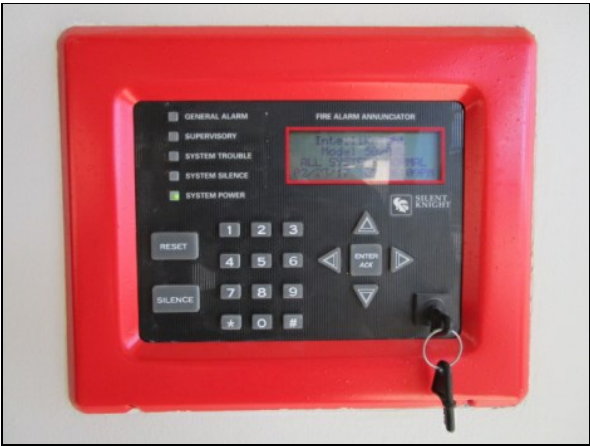
Comments: Presumed functional, indicator lights on, not tested. Includes (1) annunciator (134) sprinklers and (18) fire lights. Although some systems can last many years with only regular maintenance manufacturers do not make replacement parts for many systems once they reach a certain age. This component represents periodic technology upgrades. Panels and other smart" components should be replaced with more modern technology to ensure a quality
