# ASSOCIATION RESERVES™

SAMPLE  
Reserve Study

UPDATE - With Site Visit

Level of Service: **Update- With Site Visit (WSV)****January 1, 2019 through December 31, 2019****Findings & Recommendations****as of January 1, 2019**

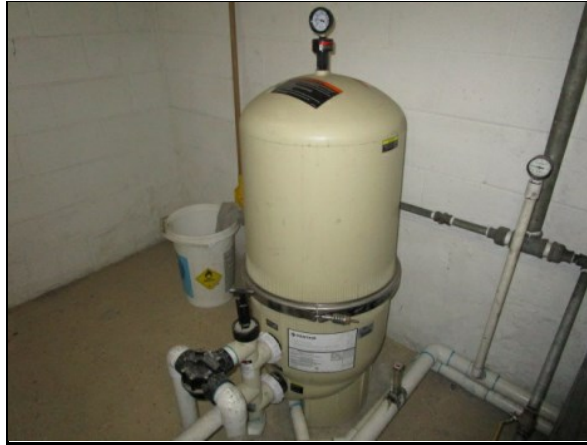
**Comp #: 1207 Pool Filter - Replace****Quantity: (1) Pentair Filter**

Comments: No signs of staining or active leakage. Good general condition. Serial # 01922891300581.

Lower estimate to replace

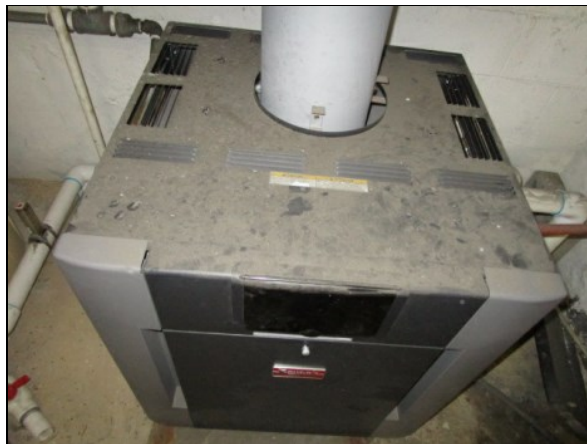
**Comp #: 1208 Pool Heater - Replace****Quantity: (1) Raypak 275,000 BTU/hr**

Comments: Generally clean - no rust or burn damage. Wires bright in color. Burner area clean. No reported problems. Serial # 1401370293.

Lower estimate for replacement heater

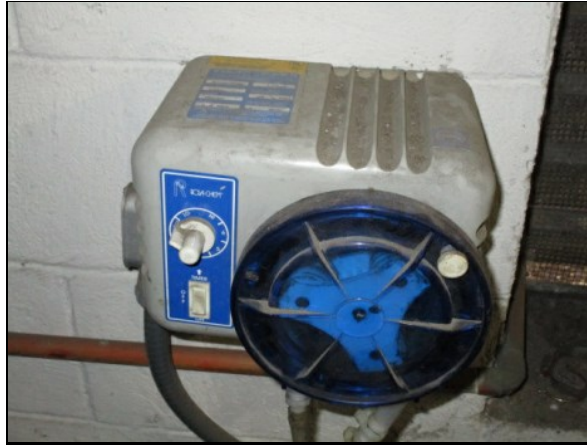
**Comp #: 1209 Chemical Feeder - Replace**

Comments: The chemical feeder is older. No reported problems but anticipate the need to replace in the near future based on aged appearance.

Lower estimate for replacement unit, installed

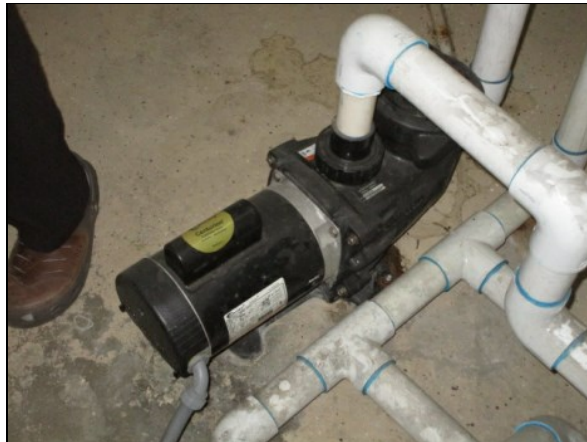
**Comp #: 1210 Pool Pump - Replace**

Comments: The pump is functional. No reported problems. No signs of corrosion or active leakage. Serial # 21120907002408013.
