# ASSOCIATION RESERVES™

## RESERVE STUDY

## PRIVATE CLUBS and RECREATION CENTERS

Report #: 17918-0

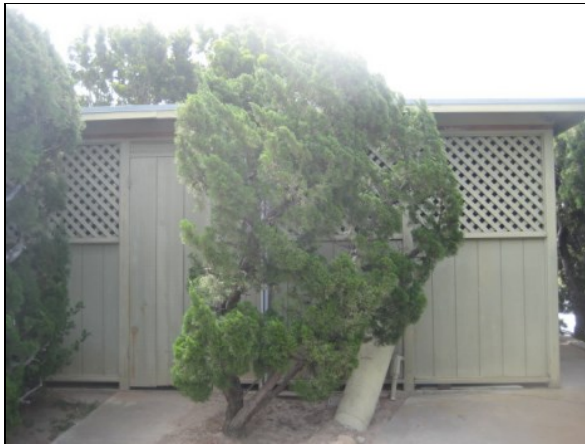
**Comp #: 1015 Pump Station Enclosures - Replace****Quantity: (1) approx 15x25 bldg**

Comments: Old wood building with flat roof. Roof currently leaks (contents of building can partly tolerate leaks). Building is not far from failure due to age and deterioration

Lower estimate for replacement structures

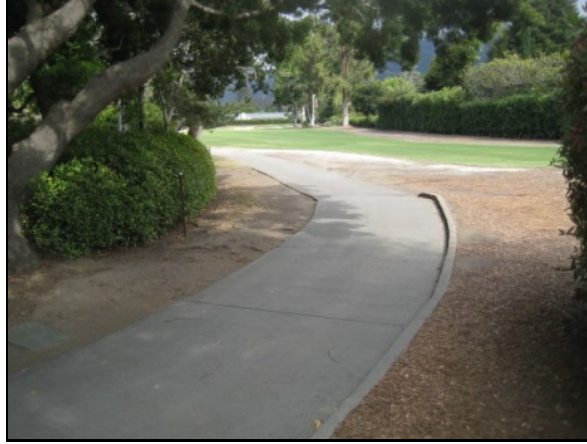
**Comp #: 2101 Cart Path - Repair****Quantity: Extensive GSF**

Comments: General good condition. Stable and intact where inspected. All concrete, no more asphalt areas. Only minor local cracks noted. Expect some local minor repairs (done within ongoing operational course maintenance budget) in addition to this larger periodic project. Note: some discussion about replacing with Decomposed Granite (DG). Expect concrete paths for time being.

Lower estimate for repairs and local  
replacements

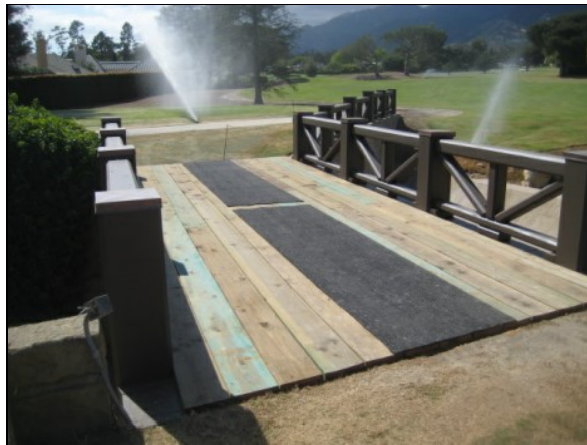
**Comp #: 2110 Golf Bridge #1 - Replace****Quantity: (1) Large bridge**

Comments: New steel frame flat bridge in good condition. No problems or deterioration to note.

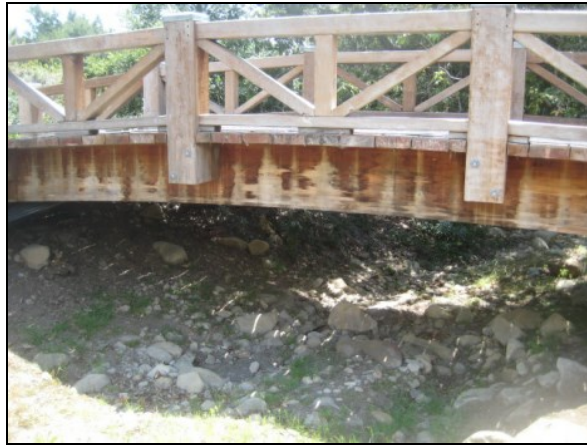
**Comp #: 2111 Golf Bridges - Repair/Replace****Quantity: (4) Large (3) small**

Comments: Some wear due to regular daily usage. Wood construction showing wear/age (weathering cracking and general dryness). Soil contact has been largely eliminated. Small bridges have historically been repaired as needed. Expect periodic major repair or replacement expenses.

Lower estimate to replace

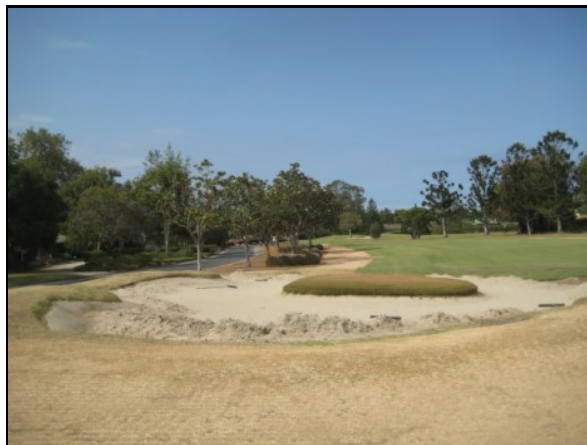
Comments: No expectation for major project at this time. All areas currently in very playable condition but expect future renovation to be necessary on approximately this cycle.

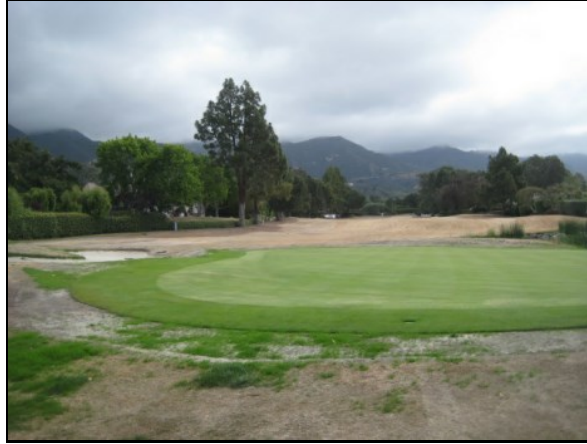
Comments: No expectation for major green reconfiguring at this time although #8 and #10 being re-contoured this year (to be less severe). All areas currently in very playable condition but expect future renovation to be necessary on approximately this cycle.

Note: could be done on a phased basis instead of as one project.

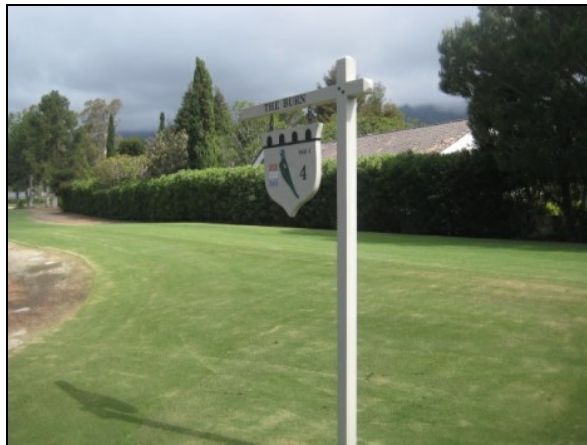
**Comp #: 2205 Tee Signage - Replace****Quantity: (18) Tee Signs**

Comments: Teak should hold up well. Signs are currently showing only mild weathering and are generally attractive (some deterioration at base some minor cracking at upper areas). But signage is aged, so replacement should be anticipated in near future.

Lower estimate for replacement signs, \$1000  
ea

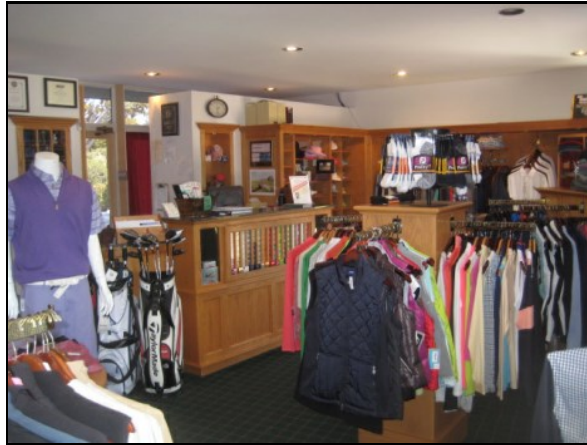
Comments: Drive-through area was captured as interior space (office). Inside of building currently in fair general condition although carpet is showing wear appropriate for this high-traffic areas. Due for refurbish in near future.

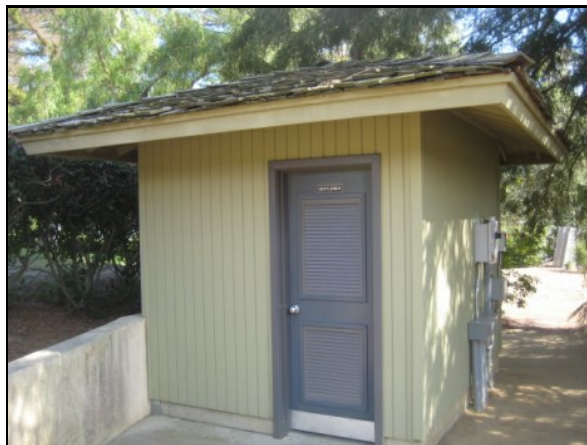
Comments: Typically 18x18 or 20x20 buildings concrete or tile floor wood shake roof. Simple fixtures (sink and toilet) laminate countertop. Functional older showing interior and exterior deterioration. Due for renovation to keep up with refurbished course and private club standards.

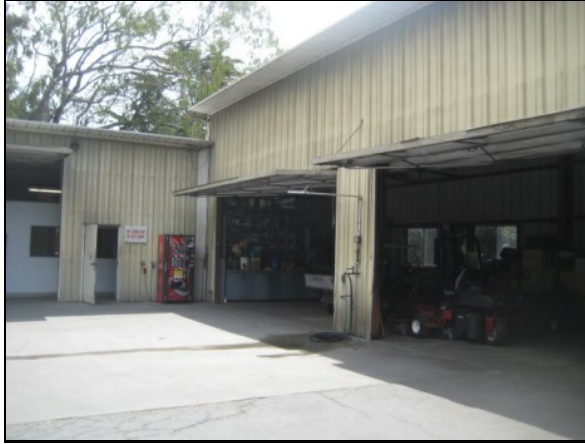
Comments: Large maintenance facility with open bays and office areas. Equipment wash-down area material storage. Currently showing significant deterioration. Siding very deteriorated concrete shows significant cracking. Functional but very deteriorated. Anticipate improved eqp storage pesticide storage etc. 50-yr old building is showing its age.

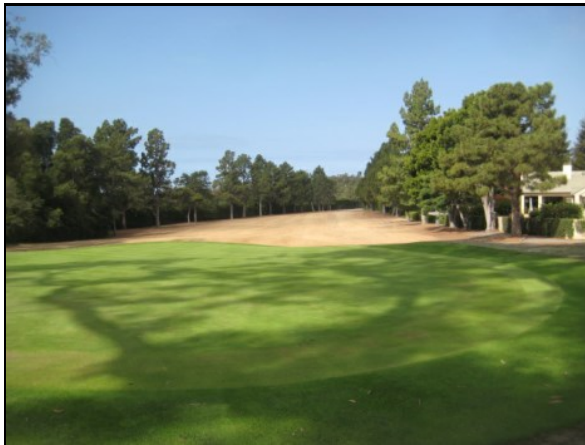
Comments: Good condition playable. Tightened fairways more natural vegetation. Very appropriate renovation project. Bermuda grass replacing blue/rye/bent. Should be hardier and requires less water.
