# ASSOCIATION RESERVES™

RESERVE  
STUDY

[YOUR PROPERTY NAME]

Report #: 17918-0

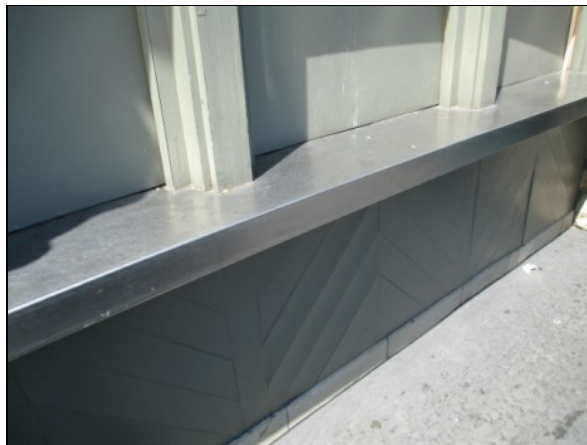
**Comp #: 904 Metal Counters - Replace**

Comments: The metal counters are clean and serviceable. No signs of any corrosion or tarnishing. With regular cleaning and maintenance these counters should be expected to reach long useful lives. Rate of deterioration is unknown. Best to repair/replace as needed as an operating expense.

Funded?: No. Life too indeterminate. Replace as needed as an operational maintenance expense.

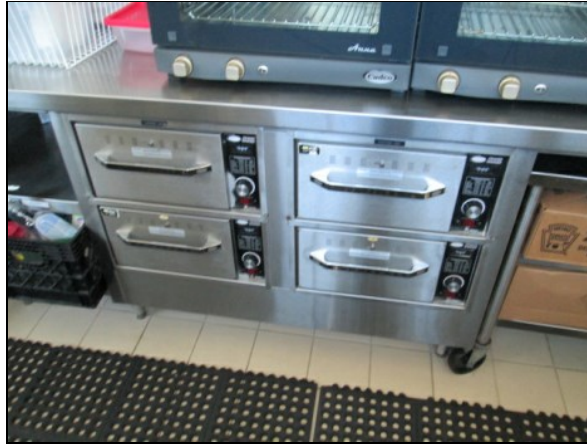
**Comp #: 905 Kitchen Equipment - Partial Replace**

Comments: Funding has been provided for periodic replacement to ensure functionality. Equipment includes: (1) US range (1) Garland broiler (2) True fridges (1) True freezer (4) stainless prep tables (2) True beverage fridges (5) Hatco display cabinets (3) Cadco mini ovens (1) Carrier HVAC (8) Hatco warmers (1) Carter-Hoffman fridge (1) Hatco food holder (1) Star beverage machine and (3) Sharp registers.

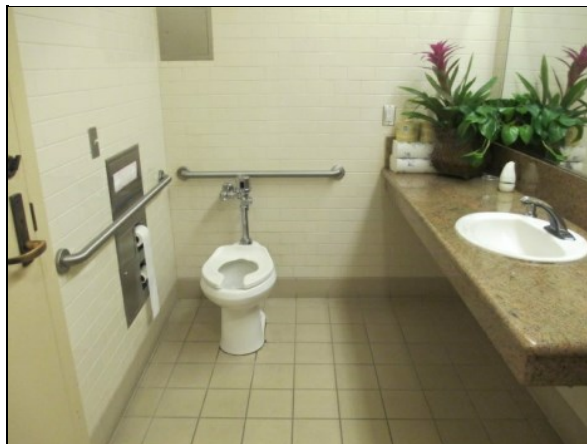
Comments: Each contains (1) shower (1) sink (1) toilet (1) trash can (1) recessed light fixture approximately 6 LF of granite countertop and approximately 400 GSF of tile floors/walls. The bathrooms are clean and aesthetically pleasing. No signs of any grime build up or discoloration. All fixtures were functional at the time of the inspection. In fair condition.

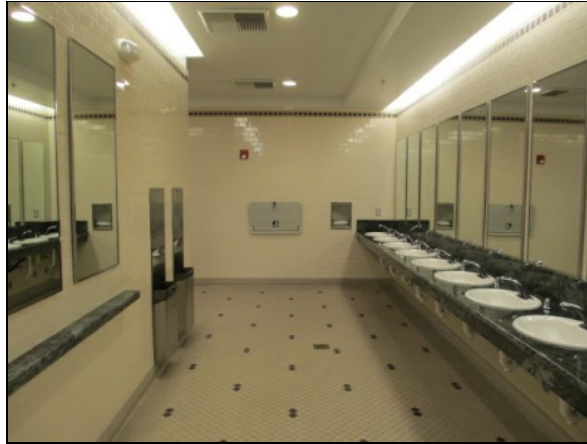
Comments: Comprised of (29) sinks (33) mirrors (18) paper towel dispensers (2) changing stations (21) urinals (52) toilets (71) dividers approximately 65 LF of countertops and approximately 7450 GSF of tile floors/walls. The bathrooms are clean and aging normally. General wear and tear due to periods of heavy traffic observed. No severe deterioration or abuse. In fair overall condition.

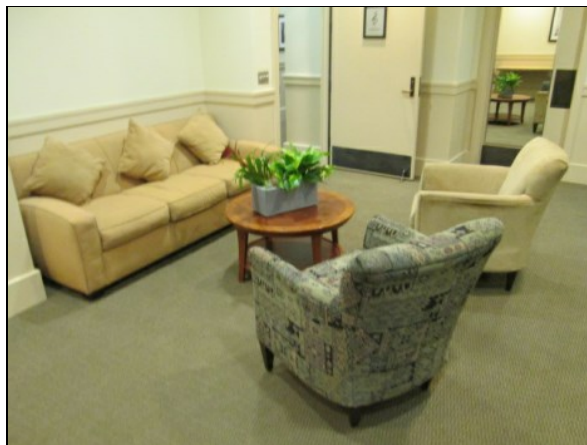
Comments: General wear/tear and usage witnessed during inspection. Some minor refurbishment done on an annual basis. This funding is for more significant refurbish projects.

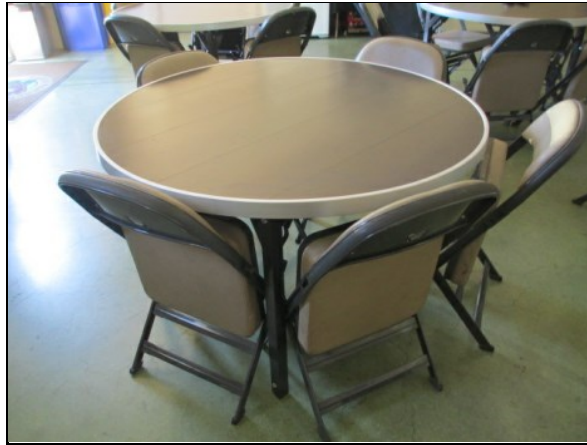
**Comp #: 911 Dining Room Furniture - Replace**

Comments: Comprised of (8) folding tables (4) round tables (20) cushioned folding chairs and (7) plastic trash cans. The furniture is serviceable and intact. Minimal wear noted but isolated staining was evident on some seat cushions. In fair overall condition. Plan on periodic replacements to maintain aesthetics.

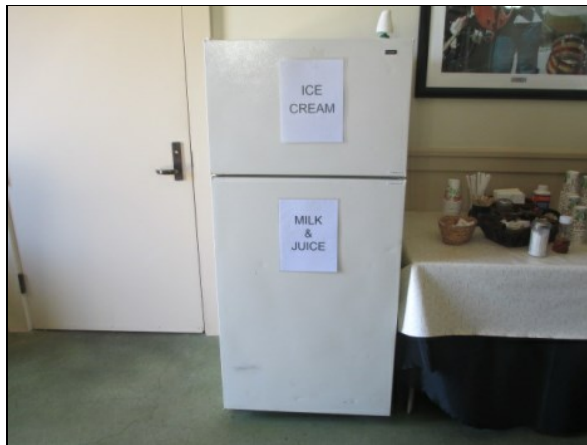
**Comp #: 912 Refrigerators - Replace**

Comments: The refrigerators are older and worn at this time. In declining condition. Regular replacements will allow all appliances to remain functional and clean.

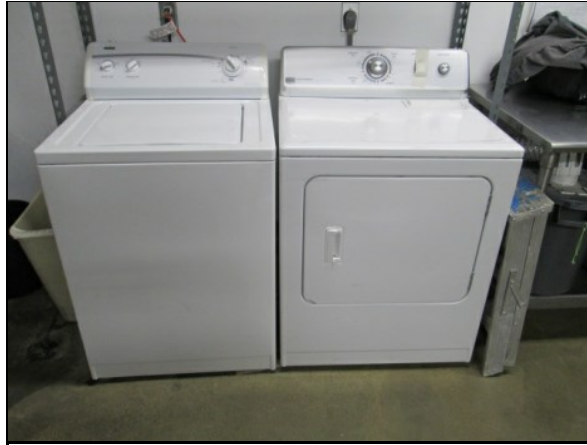
**Comp #: 915 Laundry Appliances - Replace**

Comments: Cost to replace falls below threshold for Reserve designation. Best to replace as needed as an operating expense.

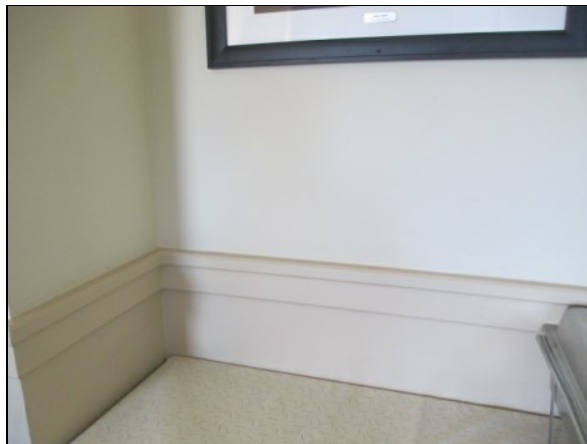
Comments: The interior surfaces are bright and attractive. Some scuffing near utility areas noted but no signs of any cracked or damaged surfaces. Paint coverage is in fair condition. Necessary to repaint annually due to heavy usage/wear.

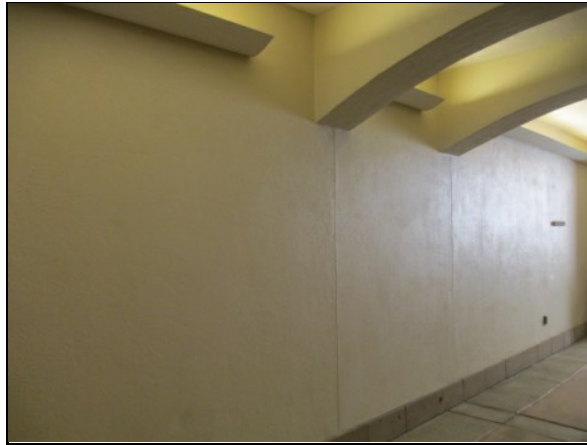
Comments: No signs of any cracking but some areas of discoloration and grime build up were noted. The surfaces are overall bright and uniform in appearance. Paint coverage is in fair condition. Stick to repaint cycles to maintain aesthetics and to reduce the risk of water intrusion.

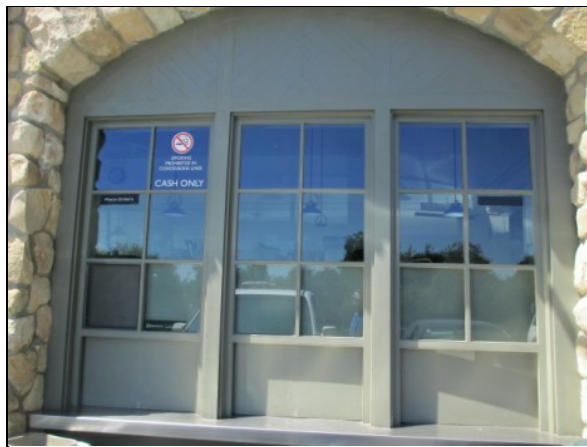
Comments: The wood surfaces are attractive and aging well. No signs of any cracking dryness or rot. In good overall condition. Due to the low cost to repaint it is best to repaint as needed as an operating expense. Stick to repaint cycles to maintain this asset.

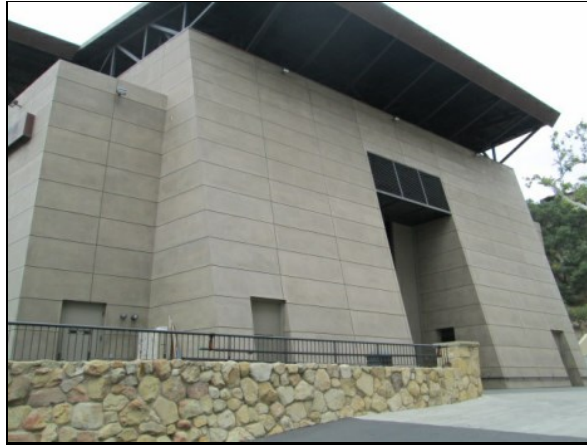
**Comp #: 1126 Stone Siding - Replace**

Comments: The stone siding is intact and aging normally. Best to make any minor repairs as needed as an operating expense. No ability to anticipate Reserve needs at this time.

Funded?: No. Very extended life anticipated. No ability to anticipate future replacement interval at this time.

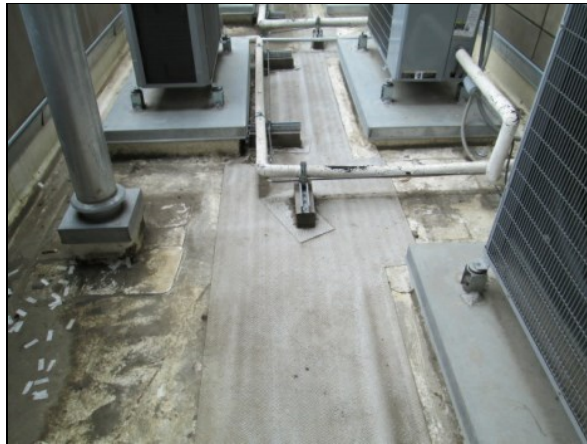
**Comp #: 1302 Cap Sheet Roof - Replace**

Comments: Cost to replace falls below threshold for Reserve designation. Best to replace as needed as an operating expense. No Reserve funding is required.

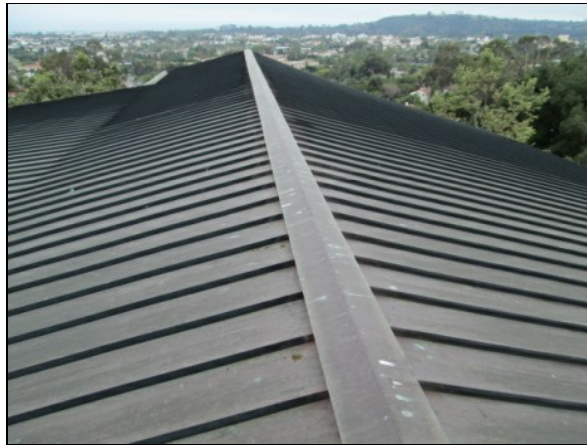
**Comp #: 1308 Metal Roof - Replace**

Comments: Minor discoloration and abrasions observed during inspection. No signs of significant damage noted and no reports of leaks or other problems. In fair condition.

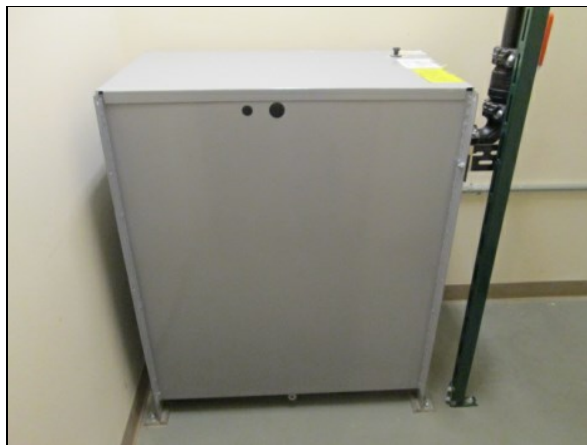
Comments: We are not licensed to inspect these systems. Reportedly functioning reliably. Not tested during inspection but found to be operational. Anticipate the need to modernize a hydraulic elevator every 20-30 years. Modernization consists primarily of replacing the controller door operator and push-button fixtures.

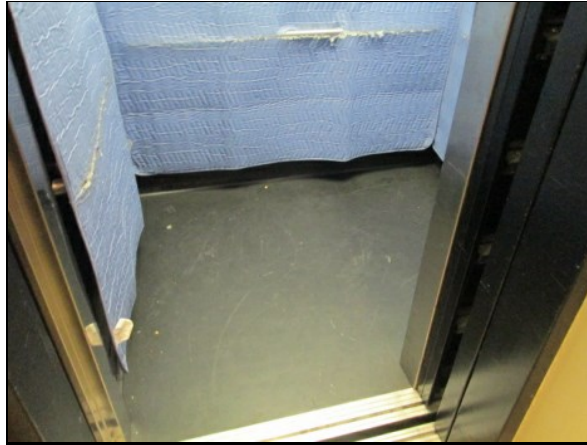
Comments: Cab interior features simple paneling and floors. Moderate to heavier wear/tear and aging observed. In serviceable but declining aesthetic condition. Best to remodel in the near future to restore aesthetics.
