Sample High-Rise Association *Honolulu, HI*

Report #: 5101-0
Beginning: January 1, 2022
Expires: December 31, 2022

RESERVE STUDY "Full"

August 9, 2021

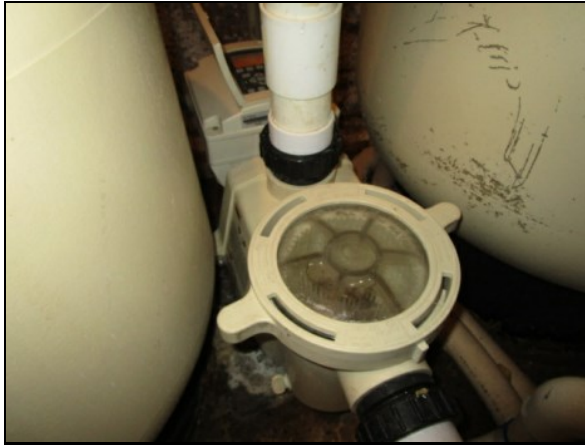
Comp #: 1210 Circulation Pumps - Replace

Comments: The pool and spa circulation pumps were recently replaced. Good condition.

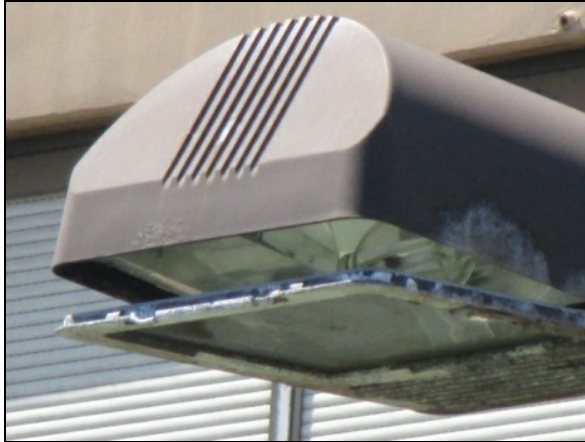
Comp #: 323 Tennis Court Lights - Replace**Quantity: (16) Fixtures, (7) Poles**

Comments: Signs of damaged fixtures. It was reported that the fixtures will be replaced in the near future. Poles are upright and stable and do not require replacement at this time. Funding for LED fixtures.

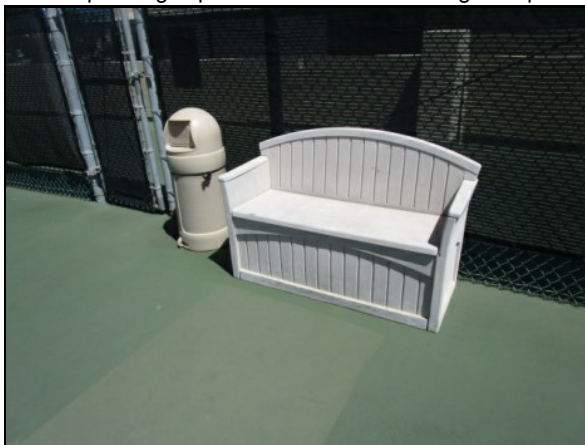
Comp #: 404 Court Furniture - Replace**Quantity: (4) Assorted Pieces**

Comments: The furniture consists of (2) vinyl trash receptacles & (2) vinyl benches. Replacement value is too small for Reserve designation. Replace as needed as an Operating expense. No Reserve funding is required.

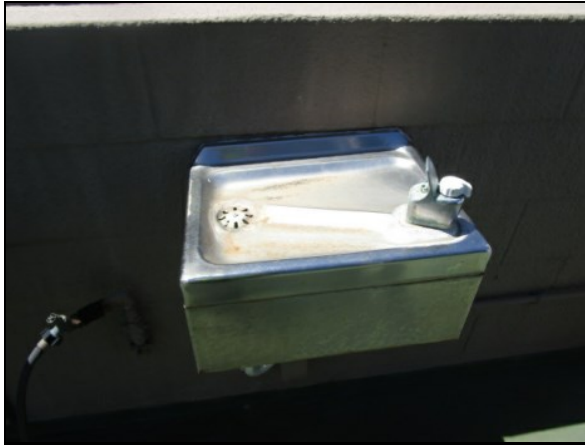
Comp #: 411 Drinking Fountain - Replace

Comments: The drinking fountain is older but intact. Fair condition.

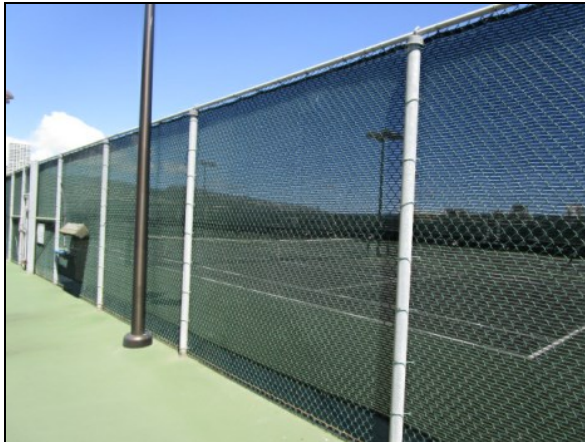
Comp #: 502 Chain Link Fence - Replace

Comments: The tennis court fence is intact and stable. No signs of advanced deterioration or corrosion. Fair condition.

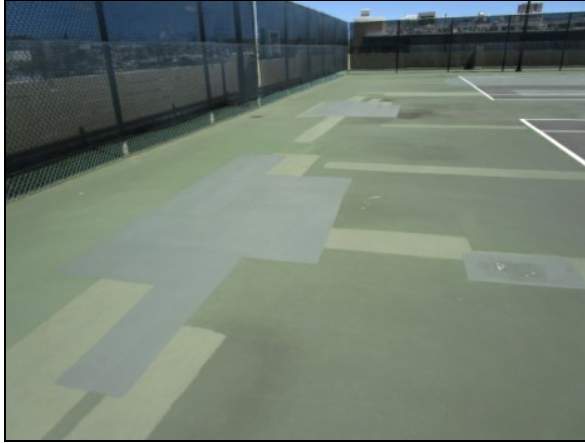
Comments: The tennis courts were recently repaired. Numerous patching observed. Signs of cracking and peeling throughout. We recommend a full recoat and restripe to restore appearance.

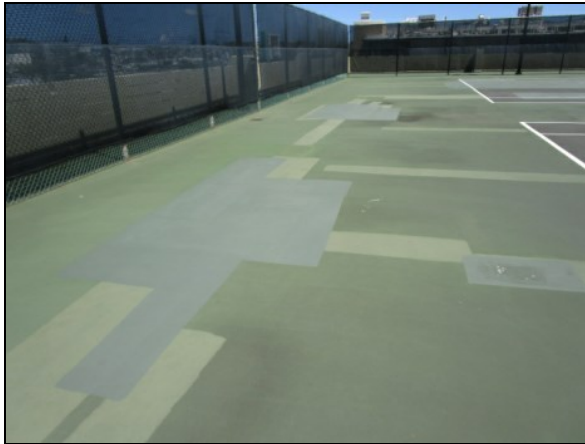
Comments: The tennis courts were recently repaired. Numerous patching observed. Signs of cracking and peeling throughout. Funding for the eventual resurfacing of the court membrane.

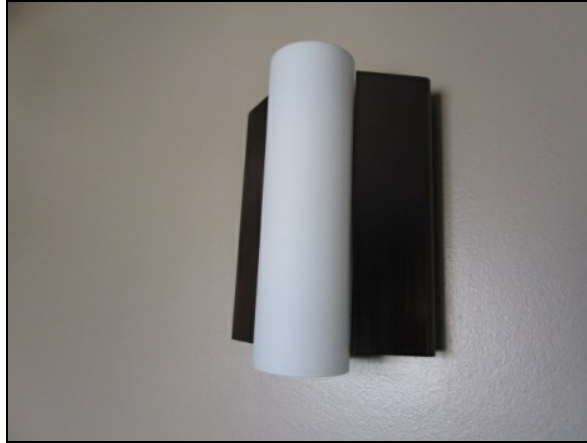
Comments: The interior decorative fixtures consists of (185) wall lights & (111) ceiling sconce lights. These fixtures appear to be newer installations. No signs of damage or abuse. Funding for periodic complete replacements in order to maintain a uniform appearance.

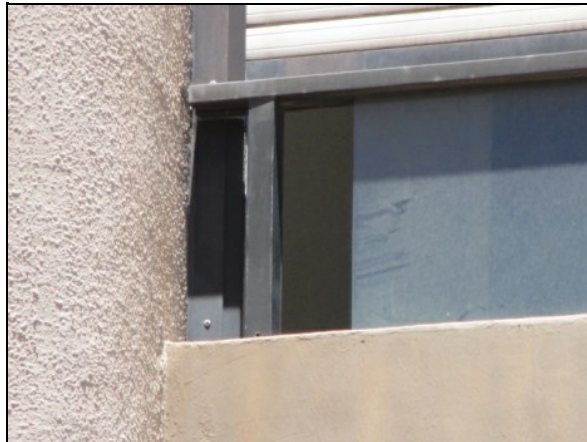
Comp #: 503 Metal Railings (lanai) - Replace**Quantity: Approx 4,662 LF**

Comments: No access to closely inspect. Signs of deterioration was evident from ground-level. Railings should be inspected on a regular basis. Funding for eventual complete replacement to maintain safety and appearance. These railings also include glass railing panels.

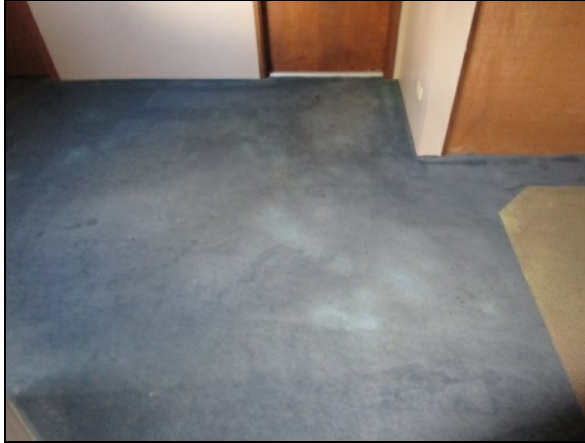
Comp #: 601 Carpet (hallways) - Replace**Quantity: Approx 1,589 GSY**

Comments: The carpeting is in fair to poor condition. Signs of discoloration, staining, and fraying. Funding for complete replacement in order to maintain a uniform appearance and to lower the overall replacement costs. Floors 36 & 37 have been slightly modified and have (1) GSY less per floor than the rest.

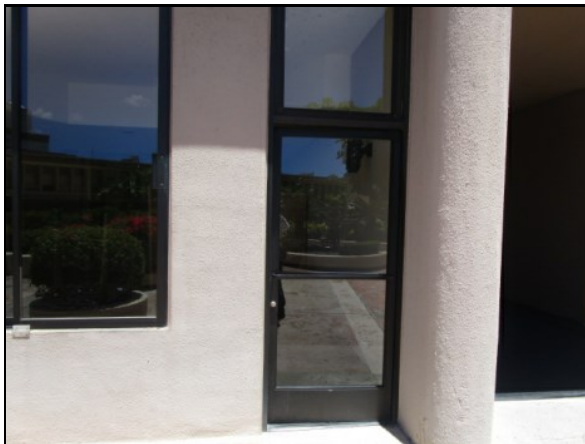
Comp #: 700 Glass Entry Doors - Replace**Quantity: (4) Glass Doors**

Comments: The glass doors were intact and functional. No reported problems. Replacement should be cycled with the windows (#1130).

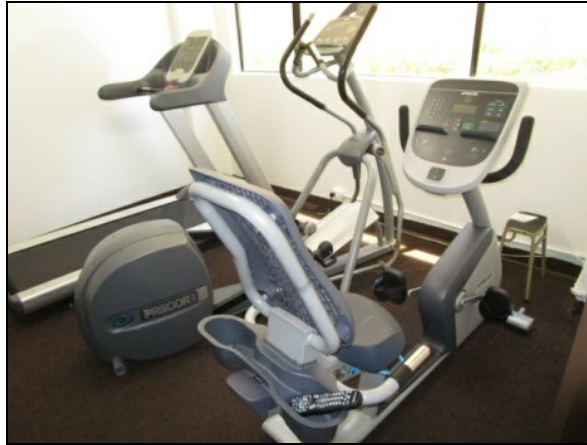
Comp #: 902 Fitness Equipment - Replace**Quantity: (6) Assorted Pieces**

Comments: (1) Precor weight machine, (1) Precor recumbent bike, (1) Precor elliptical, (1) Precor treadmill, & (2) dumbbell sets. Equipment should be maintained on a regular basis as an Operating expense. Replace the (1) Samsung TV as needed as an Operating expense.

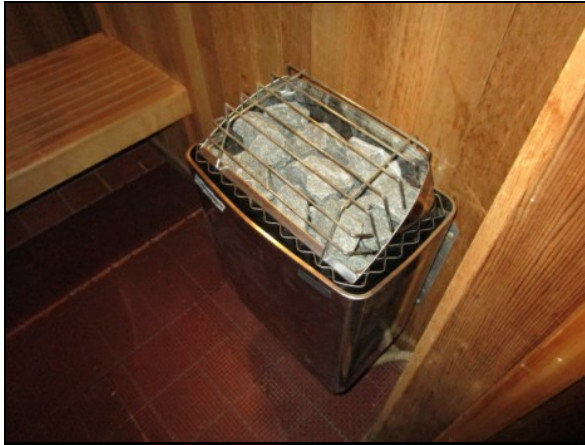
Comp #: 905 Sauna Heater - Replace**Quantity: (1) Finlandia Heater**

Comments: The sauna heater is functional and aging normally. No signs of corrosion. No reported problems.

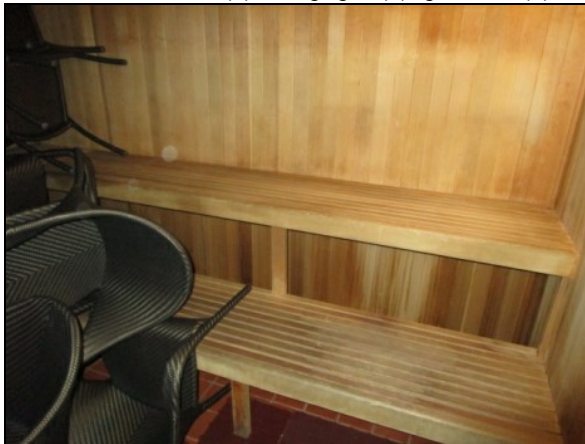
Comments: The wood panels and benches are intact. No signs of vandalism or advanced deterioration. Signs of staining on the ceiling from a past leak. Fair condition. Room includes (1) ceiling light, (1) light timer, (1) heat timer, & (1) wood/glass door.

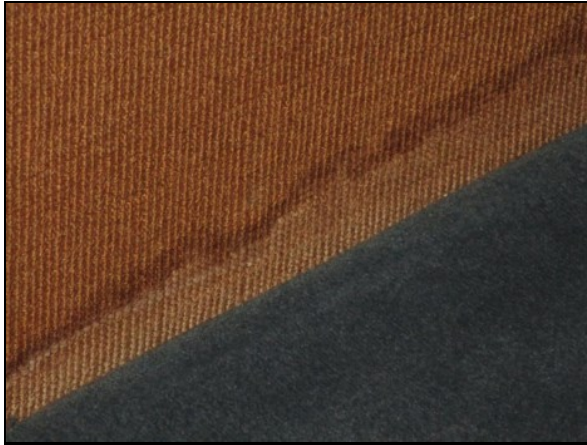
Comp #: 907 Wallcoverings (hallway) - Replace**Quantity: Approx 4,403 GSF**

Comments: The wallcoverings are in poor condition. Appear to be original. Signs of heavy staining and visible seams.

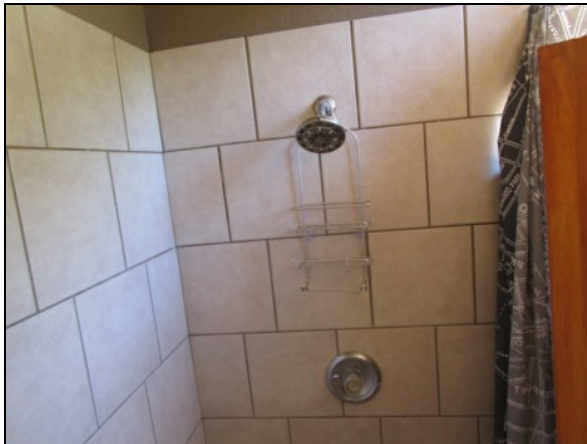
Comments: (1) shower fauxet and mixing valve, 30 GSF tile shower pan, & 96 GSF shower tile walls. Fair condition. Cycle with the remodeling of the restrooms.

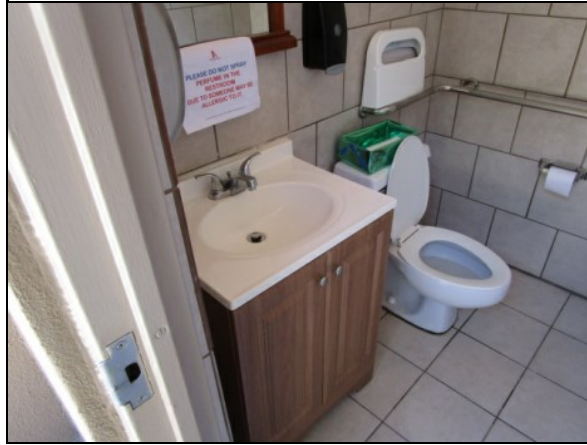
Comments: (2) toilets, (2) vanity sinks, (2) mirrors, (2) ceiling ventilation fans, (2) ceiling lights, 48 GSF of tile floors, 179 GSF of tile walls, (1) janitor sink. Fair condition. This line-item include the housekeeping closet adjacent to the restrooms.

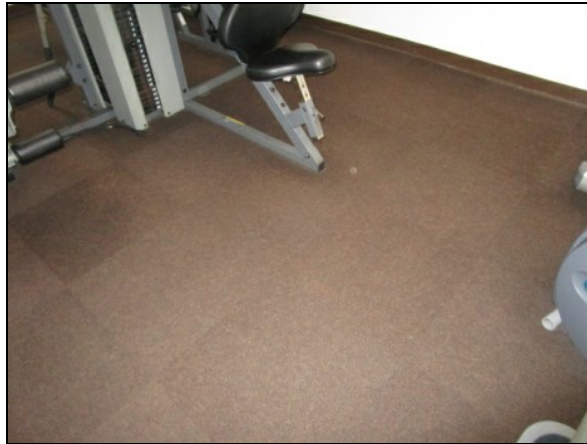
Comments: The interiors consists of 33 GSY of carpeting, (1) ceiling lights, (1) 7'x11' mirror. Interiors are aged in appearance. Fair condition.

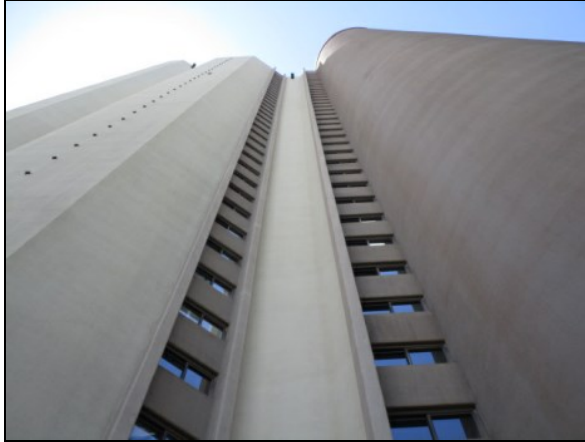
Comments: Signs of heavy staining and sections of spalling. Funding for ongoing repainting projects in order to maintain surface integrity and appearance. It is recommended that both towers be repainted together to maintain a uniform appearance and to lower the overall costs of repainting. The repainting of the parking garage should also be coordinated with this project (refer to #1115, Parking Structure chapter). Both repainting and window resealing projects should always be completed together to utilize the same davit crane equipment used by the crews (refer to #1119). The individual owners are responsible for the repainting of the interior walls and ceilings of their lanai decks. These surfaces are not included in this project scope of work.

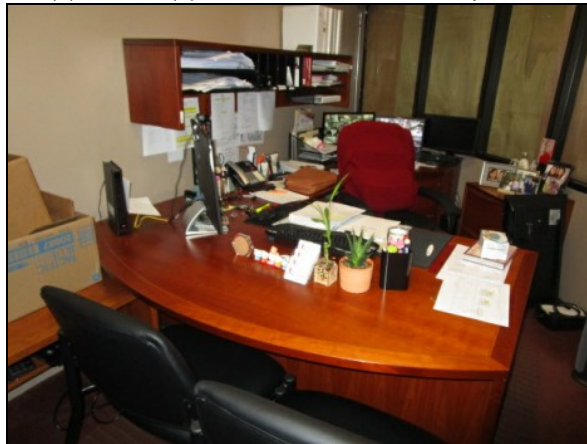
Comp #: 903 Furniture (admin) - Partial Replace**Quantity: (9) Assorted Pieces**

Comments: The furniture consists of (4) desks & (5) desk chairs. There is no expectation for complete replacement.

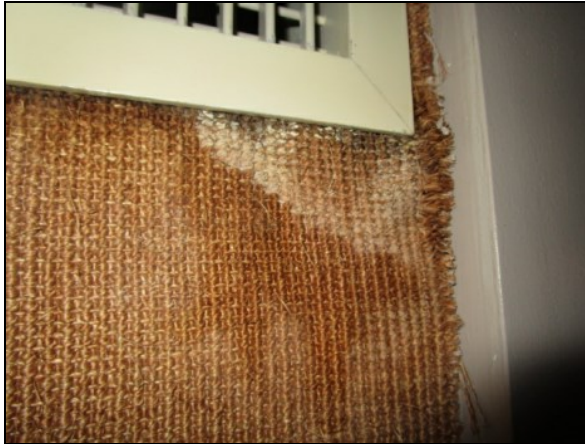
Comp #: 907 Wallcoverings (hallway) - Replace**Quantity: Approx 4,403 GSF**

Comments: The wallcoverings are in poor condition. Appear to be original. Signs of heavy staining and visible seams.

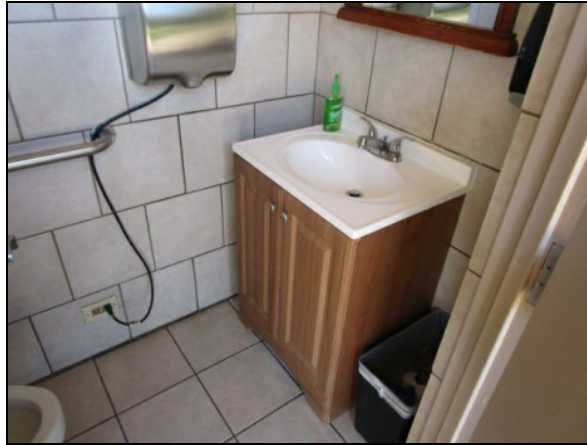
Comments: (2) toilets, (2) vanity sinks, (2) mirrors, (2) ceiling ventilation fans, (2) ceiling lights, (2) hand dryers, 36 GSF of tile floors, 180 GSF of tile walls, (1) janitor sink. Fair condition. This line-item include the housekeeping closet adjacent to the restrooms.

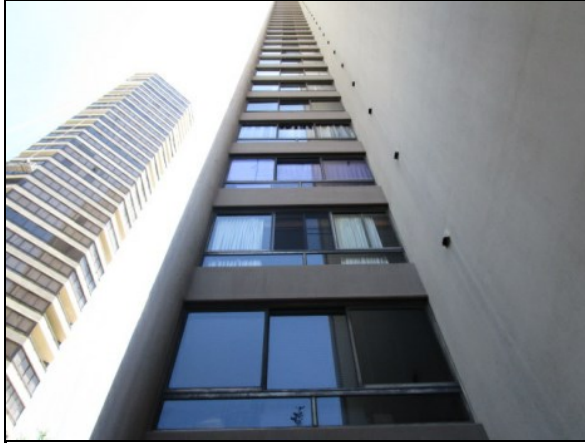
Comments: It was reported that the tower exteriors will be repainted in the near future. All exterior repainting projects should also include the recaulking of the exterior windows in order to utilize the same crews/labor, davit cranes, permits, etc. The project costs will increase if this project is done separately from the paint projects. Ongoing recaulking of the exterior windows should prevent significant water intrusion issues and additional repair and remediation expenses.

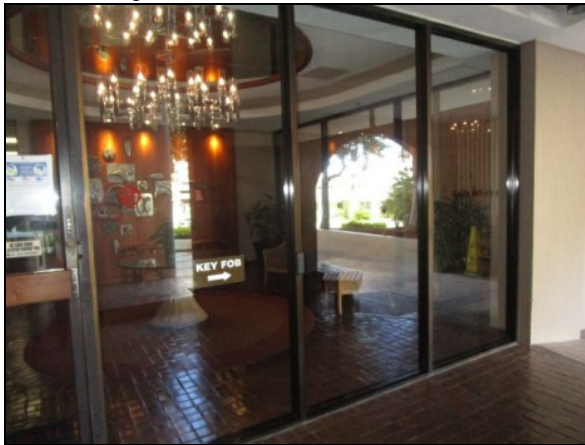
Comp #: 1130 Windows (common) - Replace**Quantity: (57) Windows**

Comments: (37) 3'x4' hallway windows, (8) 2'x6' Party Area windows, (4) 5'x7' Party Area windows, (1) 3'x3' Party Area window, (3) 3'x8' lobby windows, (4) 5'x8' lobby windows. The windows are original. Exterior joints are recaulked as part of each exterior repaint project (refer to #1115). Funding for eventual full replacement in order to maintain a uniform appearance. Anticipate the need to replace in the near future based on age.

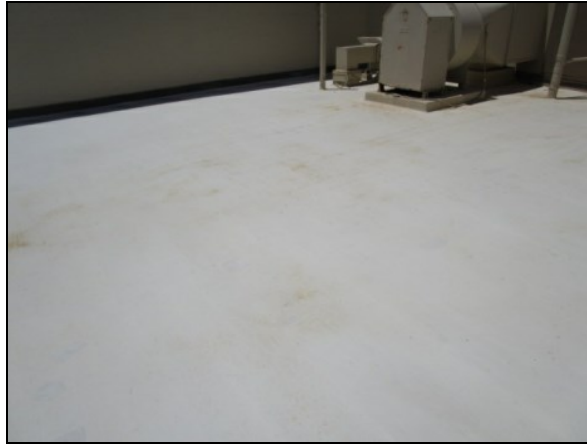
Comments: Signs of heavy bubbling, peeling, surface wear, and staining. There has been no recoating project completed on the roofs since they were last replaced and this project is overdue. No reports of water intrusion issues but this project should be completed before issues develop that could result in additional repair and remediation expenses. This project also includes the 1st floor overhang roofs.

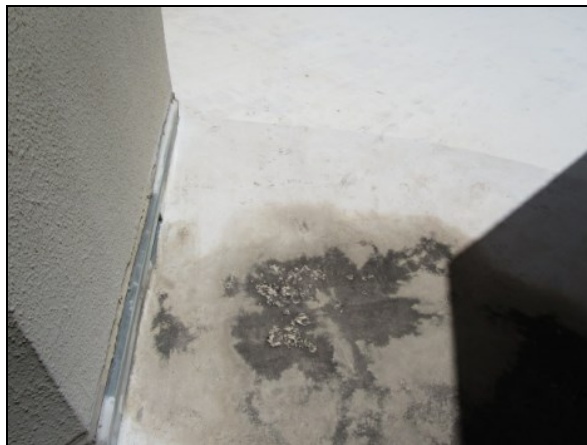
Comp #: 1302 Built-Up Roofs - Replace**Quantity: Approx 7,085 GSF**

Comments: Signs of heavy bubbling, peeling, surface wear, and staining. The recoating project for the tower roofs is overdue (refer to #1301). The useful life of this roofing system is based on the assumption that the recoating projects will be completed on schedule. The remaining useful life has been decreased based on current conditions and project history. This project also includes the 1st floor overhang roofs.

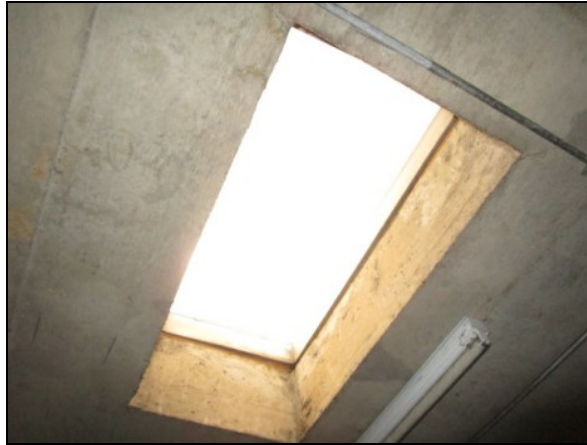
Comp #: 1311 Skylights - Replace**Quantity: (2) 3'x6' Skylights**

Comments: No access to closely inspect the skylights. No reports of water intrusion. No signs of cracking from within the elevator room. The skylights should be recaulked on a regular basis by the in-house staff to prevent water intrusion and protect the elevator equipment below. A shorter useful life has been applied due to the sensitive equipment housed below these skylights.

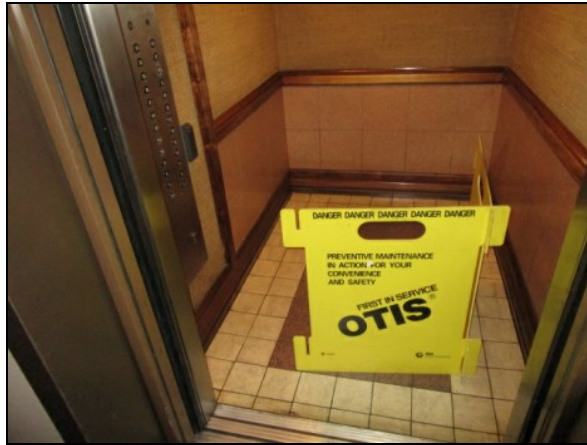
Comments: The elevator cab interiors are aged and dated. It is recommended that the cabs undergo remodeling during the elevator modernization project (#1801, Electrical & Mechanical chapter) in order to verify that new cab paneling, mirrors, etc. can accommodate the new push button panels and indicator lights.

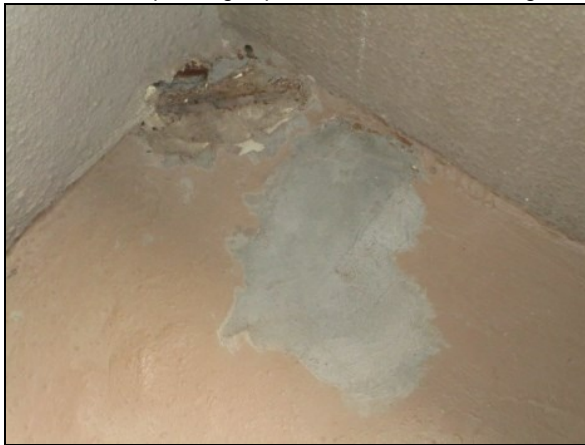
Comments: The exterior concrete landings are showing signs of peeling and cracking. A waterproofing coating should be applied on a regular basis by the in-house staff as an Operating expense. No Reserve funding is required.

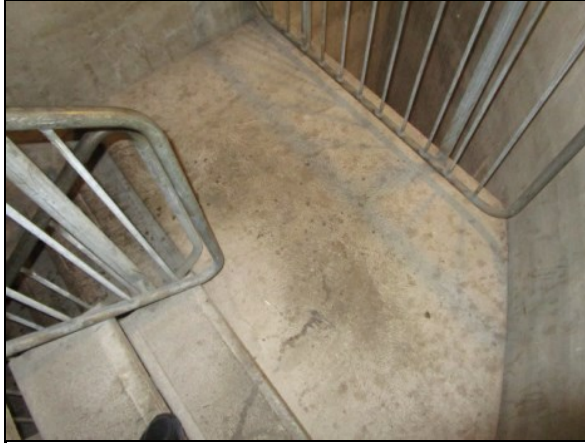
Comments: Signs of heavy staining throughout the stairwell landings and treads. Signs of minor cracking as well. These are low-visibility areas with a low aesthetic priority. Recoating of the landings and tread should be handled in sections on a regular basis by the in-house staff as an Operating expense. No Reserve funding is required. Any signs of loose or damaged treads or landings should be addressed immediately with Operating repair funds or with Special Assessment funds.

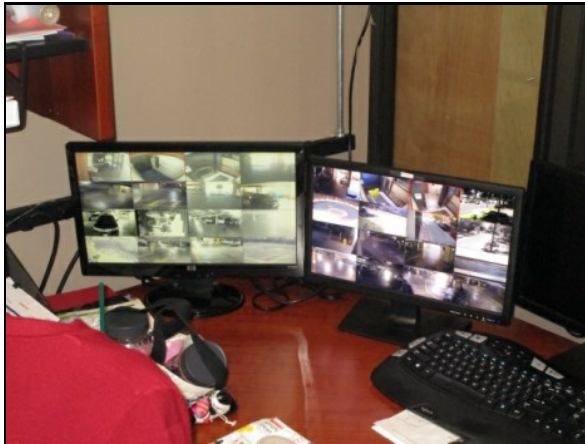
Comp #: 305 Security Camera System - Replace**Quantity: (32) Camera System**

Comments: The security camera system was not tested during inspection. Funding for periodic replacement of the security camera system to maintain reliability. Ongoing repairs and partial replacements should be handled as an Operating expense.

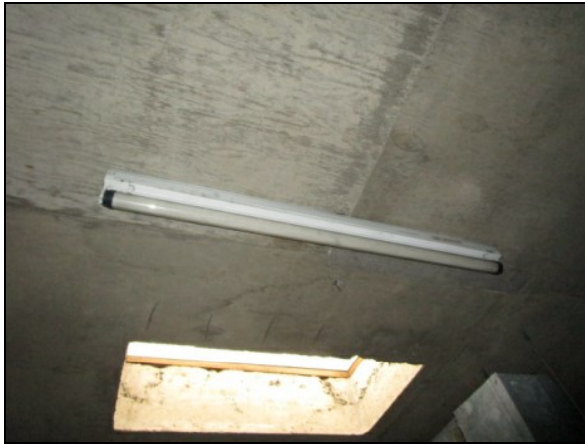
Comp #: 325 Interior Lights (utility) - Replace**Quantity: Approx (403) Fixtures**

Comments: The utility light strips and fixtures are older and have reached extended useful lives. Funding for replacement with LED fixtures.

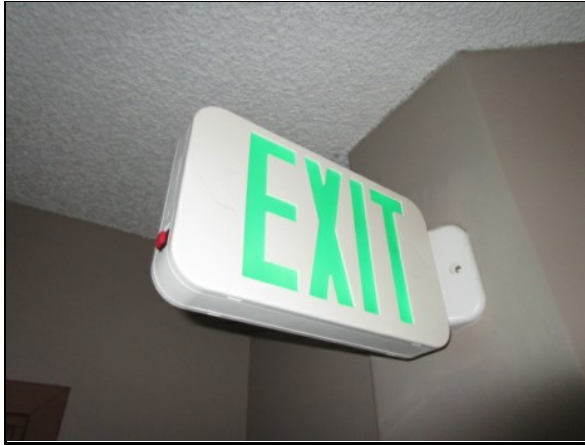
Comp #: 326 Exit Light Fixtures - Replace**Quantity: Approx (161) Fixtures**

Comments: Some hallway fixtures were damaged. Repair individual fixtures as needed as an Operating expense.

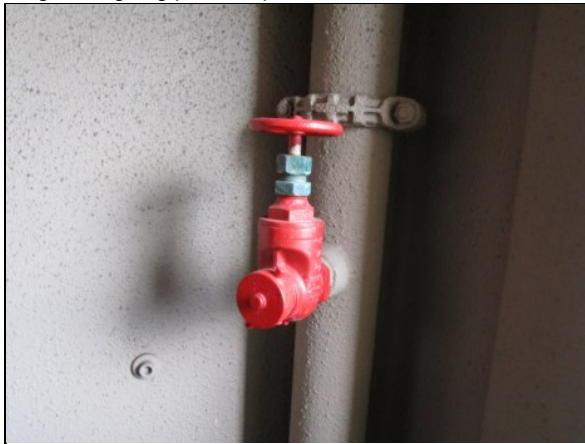
Comp #: 1830 Fire Sprinkler System - Repair**Quantity: Extensive System**

Comments: We are not licensed to inspect fire sprinkler systems. No testing was performed as part of the scope of this reserve study. This line-item provides funding for ongoing partial replacements, such as the various valves.

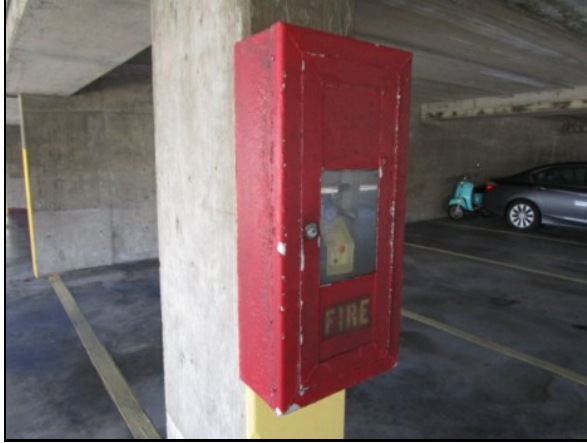
Comp #: 1835 Fire Extinguisher Cabinets- Replace

Comments: We are not licensed to inspect fire extinguishers. No testing was performed as part of the scope of this reserve study. Replace extinguishers as needed as an Operating expense. Funding for the replacement of the metal cabinets.

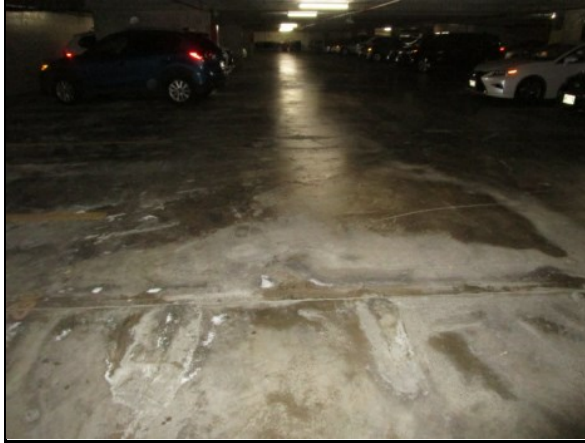
Comp #: 205 Concrete Drive - Repair**Quantity: Extensive GSF**

Comments: Under normal circumstances the parking garage concrete should not require major repairs due to interior location. However, it was reported that the garage experiences numerous flooding events, perhaps due to a low water-table. There have been no repair expenses as a result but if the flooding does cause concrete damage the project should be handled as needed as a Special Assessment. Funding provided with this line-item is for minor repairs only.

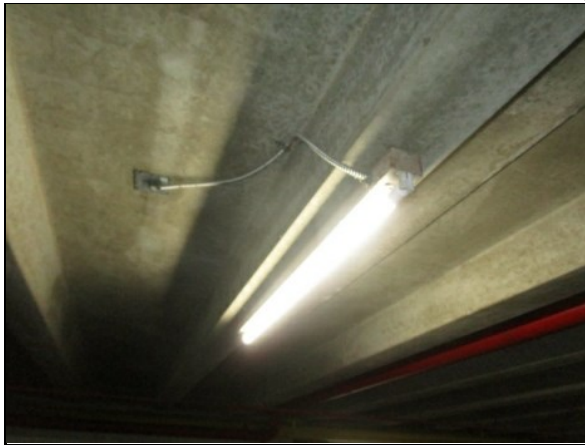
Comp #: 325 Ceiling Light Strips - Replace**Quantity: (165) Fixtures**

Comments: These light fixtures are older and have reached an extended useful life. Funding to replace with LED fixtures.

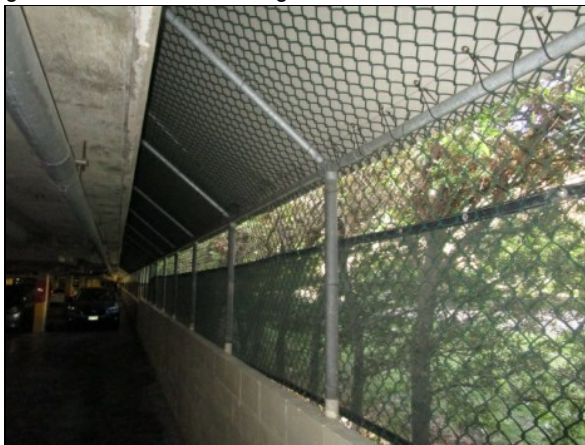
Comp #: 502 Chain Link Fence - Replace

Comments: The chain link fencing is intact and stable. No signs of failure.

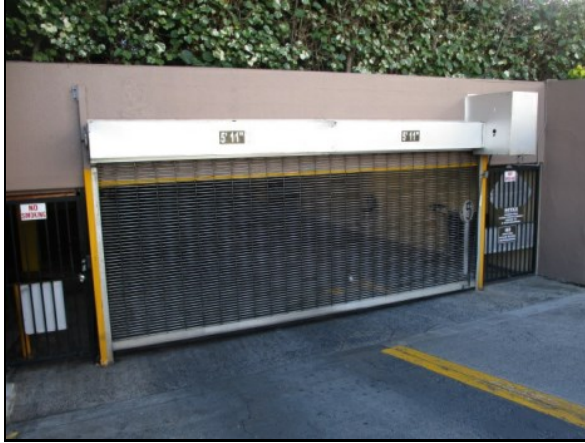
Comp #: 700 Vehicle Gate - Replace**Quantity: (1) 19 LF Roll-Up**

Comments: The vehicle gate was intact and functional. No signs of auto-damage. No reported problems. This line-item also includes the (2) pedestrian gates.

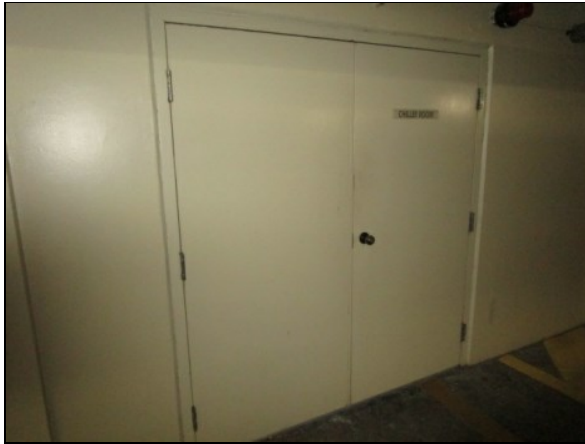
Comp #: 702 Interior Doors - Partial Replace**Quantity: (29) Doors**

Comments: (6) wood utility doors, (15) metal doors, (4) metal trash room doors, (4) metal lobby doors. Signs of heavy damage on the metal trash room doors. There is no expectation for complete replacement. Funding for ongoing partial replacements.

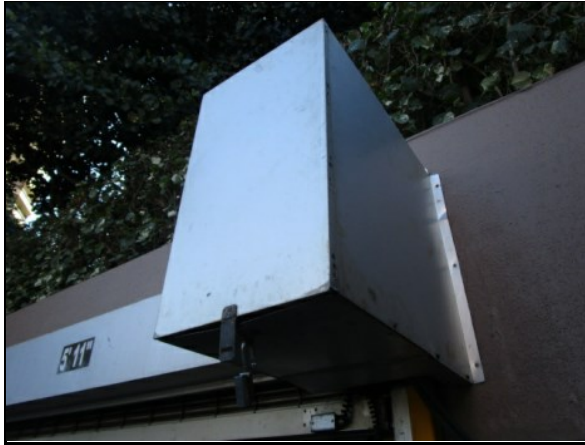
Comp #: 705 Gate Operator - Replace**Quantity: (1) Overhead Motor**

Comments: The gate operator is older but functional. Signs of moderate corrosion. Model # JAD519644.

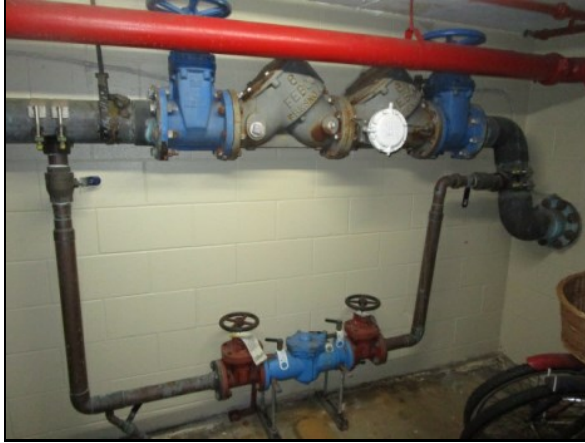
Comp #: 1001 Domestic Backflow Devices - Replace**Quantity: (2) Devices**

Comments: (1) 4" & (1) 6" device. The backflow devices should be tested annually. No signs of corrosion. These devices should prevent water from backflowing into the supply pipes with potentially harmful chemicals.

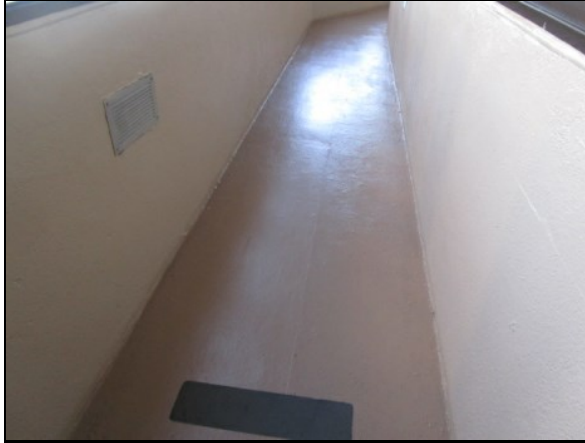
Comments: Signs of staining but no signs of bubbling or peeling at the interior corridor. The exterior walkways and the stairwell are showing signs of peeling. Surfaces should be recoated regularly to maintain appearance.

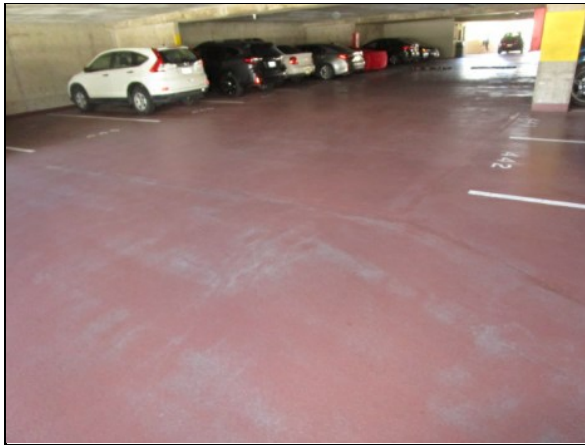
Comments: The lower parking level concrete is coated. Signs of staining throughout. It may be more cost-effective to remove this coating since the upper level is uncoated.

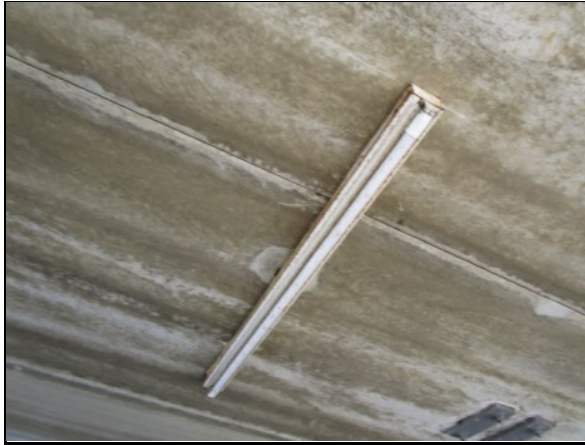
Comp #: 325 Ceiling Light Strips (a) - Replace

Comments: These fixtures are older and showing heavy corrosion. Funding to replace with LED fixtures.

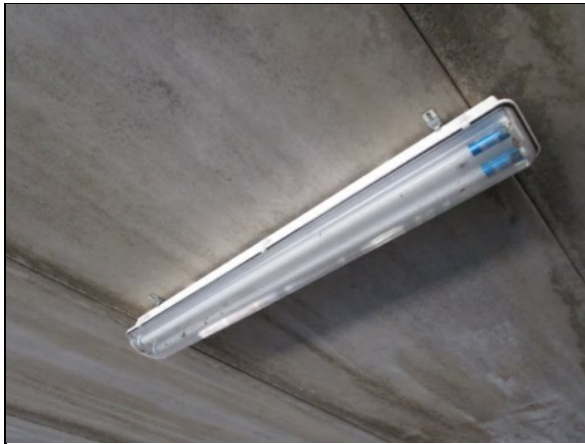
Comp #: 325 Ceiling Light Strips (b) - Replace

Comments: These LED fixtures were newer and in good condition. This line-item also includes the (3) newer fixtures at the basement parking garage that are identical to these.

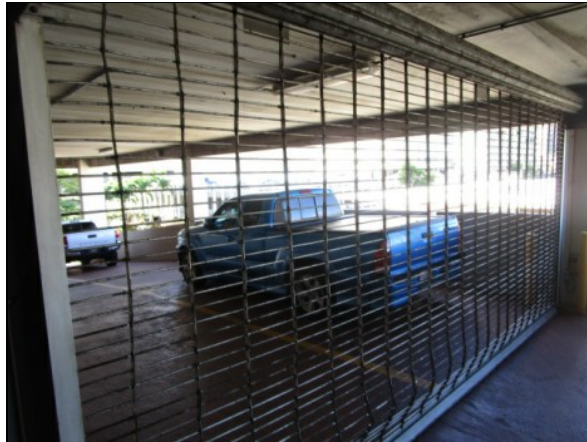
Comp #: 700 Vehicle Gate - Replace

Comments: The vehicle gate was intact and functional. No signs of auto-damage. No reported problems.

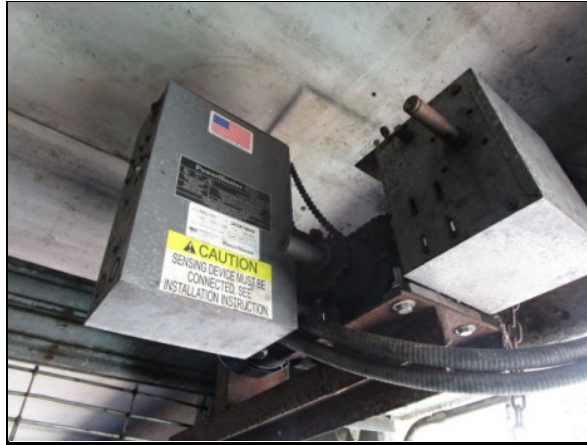
Comp #: 705 Gate Operator - Replace**Quantity: (1) PowerMaster**

Comments: The gate operator is older but functional. Signs of moderate corrosion. Model # JAD519644.

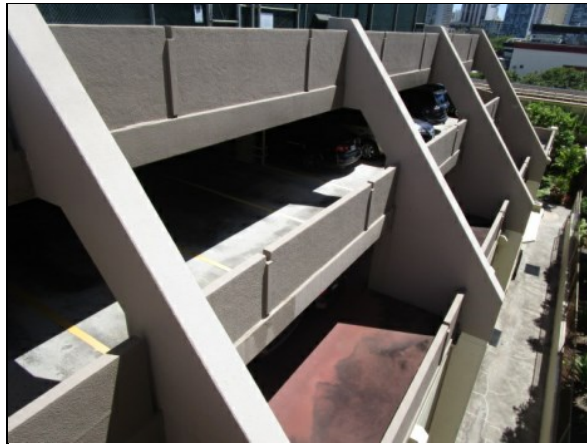
Comments: Signs of moderate peeling, bubbling, staining, and discoloration. These surfaces should be repainted in conjunction with the tower exteriors in order to maintain a uniform appearance and to lower the overall costs of repainting.

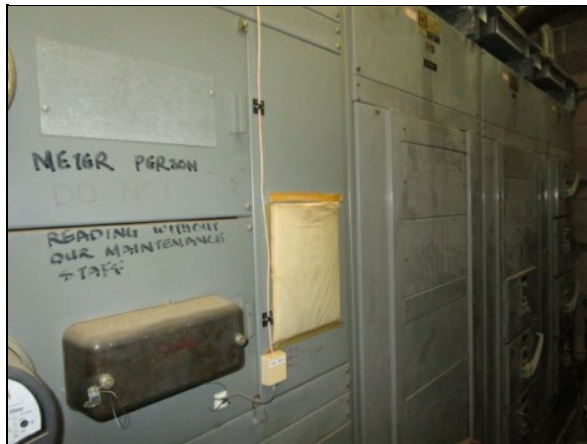
Comp #: 301 Electrical Switchgear - Replace

Comments: The electrical switchgear was not tested during inspection, but equipment is original. Anticipate the need to replace in the near future based on age.

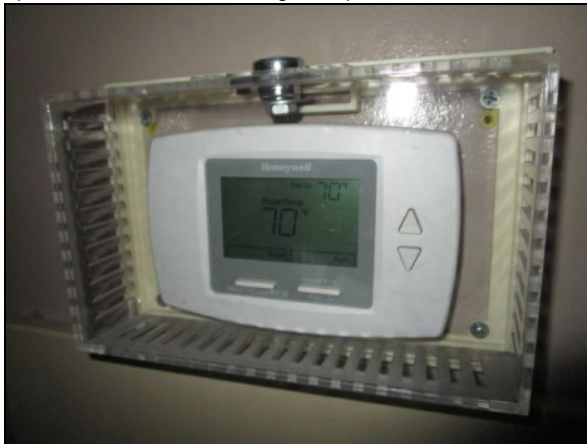
Comp #: 304 Thermostats - Replace

Comments: There is no expectation to replace all common area thermostats in one project. Replace individual thermostats as they fail as needed as an Operating expense. No Reserve funding is required.

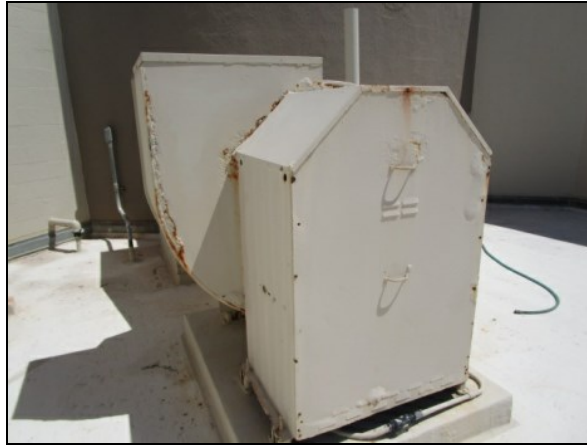
Comp #: 306 Ventilator Fans (roof) - Replace**Quantity: (10) Systems**

Comments: Diamond Head Tower: (5) systems. Ewa Tower: (5) systems. These ventilator fans service the unit dryer and bathroom vents. Signs of moderator corrosion. No reported problems. The fans motors should be repaired as needed as an Operating expense.

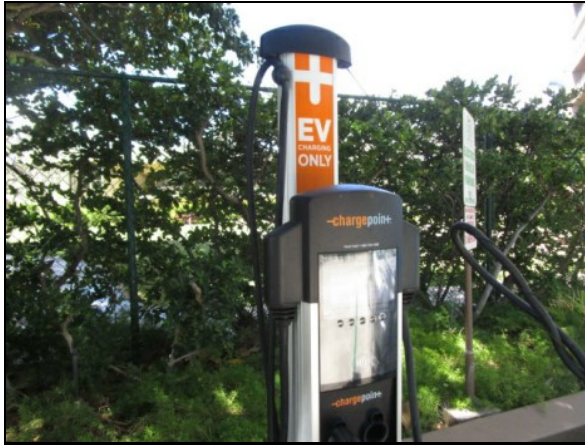
Comp #: 308 EV Chargers - Replace

Comments: These charging stations are owned by the AOA. Charging stations appear to be in good condition.

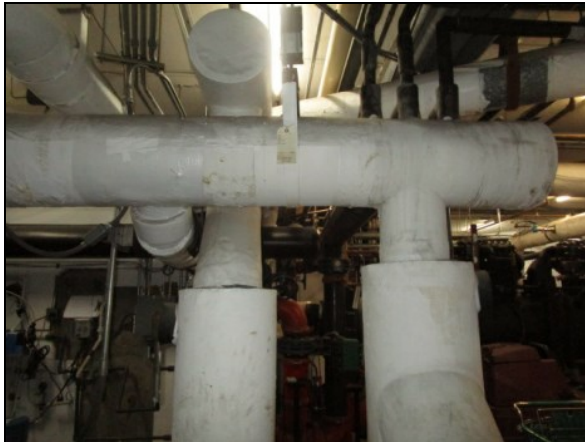
Comments: Funding for the periodic replacement of the chilled water piping and riser insulation.

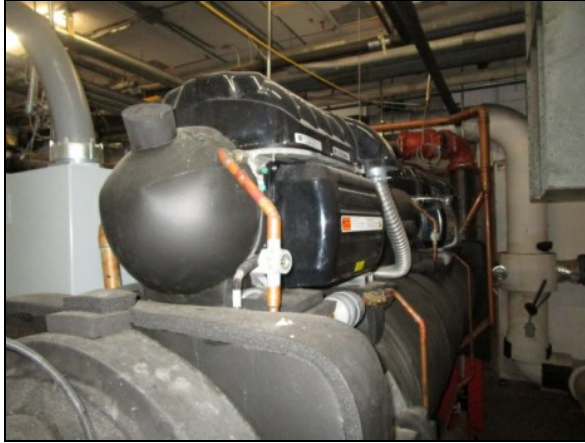
History: 2021 - Compressor #1 for Chiller # 1 Replaced

Comments: Funding for ongoing refurbishment of the liquid chiller systems. The biggest liability with these systems are the compressors, which are very expensive.

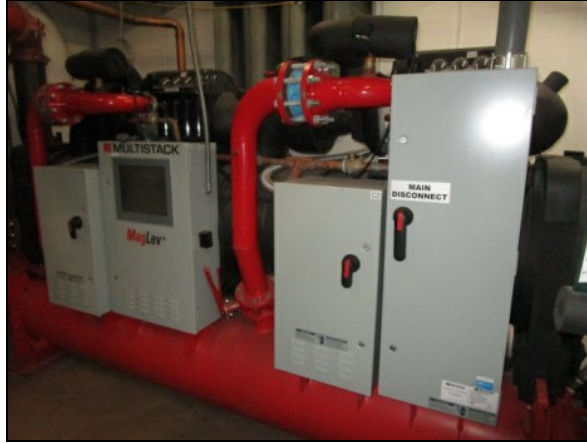
Comp #: 310 Chiller (#2) - Replace**Quantity: (1) MultiStack, 33 Ton**

Comments: This liquid chiller was recently replaced. No reported problems. Model # MS0332FC1M2W2H1CC87FN-R134A. Serial # AG01050. This line-item includes the replacement of the chiller controller panels.

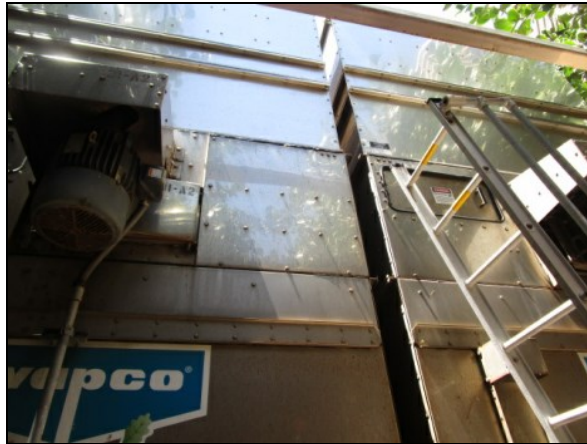
Comp #: 311 Cooling Towers - Replace**Quantity: (2) Evapco CTs**

Comments: The cooling towers were functional. No reported problems. Ongoing maintenance and minor repairs should be handled as an Operating expense. Each fan motor is 15 HP.

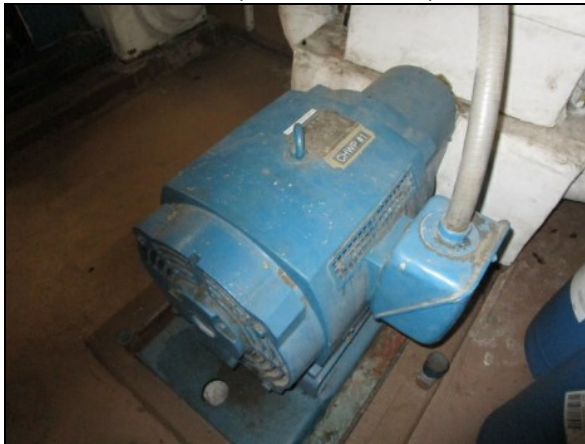
Comp #: 318 Pumps (chilled water) - Replace**Quantity: (2) 50 HP Pumps**

Comments: These pumps are older but functional. Anticipate the need to replace in the near future based on age.

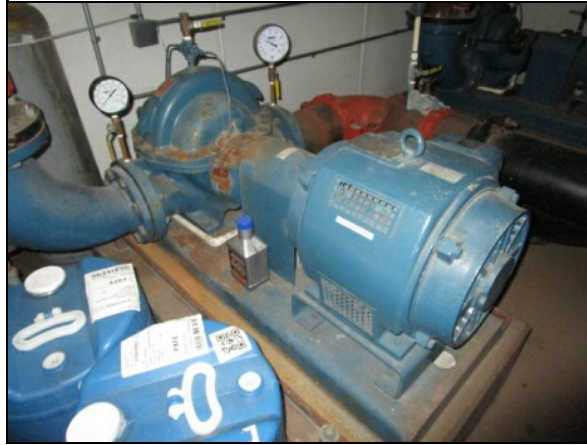
Comp #: 318 Pumps (condenser) - Replace**Quantity: (2) 25 HP Pumps**

Comments: Signs of heavy corrosion. These pumps are older but functional. Anticipate the need to replace in the near future based on age.

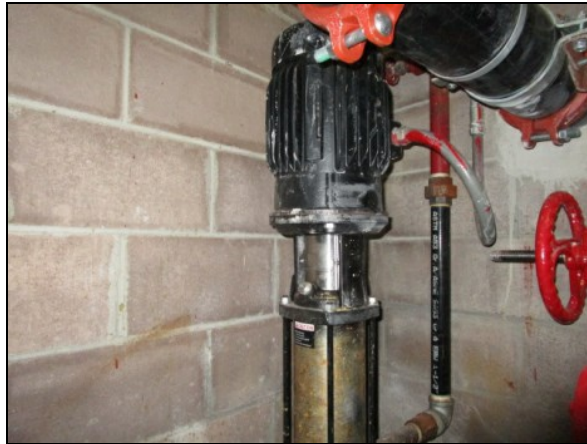
Comp #: 340 Fire Jockey Pump - Replace**Quantity: (1) 3 HP Pump**

Comments: We are not licensed to test this equipment. No testing was performed during our site inspection. The fire jockey pump and it's controller were recently replaced.

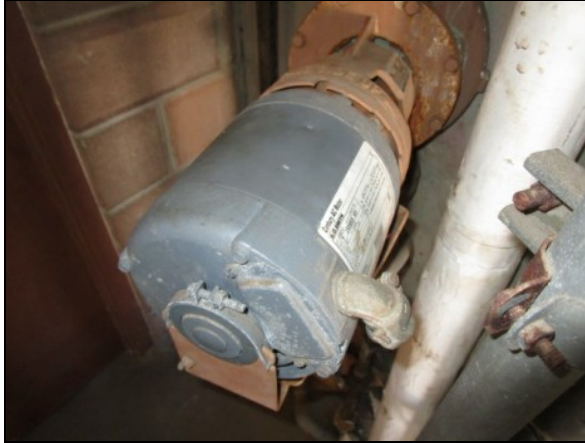
Comp #: 350 Pumps (heat pumps - upper)- Replace**Quantity: (2) 3/4 HP Pumps**

Comments: The hot water circulating pumps are older but functional. No reported problems. No signs of active leakage at time of inspection. Signs of moderate corrosion. Replacement should be coordinated with the replacement of the upper heat pumps that they're connected to (refer #303).

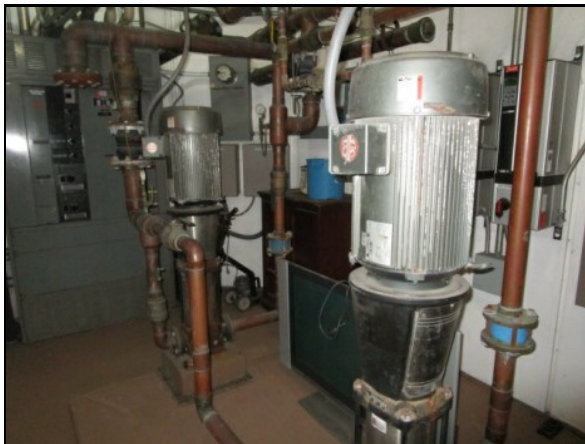
Comp #: 355 Pumps (Domestic Booster) - Replace**Quantity: (2) 20 HP System**

Comments: No reported problems with the system. No signs of active leakage. This line-item includes the pump controller. Refer to #307 for the VFDs.

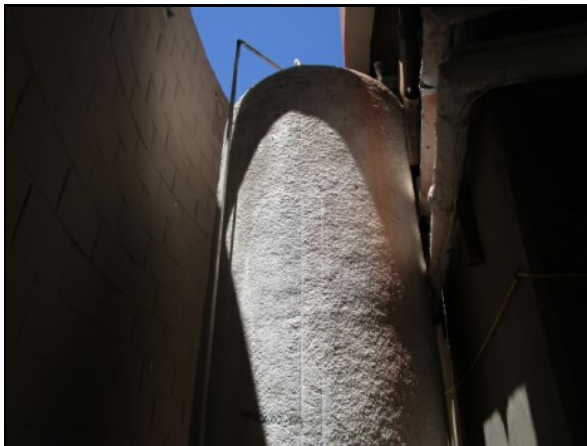
Comments: Steel tanks typically experience interior corrosion at a rate of 0.01 inches per year, which could result in tank failure at (25) years of useful life if left neglected. Removable and replacement costs can be extremely expensive, especially the rooftop tanks. To avoid this outcome, the tanks should be relined on a regular basis to thwart any interior decay. Cement liner is typically used with little down-time.
