**Sample Reserve Study
HOA/POA
*Anywhere, FL***

Report #: 35269-0
Beginning: January 1, 2022
Expires: December 31, 2022

RESERVE STUDY
"Full"

July 27, 2021

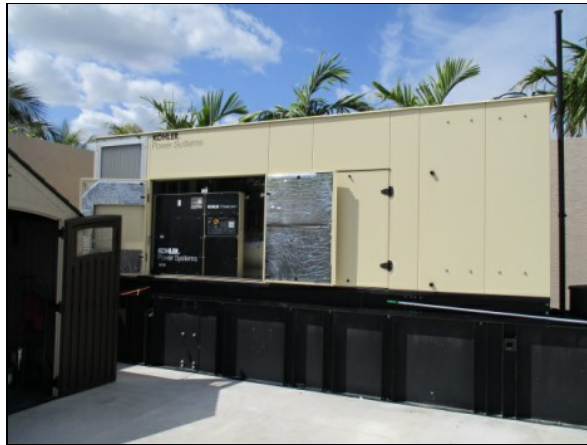
Comp #: 2549 Generator - Replace

Comments: Kohler 400-KW generator observed during inspection. Minimal or no subjective/aesthetic value for this component. Useful life is based primarily on normal expectations for service/performance life in this location. Unless otherwise noted, remaining useful life expectancy is based primarily on original installation or last replacement/purchase date, our experience with similar systems/components, and assuming normal amount of usage and good preventive maintenance. Vendors typically report that with ongoing maintenance (e.g. fluids, batteries, tune ups), useful life can be extended for many years. However, funding for complete replacement is often warranted due to lack of available replacement parts rather than failure of the generator as a whole. Treat periodic service and inspect as general maintenance expense within Operating budget, not Reserves. Generator is a key building element in this location due to risk of severe storms and power outages, and should be tested evaluated regularly to ensure proper function.

Lower estimate to replace

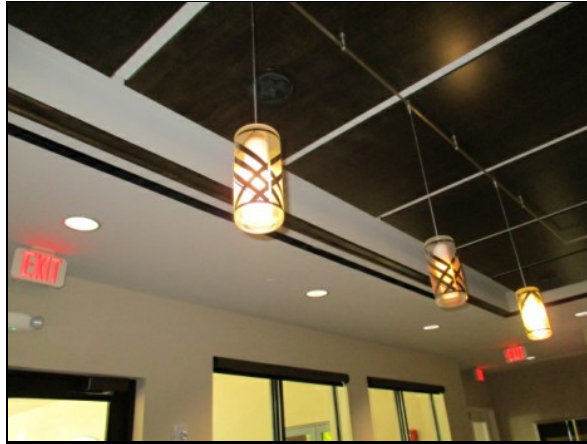
Comp #: 2558 Exit/Emergency Fixtures - Replace**Quantity: Numerous Fixtures**

Comments: In general, costs related to this component are expected to be included in the Association's Operating budget. No recommendation for Reserve funding at this time. However, any repair and maintenance or other related expenditures should be tracked, and this component should be re-evaluated during future Reserve Study updates based on most recent information and data available at that time. If deemed appropriate for Reserve funding, component can be included in the funding plan at that time.

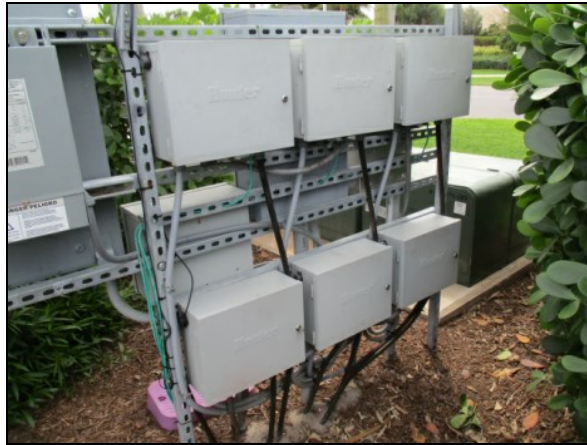
Comp #: 2587 Irrigation Controllers - Replace

Comments: Hunter controllers observed during inspection. Minimal or no subjective/aesthetic value for this component. Useful life is based primarily on normal expectations for service/performance life in this location. Unless otherwise noted, remaining useful life expectancy is based primarily on original installation or last replacement/purchase date, our experience with similar systems/components, and assuming normal amount of usage and good preventive maintenance. Irrigation controllers should have a relatively long life expectancy under normal circumstances. Replacement is often required due to lack of available replacement parts, lightning strikes, etc. as opposed to complete failure of existing equipment. Exposure to the elements can affect overall life expectancy, and controllers should be located in protected areas or within protective enclosures whenever possible. When evaluating replacement options, the Association should consider replacement with "smart" models (i.e. respond to projected weather data) to minimize unnecessary water usage. Payback period for efficient controllers that minimize water use is typically very short, easily justifying the additional costs of these options.

Lower estimate to replace

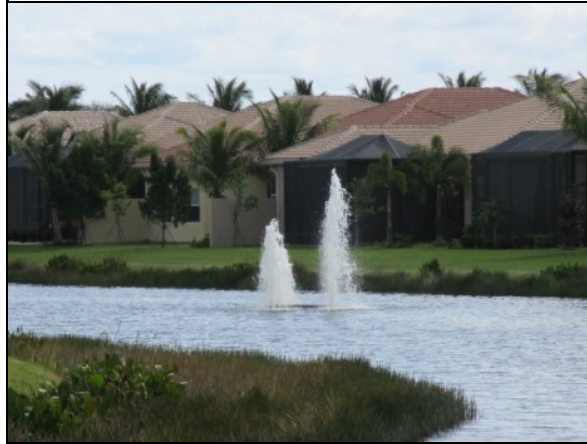
Comp #: 2595 Pond Fountains - Replace**Quantity: (4) Fountains**

Comments: Fountains are primarily aesthetic in nature and there are many different types available for replacement. Fountains should be inspected and maintained regularly by servicing vendor or maintenance staff to ensure proper function and maximize life expectancy. Consult with lake/pond vendor to ensure that fountains are properly-sized and positioned for the body of water. Costs to replace are based on similar size and features.

Lower estimate to replace

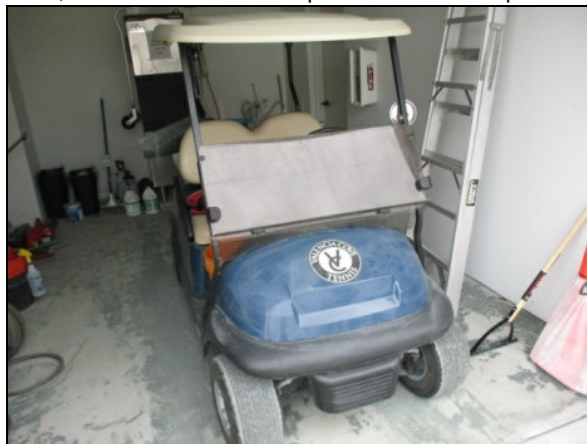
Comp #: 2599 Golf Carts - Replace**Quantity: (2) Cart(s)**

Comments: EZ-Go golf carts observed during inspection. (1) owned and (1) leased. However, association wishes to buy a new one in place of the leased cart. Minimal or no subjective/aesthetic value for this component. Useful life is based primarily on normal expectations for service/performance life in this location. Unless otherwise noted, remaining useful life expectancy is based primarily on original installation or last replacement/purchase date, our experience with similar systems/components, and assuming normal amount of usage and good preventive maintenance. Routine maintenance should be performed to maximize useful life of the cart(s). Useful life will depend on application and level of daily use, but plan to replace at the approximate interval shown below. Unless otherwise noted, cost estimates reflect replacement with comparable type, either new or lightly used.

Lower estimate to replace

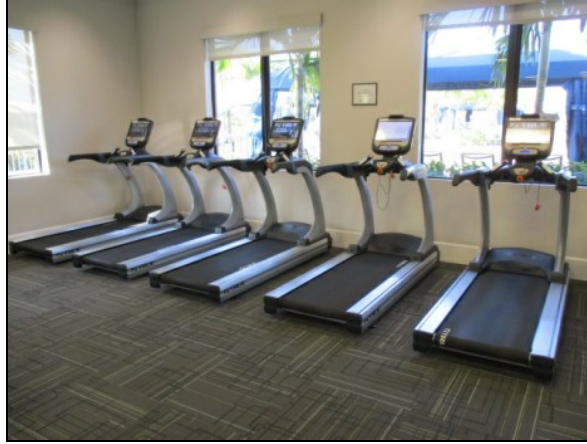
Comp #: 2727 Fitness Eqpmt (Cardio) - Replace**Quantity: (13) Pieces**

Comments: High quality TRUE brand equipment observed during inspection. Includes (6) treadmills, (4) elliptical machines, and (3) exercise bikes. In our experience, cardio equipment tends to have a shorter useful life overall than strength equipment due to more electronic components, moving parts, and advancements in technology. Inspect regularly, clean for appearance, maintain and repair promptly as needed from Operating budget to ensure safety. Best practice is to coordinate replacement of all equipment together to obtain better pricing and achieve consistent style and quality.

Lower estimate to replace

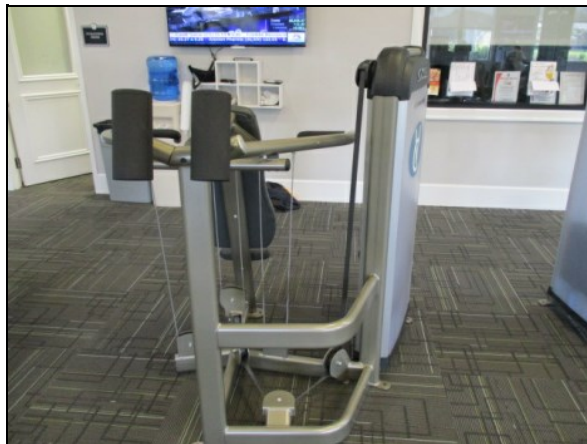
Comp #: 2728 Fitness Eqpmt (Strength) - Replace**Quantity: (15) Pieces**

Comments: Cybex brand equipment observed during inspection. Includes (11) strength stations, (2) dumbbell sets, and (2) cable towers. Strength equipment often has a longer useful life than cardio equipment, so it has been listed separately. However, many Associations still choose to replace all fitness equipment together on the same cycle. Equipment should be inspected periodically for safety and functional concerns. Cost estimates shown here are based on replacement with the same approximate types and quantities of existing assets.

Lower estimate to replace

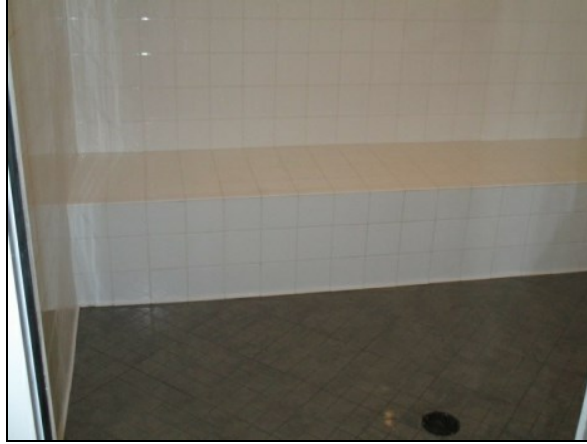
Comments: Approximately 930 GSF total tile surface area. Clean, inspect and repair as needed as an Operating expense. Tile surfaces should eventually be replaced for aesthetic reasons. Life expectancy can vary greatly depending on level of use and aesthetic preferences. Funding recommendation shown here is based on our experience with similar properties, but schedule can be adjusted during future Reserve Study updates at the Association's discretion. Timing of remodeling is ultimately subjective. Best practice is to coordinate remodeling with other amenities, such as bathrooms or other facilities.

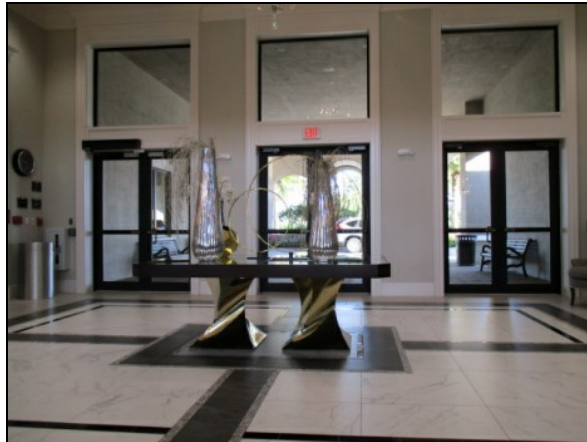
Comments: Above average styling and overall in good condition. Main hallway/corridor areas (not included in other room components) include: approximately 3,210 GSF of tile flooring, approximately 1,660 GSY of carpeting, (18) artwork pieces, (10) case goods, (17) decorative lights, (4) chandeliers, (4) trophy cases, (12) armchairs, (3) potted plants, (1) Tv, (2) bench seats, (1) extra-large bench seat, (3) sofas, (1) piano and (2) coffee tables. All in good condition at time of inspection.

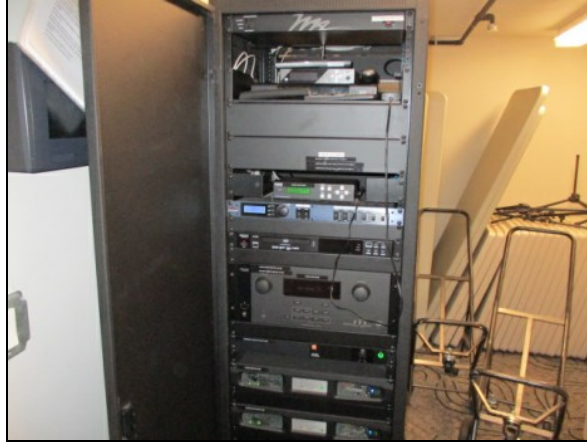
Comp #: 2745 A/V Equipment - Update/Replace**Quantity: Numerous Components**

Comments: Includes (7) amps, (1) mixer, (1) video switcher, (1) spot light, and other miscellaneous equipment. Audio/visual equipment should be maintained and tested periodically to ensure good function. For most Associations, ongoing replacement of individual components is treated as an Operating expense, but replacement of many (or all) system components may eventually be warranted. Funding allowance recommendation shown here is for replacement with new equipment, comparable in style and quality to the assets noted during our site inspection.

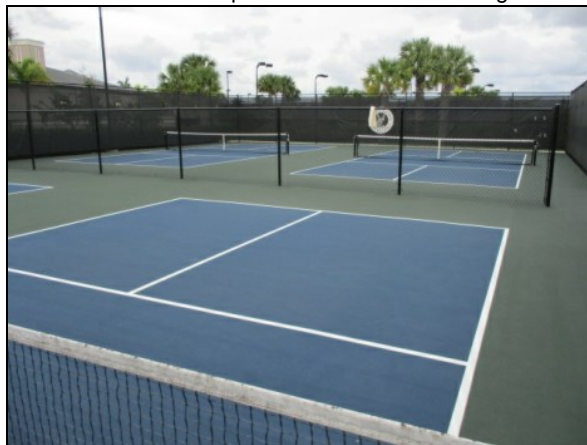
Comp #: 2821 Sport Courts - Repair/Re-coat**Quantity: (7) Courts**

Comments: (1) half basketball court, (4) pickleball courts and (2) handball courts. Sport courts should be inspected and repaired routinely as an Operating expense in order to preserve an attractive, playable court surface. Plan to repair (as-needed) and re-coat at the approximate interval shown here in order to protect the court from sunlight and weather.

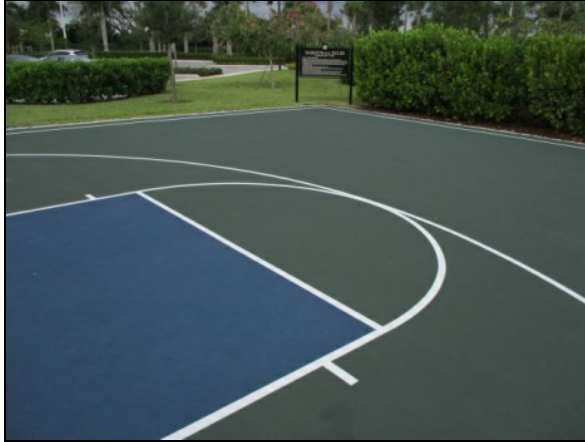
Comments: (1) half basketball court, (4) pickleball courts and (2) handball courts. Assuming proper maintenance and proper re-coating schedules, the court surface should have a relatively long life expectancy. Over time, exposure to UV light, wind rain and foot traffic will deteriorate the surface to the point of failure. Prior to resurfacing, consult with vendors to identify any structural problems, such as poor grade, lack of drainage, high spots, etc. Plan to resurface at the approximate interval shown below in order to preserve the appearance and usefulness of the court surface. Best practice is to coordinate with other projects, such as fencing and/or lighting replacement.

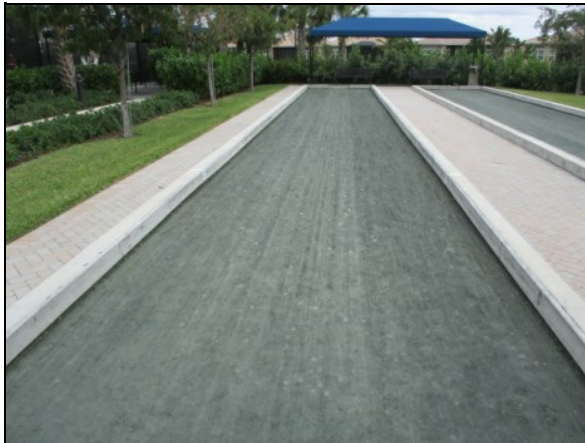
Comp #: 2823 Bocce Ball Courts - Repair/Maintain**Quantity: (2) Court(s)**

Comments: Har-Tru surface. Bocce courts should be inspected periodically for trip hazards or impediments to play. Costs shown here assume courts will be resurfaced/replaced with same materials as currently in place unless otherwise noted.

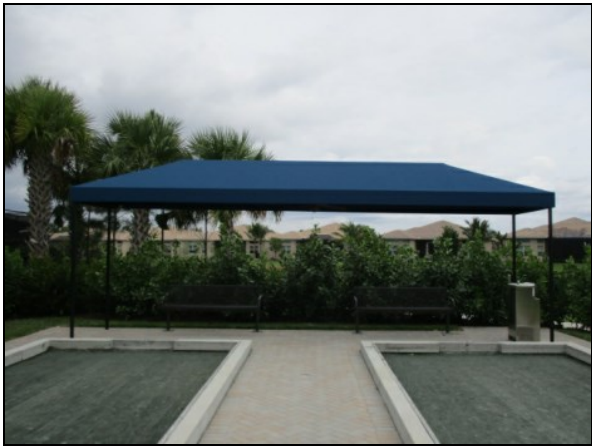
Comp #: 2829 Sports Ct Furnishings - Replace

Comments: (8) drinking fountains, (6) tables, (43) chairs, and (7) trash cans counted during inspection. Inspect regularly and repair/replace net/hoop as needed within annual Operating budget. Although sturdy materials/equipment, plan for eventual replacement at the time frame below if not damaged or abused. Best timed with other larger court projects for cost efficiency/consistency.
