Sample Townhome Community II
WA 2022 FY
Anytown, WA

Report #: 9999-0
Beginning: January 1, 2022
Expires: December 31, 2022

RESERVE STUDY
"Full"

July 29, 2021

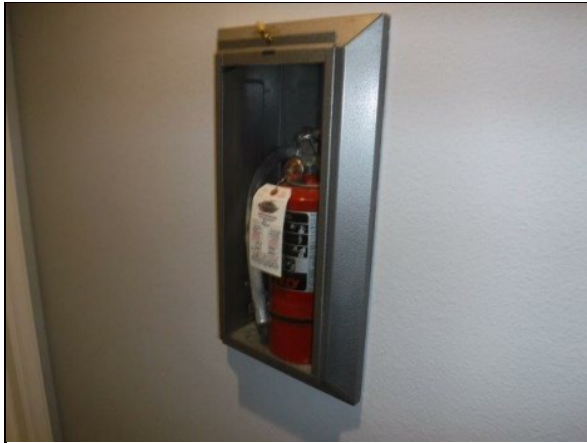
Comp #: 966 Fire Extinguishers-Inspect/Replace

Comments: The fire extinguishers were observed to be in stable condition and are assumed to function properly.

Follow all local fire code and inspection requirements. Replace extinguishers utilizing operating funds as recommended after inspection. If large-scale replacement becomes necessary, funding can be added to this component in a future report.

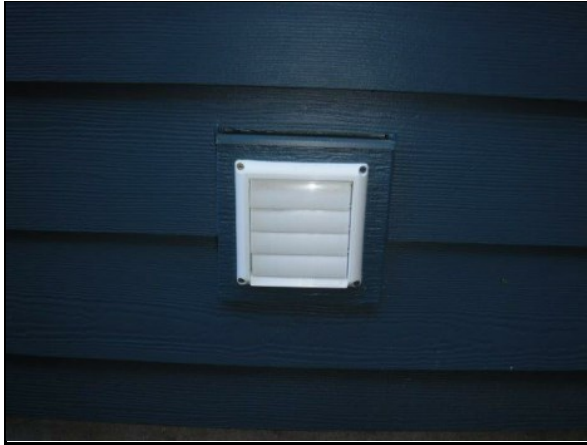
Comp #: 975 Vents - Clean & Repair

Comments: The buildings include multiple vents that serve various purposes. We recommend the association have the vents inspected and cleaned annually with operating funds. Heightened attention should be given to dryer vents to ensure no blockages have occurred. Dirty/blocked dryer vents (and hoses) have the potential to lead to a fire hazard.

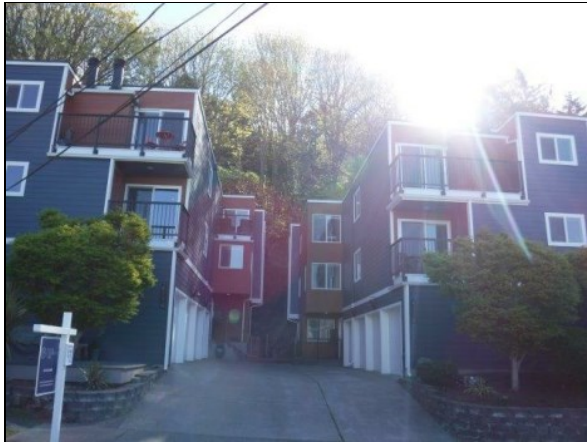
Comments: We highly recommend having a comprehensive energy audit of the building to analyze cost efficiencies and timing of equipment replacement. Contact Seattle City Light to learn about energy conservation and potential rebate offers. Companies like Washington Energy Services and Evergreen Energy Services offer onsite energy audits for a minimal fee.

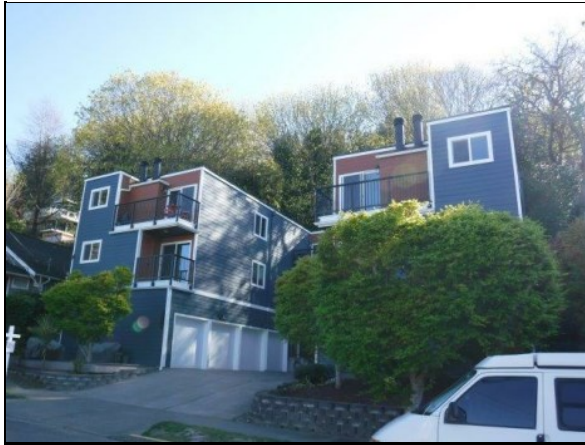
Comments: There were no reported problems at this time. A reserve study is a budget model, limited to visual exterior observations and research. It is outside the scope of our services, and the purpose of a reserve study, to assess the adequacy of the building envelope performance, as many of the key details are hidden from view. Any areas of concern observable from exterior observation have been noted in the various component field notes throughout this report. We highly recommend regular professional inspections by a qualified engineering, architectural, or building envelope consulting firm to evaluate the performance of the building envelope. Many associations are required by their Declaration to have annual inspections by a qualified architect or engineer to assess the physical condition of the building envelope enclosure. The building envelope inspection typically covers the roofs, decks, siding, windows, doors, sealants/caulking, and flashings. As the building ages, and the waterproofing typically deteriorates, provide more frequent inspections.

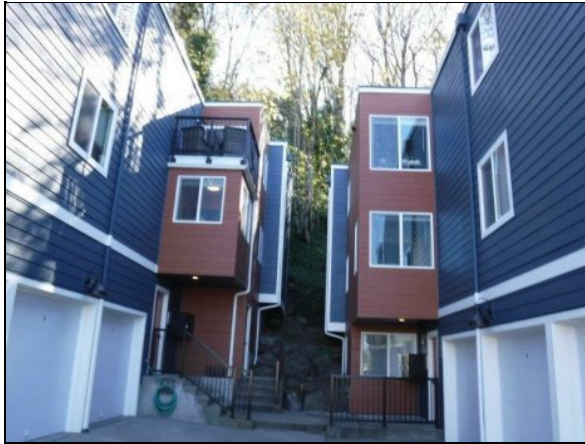
Comments: Many associations are required to have annual inspections by a qualified engineer or architect to assess the physical condition of the improvements. The inspection typically covers, at a minimum, the building envelope including roofs, siding, decks, waterproofing/sealants, flashings, glazing systems, and doors. Forensic evaluation, building drops, etc. are beyond the scope of a typical reserve study. Although your association's governing documents do not appear to have such a requirement, we recommend that the Board provide for periodic building envelope inspections, funded from the operating budget, to help ensure critical areas are functioning properly.

In addition to an annual inspection, we recommend the association annually survey residents to inquire about conditions only visible from the unit interiors that the association may not be aware exist. Survey questions may include, but are not limited to, water intrusion/organic growth (particularly at windows and doors, skylights, water heaters, plumbing fixtures, etc), cracking or any other movement of drywall or structural members, and any other general building concerns. Such surveys can be key in identifying potential concerns early, thus increasing the opportunity to conduct repairs before advanced deterioration/damage and, therefore, larger expense occurs.
