**Sample Timeshare Property**

***Anywhere, XX***

Report #: 17918-1  
Beginning: January 1, 2026  
Expires: December 31, 2026

**RESERVE STUDY**  
**Update "With-Site-Visit"**

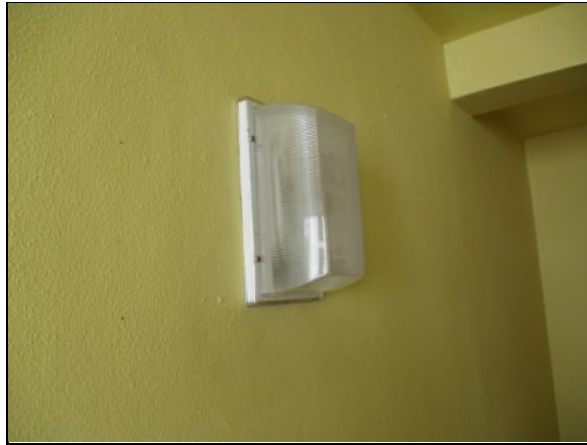
Observed during daylight hours but assumed to be in functional, operating condition. As routine maintenance, clean by wiping down with an appropriate cleaner, change bulbs and repair as needed. Individual replacements should be considered an Operating expense. If available, an extra supply of replacement fixtures should be kept on-site to allow for prompt individual replacements. Best practice is to plan for total replacement to periodically restore an attractive aesthetic standard within the property's common areas. Based on evident conditions and repair/replacement history provided by the Client during this engagement, we recommend financially preparing for comprehensive replacement at the approximate time frame below. Unless otherwise noted, costs shown here are based on replacement with comparable quantity and style of lights as existing. We recommend consideration of LED fixtures or other energy-saving options whenever possible.

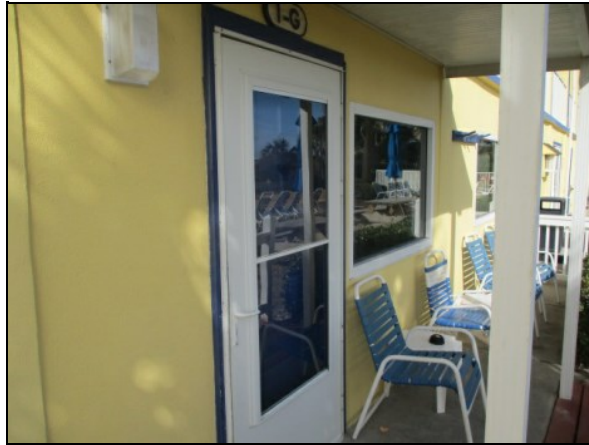
**Comp #: 23630 Door - Metal/Glass - Units****Approx Quantity: 50 Each****Location:** Building exterior (beach side)**Funded?:** Yes. Meets the CAI Reserve Study Standards three-part test.**History:****Comments:** \*NOTE: A 2015 code date was present on these doors. The remaining useful life of this component has been set based on consideration of that information, beachside location, and the conditions visually evident at the time of inspection.

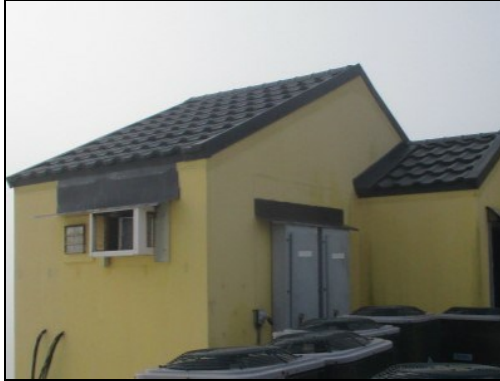
**Comp #: 23810 Roof - Metal****Approx Quantity: 250 GSF****Location:** Elevator Room and Stairs**Funded?:** Yes. Meets the CAI Reserve Study Standards three-part test.**History:** Replaced in 2016 at an approximate cost of \$5,500 (per information provided)

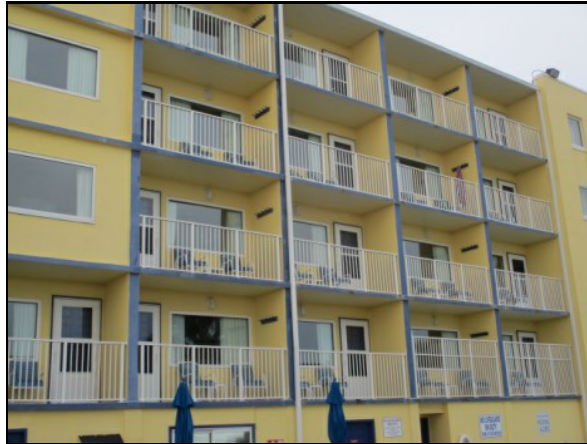
**Comp #: 23840 Gutter/Downspout****Approx Quantity: 600 LF****Location:** Building rooftop/perimeters**Funded?:** Yes. Meets the CAI Reserve Study Standards three-part test.**History:** Replaced in 2020 at an approximate cost of \$8,000 (per information provided)**Comments:** Gutters and downspouts determined to be in fair condition typically exhibit some normal wear and tear, but drainage away from the roof and building appears to be adequate. Generally believed to be aging normally.

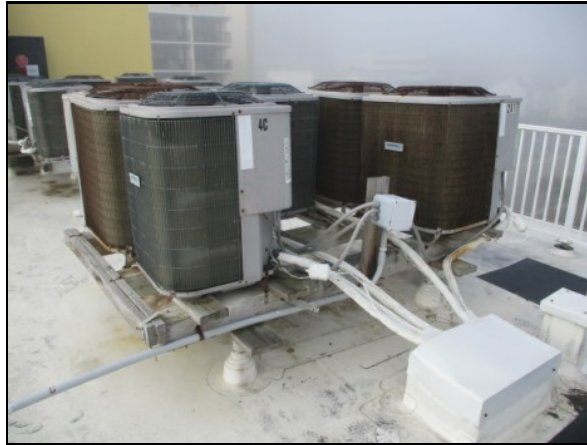
**Comp #: 23875 HVAC Stands****Approx Quantity: 52 Each****Location:** Building rooftop**Funded?:** Yes. Meets the CAI Reserve Study Standards three-part test.**History:****Comments:** \*NOTE: The remaining useful life of this component has been adjusted to cycle replacement of the HVAC stands with replacement of the single ply roofing (component #23780).

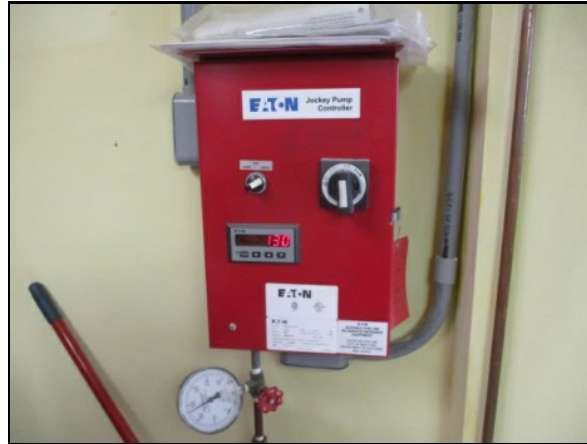
**Comp #: 25600 Fire Sprinkler - Pump/Controls - Main****Approx Quantity: 1 Each****Location:** Mechanical room (Ground Floor)**Funded?:** Yes. Meets the CAI Reserve Study Standards three-part test.**History:** (Listed below)**Comments:** Project History (As Reported/Available) -

2016: Main and jockey pump systems installed/replaced (per evident tag information)

Pump was not tested during site inspection, and is assumed to be functional unless otherwise noted. The system should be inspected, tested and repaired as needed on a regular basis by qualified vendor to ensure optimal performance. Fire sprinkler/suppression pump and control panel should have a long useful life expectancy under normal circumstances, with no aesthetic priority to the Client. Over time, replacement parts may not be available and the Client may need to replace the entire pump assembly, control panel, etc prior to actual functional failure as a safety precaution. Unless otherwise noted, remaining useful life expectancy is based primarily on original installation or last replacement/purchase date, our experience with similar systems/components, and assuming normal amount of usage and good preventive maintenance. However, the Client should track and report all repair/replacement expenditures related to the pump system. This component should be re-evaluated during future Reserve Study updates to incorporate any new information available at that time.

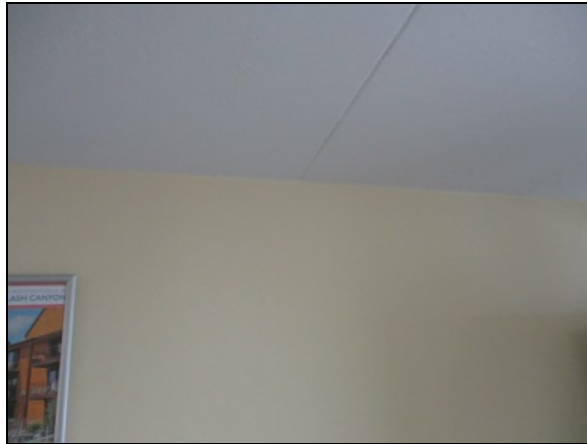
**Comp #: 27010 Paint - Interior****Approx Quantity: 2,100 GSF****Location:** Common interiors (laundry room, concierge room, and office)**Funded?:** Yes. Meets the CAI Reserve Study Standards three-part test.**History:****Comments:** Fair condition: Interior areas determined to be in fair condition typically exhibit some minor, routine marks and scuffs, small sections of peeling paint, etc. Overall appearance is satisfactory.

Regular cycles of professional painting are recommended to maintain appearance. Small touch-up projects can be conducted as needed as a maintenance expense, but comprehensive painting of interior areas will restore a consistent look and quality to all areas. Best practice is to coordinate at same time as other interior projects (flooring, furnishings, lighting, etc.) whenever possible to minimize downtime and maintain consistent quality standard. Based on evident conditions and/or project history provided during this engagement, we recommend repainting at the approximate interval shown below. Unless otherwise noted, cost estimates below are intended for painting only and not inclusive of any extensive wall repairs/renovations (such as trim work, etc.).

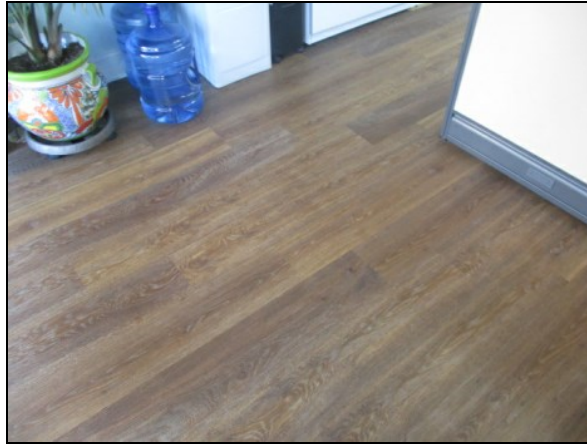
**Comp #: 27180 Flooring - Vinyl (LVP)**

Fair condition: Vinyl/resilient determined to be in fair condition typically exhibit routine signs of age and wear, such as staining and minor cracking, tears, etc. Appearance is still generally consistent at this stage.

Aesthetic value of this type of flooring is generally lower, so condition determination is based primarily on physical condition unless otherwise noted. Higher priority for aesthetics should be considered if area is accessed by residents and guests of the property. Inspect regularly, repair any damaged areas and clean using operating/maintenance budget. Although vinyl flooring should have a very long useful life in this application, comprehensive replacement should eventually be expected to maintain good standards in the common areas. Costs can vary based on quality and style of flooring selected. Unless otherwise noted, cost estimates below assume replacement with similar quantity and quality as existing.

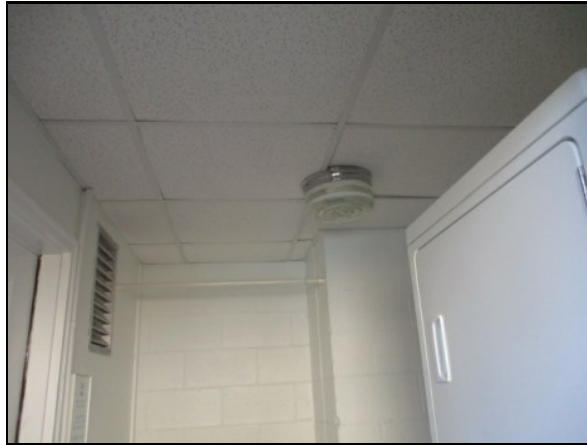
**Comp #: 27190 Drop/Suspended Ceiling****Approx Quantity: 750 GSF****Location:** Common interiors (laundry room, concierge room, and office)**Funded?:** Yes. Too small for Reserve designation.**History:****Comments:** Fair condition: Suspended ceiling systems (AKA “drop” ceilings) determined to be in fair condition typically exhibit only routine signs of physical deterioration. Appearance is generally consistent in all areas.

Suspended ceiling systems should have a very long life under most circumstances. Individual panels should be replaced as needed through the Operating budget. Based on evident conditions, original installation date, and prior project history provided during this engagement, we recommend planning on complete replacement at the approximate interval shown below. Replacement will restore aesthetic value in the common areas. Best practice is to coordinate this work with other interior finish projects (painting, flooring, etc.) whenever possible in order to minimize downtime and maintain consistency. Unless otherwise noted, cost estimates shown below assume replacement with a similar type to the existing system.

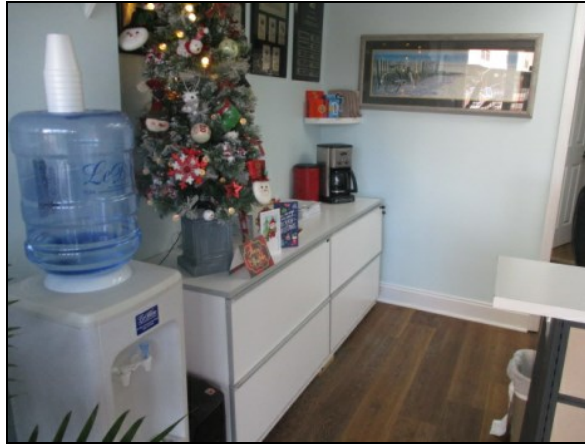
**Comments:** Fair condition: Fixtures, furnishings, and equipment (FF&E) determined to be in fair condition may exhibit light to moderate wear and tear, but are still in generally serviceable condition. Style is consistent but may be becoming outdated at this stage.

Individual fixtures, furnishings, and/or equipment (FF&E) pieces should be repaired/replaced as needed by the Client. Based on evident conditions and/or information provided during this engagement, this component represents a "supplemental" allowance for replacement/refurbishment of interior FF&E in order to maintain a desirable aesthetic in the common areas. Remaining useful life shown below is based on consideration of asset conditions as well as Client replacement history. Costs of replacement can vary greatly depending the style and quality of replacement options. Best practice is to coordinate this type of project with other interior projects such as flooring replacement, painting, etc. Moving forward, the Client should track and report all replacement expenditures related to this component. This component should then be re-evaluated during future Reserve Study Updates based on the most current information available at that time.

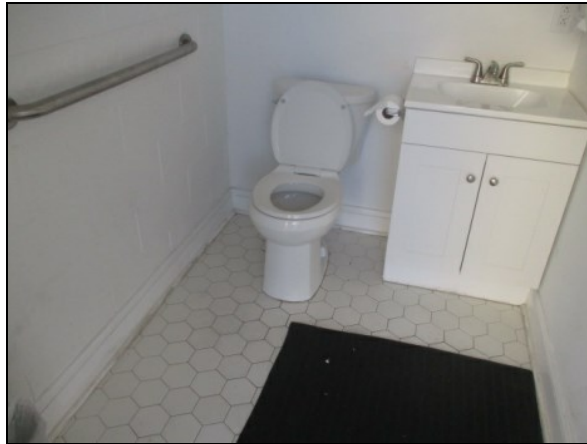
**Comp #: 27490 Renovate - Bathrooms****Approx Quantity: 3 Each****Location:** Common bathrooms (ground floor)**Funded?:** Yes. Meets the CAI Reserve Study Standards three-part test.**History:****Comments:** Approximate Bathroom Measurement/Count (Per Bathroom) -

Fair to poor condition: Bathrooms determined to be in fair to poor condition typically exhibit some moderate signs of use and age. Finishes are clean but showing some wear. All fixtures are assumed to be functional, but may be becoming outdated at this stage. Generally in serviceable condition.

As routine maintenance, inspect regularly and perform any needed repairs promptly utilizing general Operating funds. Typical remodeling project can include some or all of the following: replacement of plumbing fixtures, partitions, countertops, lighting, flooring, ventilation fans, accessories, décor, etc. Best practice is to coordinate this project with other amenity areas, such as kitchens or other amenity rooms. Remaining useful life is based on consideration of materials, evident conditions, and/or remodeling/renovation history provided during the engagement. Costs can significantly vary based on an anticipated scope of work as well as materials chosen for remodeling/renovation. Unless otherwise noted, estimates shown are based primarily on light to moderate cosmetic remodeling, not complete "gut" remodel projects.

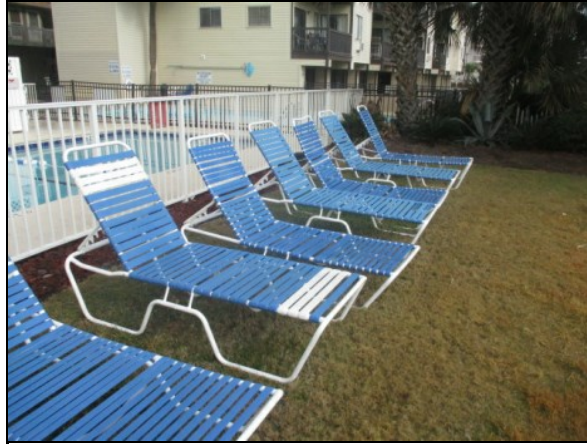
Fair condition: Chaise lounges determined to be in fair condition typically exhibits routine, noticeable signs of wear and age, but appearance is still decent and consistent, acceptable for the standards of the property.

We recommend regular inspections and repair or replacement of any damaged pieces promptly to ensure safety. Protected storage of furniture when not in use can help to extend useful life. Best practice is to replace all pieces together in order to maintain consistent style and quality in the pool/recreation area. Individual pieces can be replaced as needed each year as an Operating expense. Costs can vary greatly based on quantity and type of pieces selected for replacement. Funding recommendation shown here is based on replacement with comparable number and quality of pieces as existing.

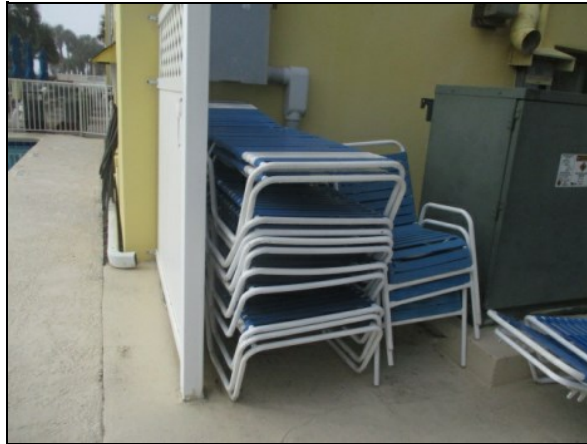
Fair condition: Dining chairs determined to be in fair condition typically exhibits routine, noticeable signs of wear and age, but appearance is still decent and consistent, acceptable for the standards of the property.

We recommend regular inspections and repair or replacement of any damaged pieces promptly to ensure safety. Protected storage of furniture when not in use can help to extend useful life. Best practice is to replace all pieces together in order to maintain consistent style and quality in the pool/recreation area. Individual pieces can be replaced as needed each year as an Operating expense. Costs can vary greatly based on quantity and type of pieces selected for replacement. Funding recommendation shown here is based on replacement with comparable number and quality of pieces as existing.

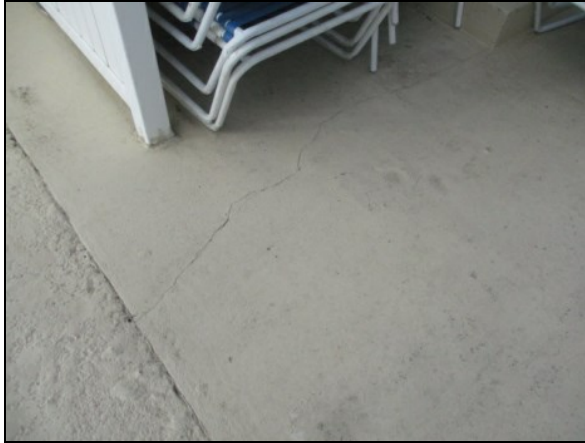
**Comp #: 27680 Pool Deck - Coated - Resurface****Approx Quantity: 900 GSF****Location:** Pool deck**Funded?:** Yes. Meets the CAI Reserve Study Standards three-part test.**History:****Comments:** \*NOTE: Standard coating projects (typically conducted once every 3 to 5 years) are anticipated to be conducted through the client's Operating budget (cost is below \$3,000 threshold set for Reserve funding).

This component refers to the eventual need to completely resurface/replace decking systems, typically required after multiple finish coats have been applied, or in cases of advanced deterioration. Deck resurfacing includes grinding the current surface down to bare concrete and then installing a new waterproofing layer/system. This may be recommended when the aesthetic condition of the deck can no longer be restored through future deck re-coating, such as advanced cracking, chipping of the deck surface, or lack of texture (for safety concern). Resurfacing may also be warranted for changes in design/appearance alone. Based on evident conditions and/or information provided during this engagement, we recommend that the Client plan to resurface at the approximate interval below. Unless otherwise noted, cost estimates assume with a similar deck type as currently in place.

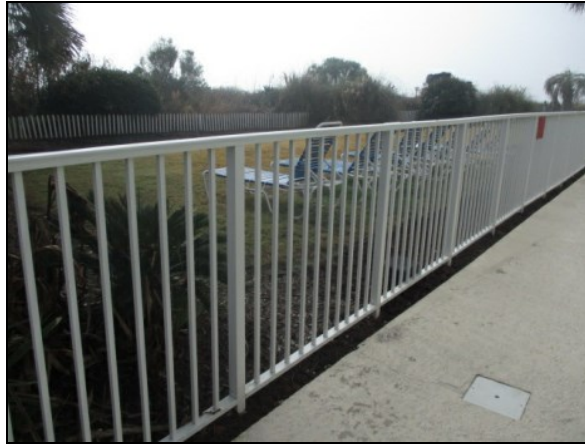
**Comp #: 27710 Pool Fencing - Aluminum****Approx Quantity: 140 LF****Location:** Perimeter of pool deck**Funded?:** Yes. Meets the CAI Reserve Study Standards three-part test.**History:** Replaced in 2018 at an unreported cost (per satellite imagery)**Comments:** Fair condition: Pool fencing determined to be in fair condition typically exhibits some minor to moderate amounts of surface wear and other signs of age, which may include corrosion, loose or unstable pieces/sections or hardware, and/or overgrowth by surrounding vegetation. Overall, appears to be in serviceable but declining condition.

We recommend that the client periodically clean fencing with an appropriate cleaner and touch up paint as needed in between regular paint cycles. Gates and locks should be inspected to make sure they close and lock properly as a faulty perimeter around a pool area can expose a Client to significant liability risk. As a routine maintenance item, fence should be inspected regularly and repaired as needed through the Operating budget to ensure safety. When evaluating replacements, be sure to comply with any applicable building codes. When possible, replacement should be coordinated with other projects, such as pool deck projects, other fencing/railing work, etc. Based on evident conditions, aesthetic standard considerations, and/or Client history provided during this engagement, we recommend replacement at the approximate interval shown below. Unless otherwise noted, cost estimates below assume replacement with a similar material/height as currently in place.

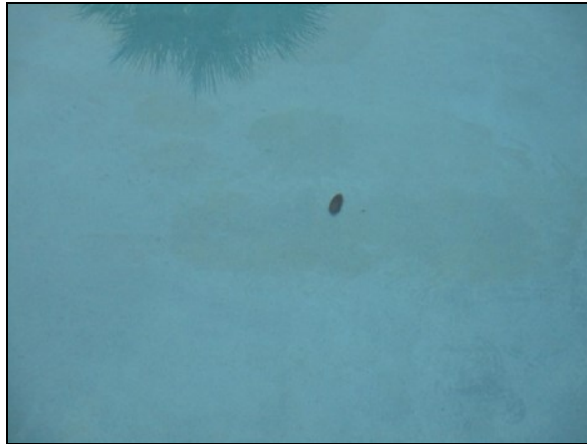
**Comp #: 27730 Pool - Resurface****Approx Quantity: 1 Lump Sum****Location:** Pool Deck (Interior surface of swimming pool)**Funded?:** Yes. Meets the CAI Reserve Study Standards three-part test.**History:****Comments:** \*NOTE: Per information provided, the pool area is shared between this property and an adjacent property. As such, the client is reportedly only responsible for 50% of the cost obligation for this component. Estimates shown below have been adjusted accordingly.

Fair to Poor condition: Swimming pools determined to be in fair to poor condition typically exhibit moderate discoloration or staining, and/or chipped, scratched or cracked areas. Pitted, rough texture is usually noticeable in many/most areas at this stage.

Minor repairs and routine cleaning/maintenance should be considered an Operating expense. Pool resurfacing will restore the aesthetic quality of the pool while protecting the actual concrete shell of the pool from deterioration. This type of project is best suited for slow/offseason to minimize downtime during periods when pool is used heavily. Should be expected at the approximate interval shown below; in some cases, schedule may need to be accelerated due to improper chemical balances or aesthetic preferences of the Client. While drained for resurfacing, any other repairs to lighting, handrails, stairs, ladders, etc. should be conducted as needed.

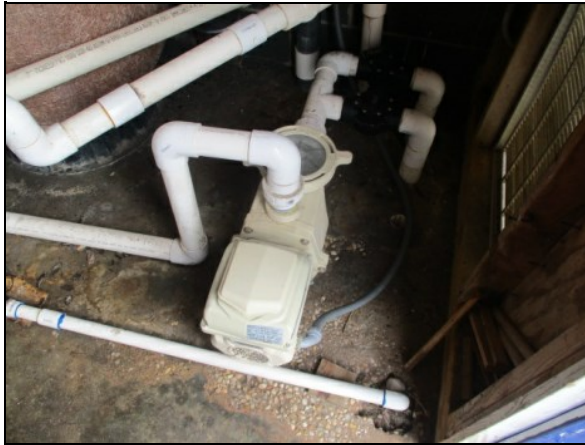
**Comp #: 27830 Pump - Pool****Approx Quantity: 1 Each****Location:** Pool equipment room**Funded?:** Yes. Meets the CAI Reserve Study Standards three-part test.**History:** Replaced in 2020 (per evident tag information)**Comments:** \*NOTE: Per information provided, the pool area is shared between this property and an adjacent property. As such, the client is reportedly only responsible for 50% of the cost obligation for this component. Estimates shown below have been adjusted accordingly.

Pumps should be inspected regularly for leaks and other mechanical problems. Minimal or no subjective/aesthetic value for pool and spa equipment. Useful life is based primarily on normal expectations for service/performance life in this location. Unless otherwise noted, remaining useful life expectancy is based primarily on original installation or last replacement/purchase date, our experience with similar systems/components, and assuming normal amount of usage and good preventive maintenance. Cost shown is based on replacement with the same types/sizes, and may include a small allowance for new piping, valve replacements, and other repairs to be conducted as needed.

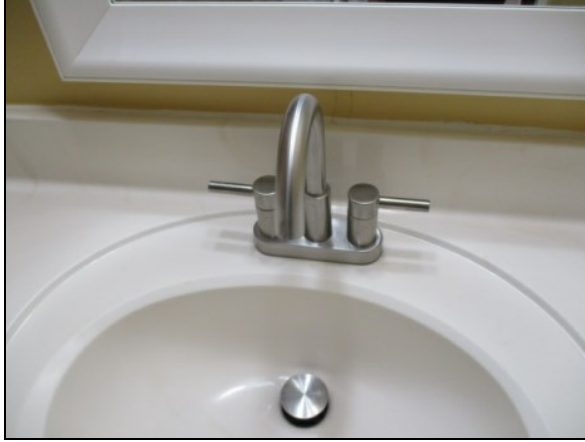
**Comp #: 29595 Faucet - Bathrooms****Approx Quantity: 50 Each****Location:** Unit/villa interiors (bathrooms)**Funded?:** Yes. Meets the CAI Reserve Study Standards three-part test.**History:****Comments:** Approximate Count Per Unit: (1)

**Remaining Life:**

10 years

**Lower Estimate:** \$ 7,880**Higher Estimate:** \$ 9,630**Cost Source:** AR Cost Database

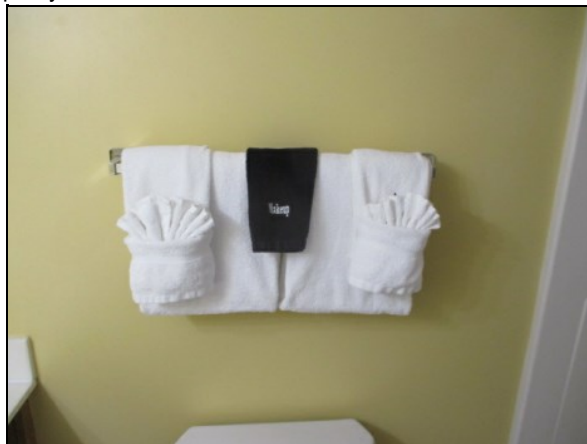
**Comp #: 29647 Bathroom Accessories****Approx Quantity: 50 Each****Location:** Unit/villa interiors (bathrooms)**Funded?:** Yes. Meets the CAI Reserve Study Standards three-part test.**History:****Comments:** \*NOTE: Bathroom accessories funding is intended to fund for replacement of mounted hardware such as ADA handrails (if present), towel bars, and toilet paper holders.

**Remaining Life:**

10 years

**Lower Estimate:** \$ 6,750**Higher Estimate:** \$ 8,250**Cost Source:** AR Cost Database

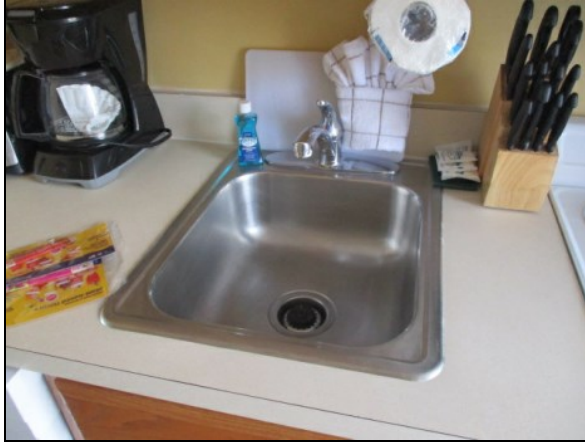
**Comp #: 29661 Faucet - Kitchen****Approx Quantity: 50 Each****Location:** Unit/villa interiors (kitchens)**Funded?:** Yes. Meets the CAI Reserve Study Standards three-part test.**History:****Comments:** Approximate Count Per Unit: (1)

**Remaining Life:**

10 years

**Lower Estimate:** \$ 10,100**Higher Estimate:** \$ 12,400**Cost Source:** AR Cost Database
