**Sample Association**  
**Mid-Rise**  
***Anywhere, CA***

# RESERVE STUDY

## Update "With-Site-Visit"

August 5, 2026

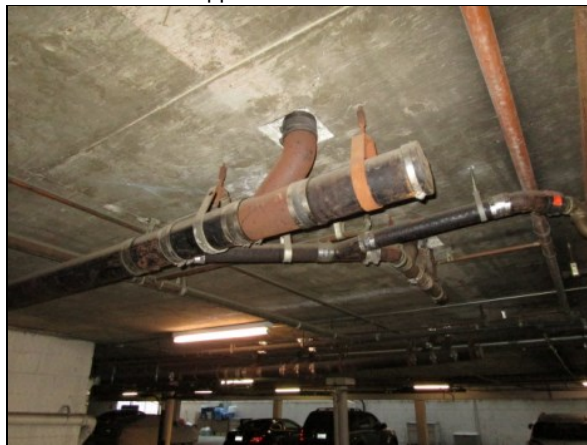
**Comments:** Minor plumbing repairs and maintenance should be conducted annually as an Operating expense. Plumbing repairs have been gradually increasing, leading association to conduct an evaluation of their plumbing lines through a qualified contractor. This included camera work at the lines, which resulted in recommendations to re-pipe the building within the next year or two. Preliminary proposals obtained revealed an approximate current cost estimate for this type of project at \$3,000-4,000/unit.
