# VACATION OWNERSHIP RESORT

## RESERVE STUDY

## Site Inspection Notes

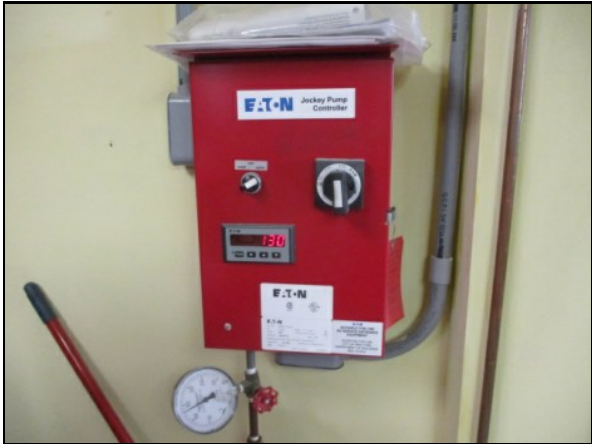
Pump was not tested during site inspection, and is assumed to be functional unless otherwise noted. The system should be inspected, tested and repaired as needed on a regular basis by qualified vendor to ensure optimal performance. Fire sprinkler/suppression pump and control panel should have a long useful life expectancy under normal circumstances, with no aesthetic priority to the Client. Over time, replacement parts may not be available and the Client may need to replace the entire pump assembly, control panel, etc prior to actual functional failure as a safety precaution. Unless otherwise noted, remaining useful life expectancy is based primarily on original installation or last replacement/purchase date, our experience with similar systems/components, and assuming normal amount of usage and good preventive maintenance. However, the Client should track and report all repair/replacement expenditures related to the pump system. This component should be re-evaluated during future Reserve Study updates to incorporate any new information available at that time.

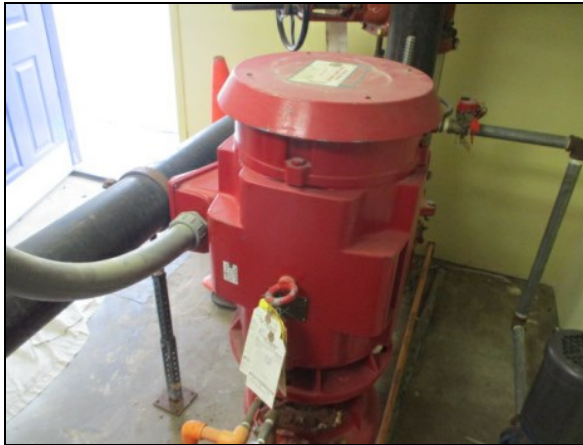
Pump was not tested during site inspection, and is assumed to be functional unless otherwise noted. The system should be inspected, tested and repaired as needed on a regular basis by qualified vendor to ensure optimal performance. Fire sprinkler/suppression pump and control panel should have a long useful life expectancy under normal circumstances, with no aesthetic priority to the Client. Over time, replacement parts may not be available and the Client may need to replace the entire pump assembly, control panel, etc prior to actual functional failure as a safety precaution. Unless otherwise noted, remaining useful life expectancy is based primarily on original installation or last replacement/purchase date, our experience with similar systems/components, and assuming normal amount of usage and good preventive maintenance. However, the Client should track and report all repair/replacement expenditures related to the pump system. This component should be re-evaluated during future Reserve Study updates to incorporate any new information available at that time.

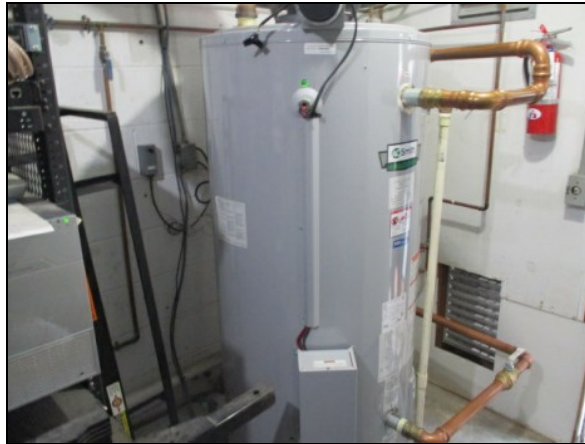
System was not tested during the inspection, but is assumed to be functional. Water heater life expectancies can vary greatly depending on level of use, type of technology, amount of preventive maintenance and other factors. Minimal or no subjective/aesthetic value for this component. Useful life is based primarily on normal expectations for service/performance life in this location. Heater should be inspected and repaired as-needed by servicing vendor or maintenance staff. Even with ongoing maintenance and repairs considered, we recommend that the Client financially prepare to replace at the approximate interval shown below. Remaining useful life expectancy is based primarily on original installation or last replacement/purchase date, our experience with similar systems/components, and assuming normal amount of usage and good preventive maintenance. When evaluating replacements, we recommend choosing high-efficiency or tankless models if possible in order to minimize energy usage.

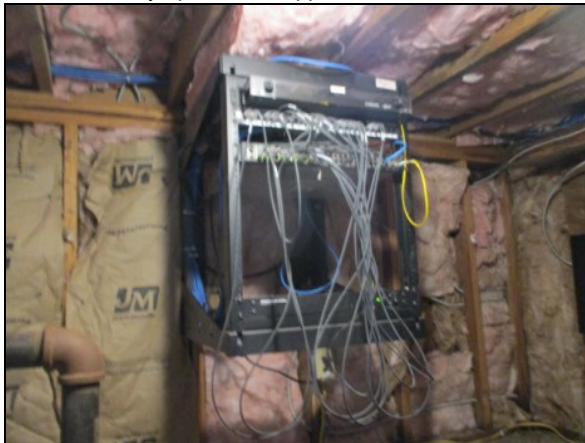
**Comments:** Minimal or no subjective/aesthetic value for this component. Useful life is based primarily on normal expectations for service/performance life in this location. Computers and other IT equipment have a relatively short useful life (depending on the application and level of use) due to advancements in technology. Plan to replace/upgrade the existing equipment at the approximate interval shown here to ensure proper function and uninterrupted service. Keep track of any partial replacements and include cost history during future Reserve Study updates as-applicable.

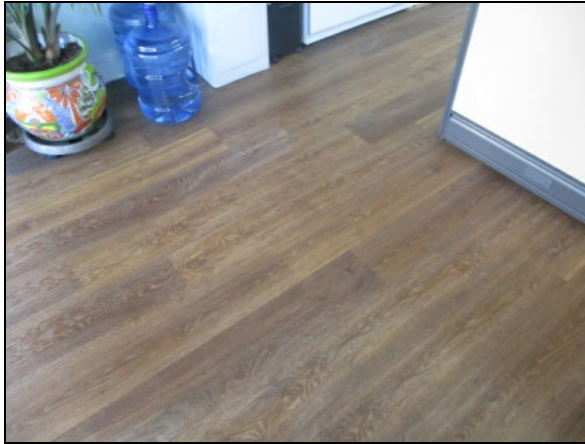
Fair condition: Vinyl/resilient determined to be in fair condition typically exhibit routine signs of age and wear, such as staining and minor cracking, tears, etc. Appearance is still generally consistent at this stage.

Aesthetic value of this type of flooring is generally lower, so condition determination is based primarily on physical condition unless otherwise noted. Higher priority for aesthetics should be considered if area is accessed by residents and guests of the property. Inspect regularly, repair any damaged areas and clean using operating/maintenance budget. Although vinyl flooring should have a very long useful life in this application, comprehensive replacement should eventually be expected to maintain good standards in the common areas. Costs can vary based on quality and style of flooring selected. Unless otherwise noted, cost estimates below assume replacement with similar quantity and quality as existing.

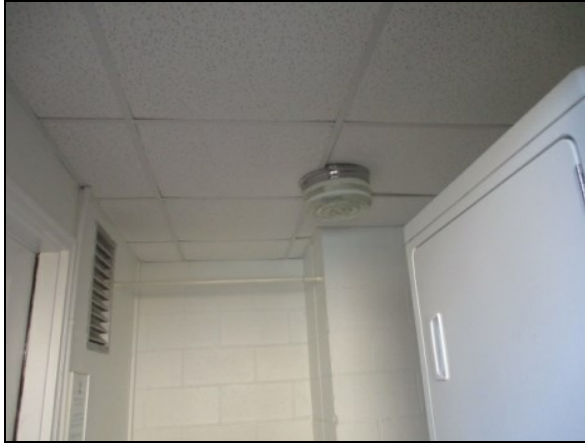
**Comments:** Fair condition: Suspended ceiling systems (AKA “drop” ceilings) determined to be in fair condition typically exhibit only routine signs of physical deterioration. Appearance is generally consistent in all areas.

Suspended ceiling systems should have a very long life under most circumstances. Individual panels should be replaced as needed through the Operating budget. Based on evident conditions, original installation date, and prior project history provided during this engagement, we recommend planning on complete replacement at the approximate interval shown below. Replacement will restore aesthetic value in the common areas. Best practice is to coordinate this work with other interior finish projects (painting, flooring, etc.) whenever possible in order to minimize downtime and maintain consistency. Unless otherwise noted, cost estimates shown below assume replacement with a similar type to the existing system.

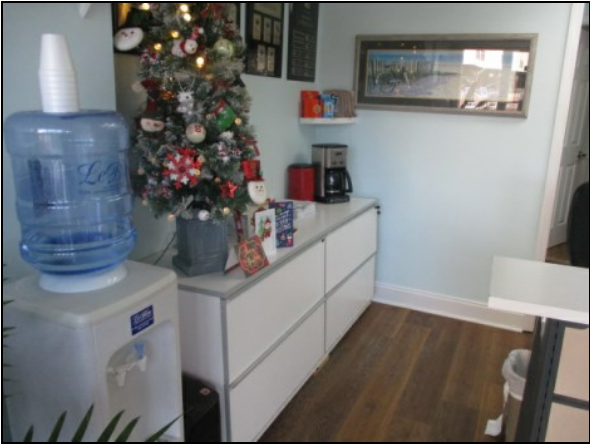
**Comments:** Fair condition: Fixtures, furnishings, and equipment (FF&E) determined to be in fair condition may exhibit light to moderate wear and tear, but are still in generally serviceable condition. Style is consistent but may be becoming outdated at this stage.

Individual fixtures, furnishings, and/or equipment (FF&E) pieces should be repaired/replaced as needed by the Client. Based on evident conditions and/or information provided during this engagement, this component represents a “supplemental” allowance for replacement/refurbishment of interior FF&E in order to maintain a desirable aesthetic in the common areas. Remaining useful life shown below is based on consideration of asset conditions as well as Client replacement history. Costs of replacement can vary greatly depending the style and quality of replacement options. Best practice is to coordinate this type of project with other interior projects such as flooring replacement, painting, etc. Moving forward, the Client should track and report all replacement expenditures related to this component. This component should then be re-evaluated during future Reserve Study Updates based on the most current information available at that time.

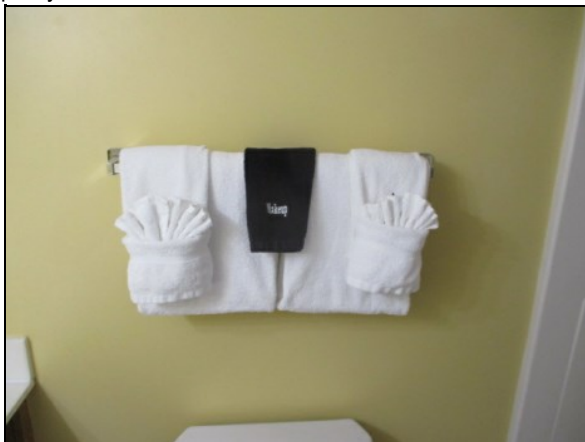
**Comp #: 29647 Bathroom Accessories****Approx Quantity: 50 Each****Location:** Unit/villa interiors (bathrooms)**Funded?:** Yes. Meets the CAI Reserve Study Standards three-part test.**History:****Comments:** \*NOTE: Bathroom accessories funding is intended to fund for replacement of mounted hardware such as ADA handrails (if present), towel bars, and toilet paper holders.

**Useful Life:**  
14 years**Remaining Life:**  
10 years
