ASSOCIATION RESERVES™

Welcome to your Reserve Study!

Reserve Study is a valuable tool to help you budget responsibly for your property. This report contains all the information you need to avoid surprise expenses, make informed decisions, save money, and protect property values.

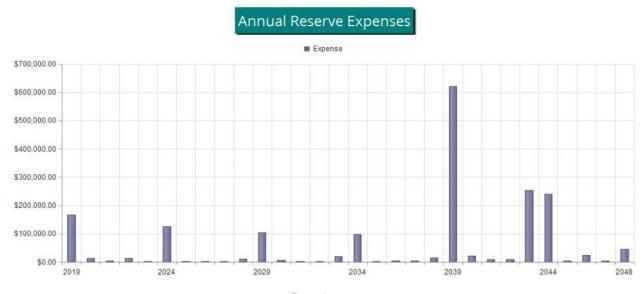
The figure below summarizes the projected future expenses at your property as defined by your Reserve Component List. A summary of these components are shown in the Component Details table, while a summary of the expenses themselves are shown in the 30-yr Expense Summary table. Note the future years of high projected Reserve expenses. Note the significant cyclical nature of expenses, with a number of projects "due" to be accomplished at this time. Looking ahead, the large expense year in approx 20 yrs is the anticipated water tower replacement project.

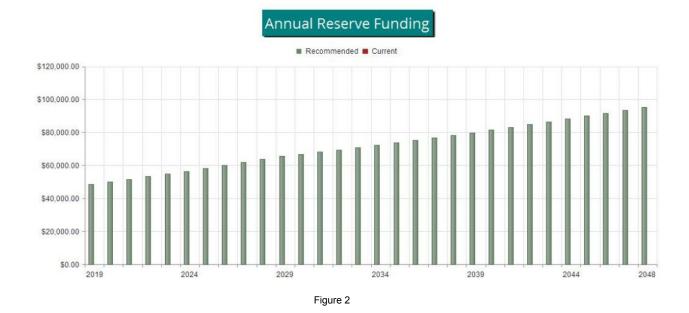
Based on your current Percent Funded and your near-term and long-term Reserve needs, we are recommending budgeted contributions of \$48,760 per month this Fiscal Year along with a one-time cash infusion (special assessment) of \$95,840. The overall 30-yr plan, in perspective, is shown below. This same information is shown numerically in both the 30-yr Summary and the Cash Flow Detail tables.

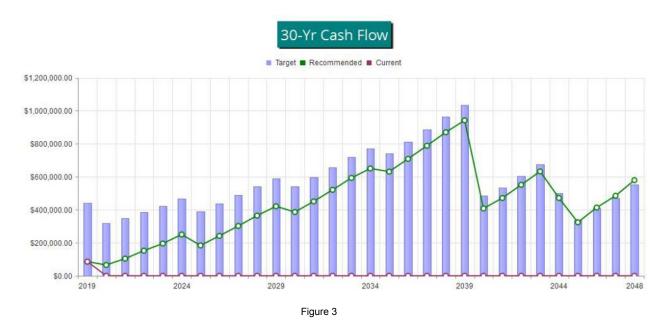
The following chart shows your Reserve balance under our recommended Full Funding Plan and at your current budgeted contribution rate, compared to your always-changing Fully Funded Balance target.

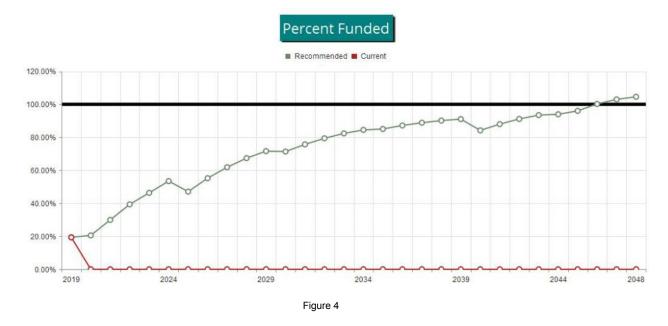
This figure shows the same information plotted on a Percent Funded scale. It is clear here to see how your Reserve Fund strength approaches the 100% Funded level under our recommended multi-yr Funding Plan.
