Sample Vacation Ownership Property *Anywhere, NC*

Report #: 17918-1
Beginning: January 1, 2026
Expires: December 31, 2026

RESERVE STUDY Update "With-Site-Visit"

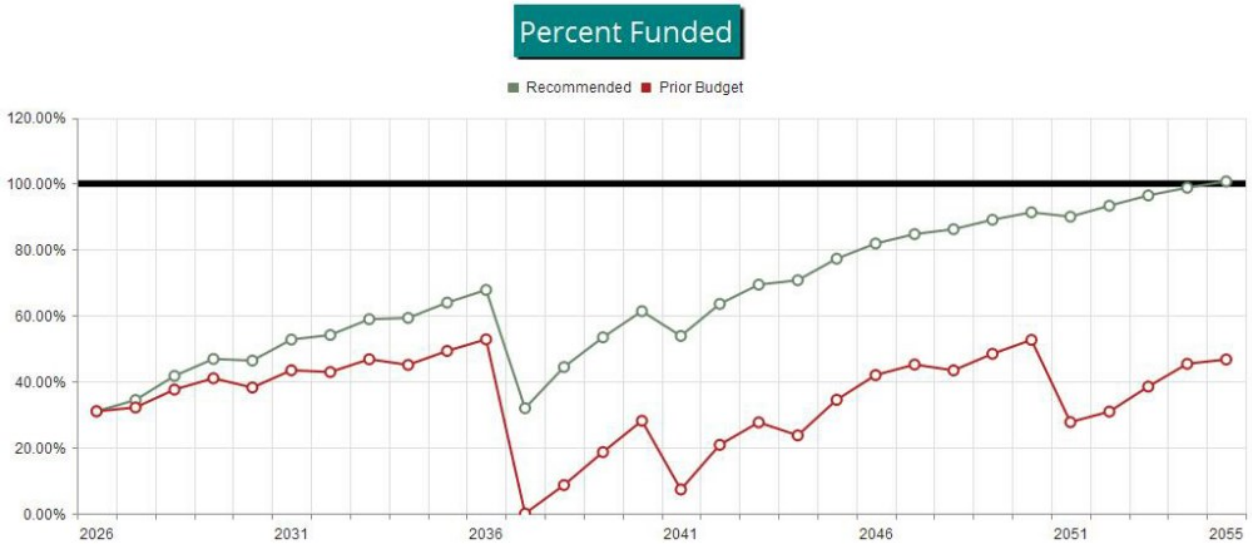
Figure 4

This figure shows the same information plotted on a Percent Funded scale. It is clear here to see how your Reserve Fund strength approaches the 100% Funded level under our recommended multi-yr Funding Plan.

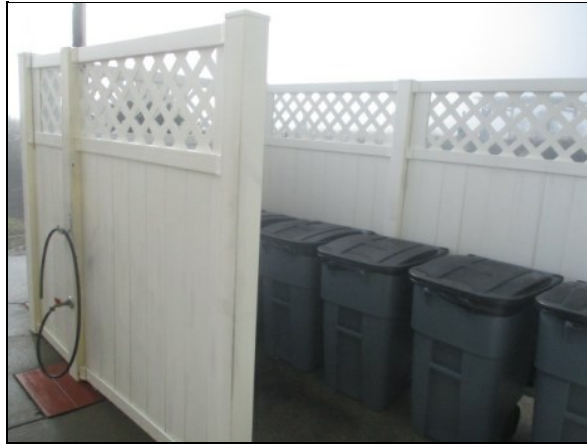
Useful Life:
20 years

Remaining Life:
5 years

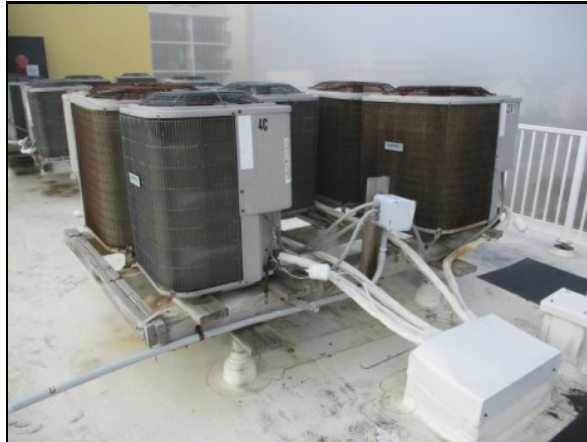
Comments: *NOTE: The remaining useful life of this component has been adjusted to cycle replacement of the HVAC stands with replacement of the single ply roofing (component #23780).

Minimal or no subjective/aesthetic value for this component. Useful life is based primarily on normal expectations for service/performance life in this location. We recommend that routine repairs and maintenance be budgeted as an Operating expense. Funding estimates shown below are for structures similar to existing, although the stands may need to be raised for code purposes.

Useful Life:
30 years

Remaining Life:
5 years

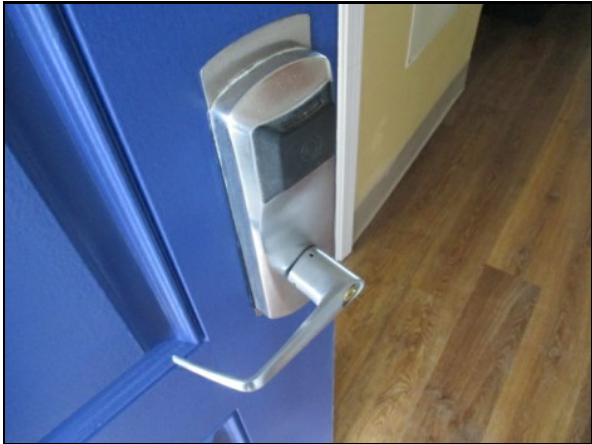
History: Readers/locks replaced in 2025 at an approximate cost of \$19,827 (per information provided)

Reader devices are assumed to be functional. Minimal or no subjective/aesthetic value for this component. Individual readers can often be replaced as an Operating expense due to damage or localized failures. Due to use, exposure, and advancements in technology, we recommend to plan for replacement of devices and control system at the approximate interval shown below. To ensure a functional, compatible system and obtain better pricing, plan on replacing all devices together as one project. Any partial repair and/or replacement expenditures should be tracked, and this component should be re-evaluated during future Reserve Study updates based on most recent information and data available.

Useful Life:
10 years

Remaining Life:
9 years

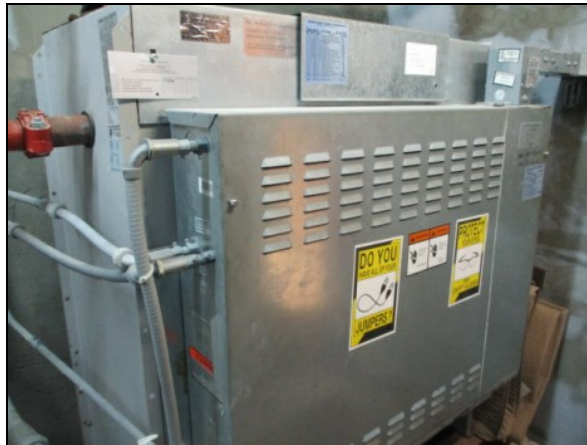
Elevators should be inspected regularly and tested as a preventive maintenance expense. A modernization project typically includes replacement/upgrade of controller, mechanical door equipment, push-button fixtures, and minor electrical work or fire alarm work by others (such as code-required changes, etc.). Traction elevators may require replacement of the hoist machine and hydraulic elevators may require replacement of the hydraulic pumping unit, but replacement depends on the functionality, age, and integration potential of the respective systems. We recommend thorough evaluation of these components by qualified professionals in order to determine whether they will need to be included with the scope of work for modernization. Elevator vendors typically recommend modernization cycles every 20-30 years for continued smooth, safe operation, technology advances and/or code changes. In our experience, actual interval will typically vary depending on level of use, maintenance, availability of replacement parts, etc. For coastal properties or those where the elevator equipment is more exposed to environmental factors, useful life can be closer to 15-20 years. Properties with higher levels of use and/or instances of vandalism can also experience shorter useful lives. When remaining useful life is below 5 years, we recommend beginning discussion with your elevator vendor to determine the most cost effective specifications and approach to a modernization project. Modernization should be anticipated and planned proactively, as lead time for required parts can be months-long if done on short notice. To minimize elevator downtime, schedule the project ahead of time and consult with elevator vendor for more information. Some properties opt to hire an elevator consultant to draft a scope of work and oversee the process of obtaining estimates, and installation for compliance. Costs shown here may need to be re-evaluated during future Reserve Study updates depending on scopes of work (such as unpredictable electrical/fire safety code changes, machinery replacement, etc.) and should be monitored during future Reserve Study updates.

Useful Life:
25 years

Remaining Life:
7 years

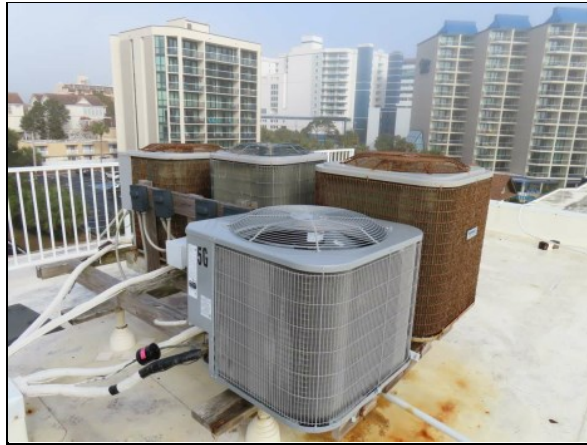
Comp #: 25230 HVAC - Partial Replace Allowance

Comments: *NOTE: There were varied ages and conditions evident for all systems throughout the property. For that reason, an annual allowance has been incorporated for ongoing replacement of approximately (5) systems per year. Actual replacement projects and history should be tracked by the client moving forward and reported during future Reserve Study updates. This component can then be re-evaluated based on the most current information available at that time.

GENERAL INFORMATION: Minimal or no subjective/aesthetic value for this component. Useful life is based primarily on normal expectations for service/performance life in this location. We recommend that routine repairs and maintenance such as filter replacements, system flushing, etc. be budgeted as an Operating expense. Useful life can often be extended with proactive service and maintenance. Remaining useful life expectancy is based primarily on original installation or last replacement/purchase date, our experience with similar systems/components, and assuming normal amount of usage and good preventive maintenance. Funding estimates shown below are for system(s) with same type and size/capacity as the current system. For split systems, we recommend budgeting to replace the entire system (condensing unit and air handler) together in order to obtain better unit pricing and ensure maximum efficiency, refrigerant compatibility, etc. If additional costs are expected during replacement, such as for system reconfiguration or expansion, ductwork repairs, electrical work, etc. costs should be re-evaluated and adjusted as needed during future Reserve Study updates.

Useful Life:
1 years

Remaining Life:
0 years

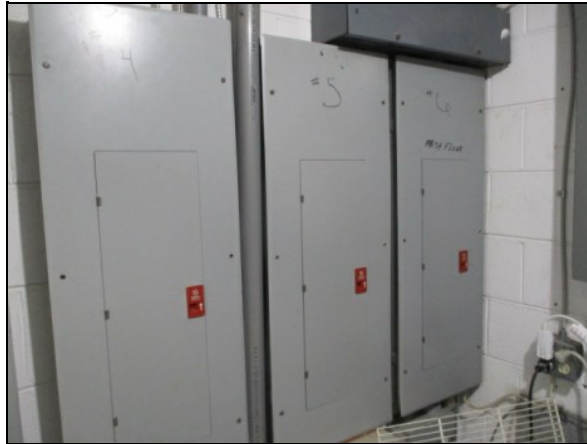
Comp #: 25510 Electrical System - Inspect/Repair

Comments: Detailed analysis of electrical infrastructure is not included within the scope of this Reserve Study. Some electrical system components used historically have been found to be life-limited, but even when component failures occur, the predictability of such failures in terms of frequency and scope is very difficult to determine. Manufacturing defects may become apparent from time to time and certain site conditions can contribute to premature deterioration of system components. Typically, if installed per architectural specifications and local building codes, there is no predictable time frame for large scale repair/replacement expenses within the scope of our report. In our experience working with similar Clients, service life typically lasts well beyond rated life of components. Treat minor repairs as ongoing maintenance expense. Periodic inspections of distribution system by qualified electrician are wise to clean and tighten, exercise breakers, etc. Some Clients employ infrared or other testing methodologies to identify trouble spots and potential hazards. Based on information provided by the client, this component includes a "supplemental" allowance for future inspection of electrical panels and infrastructure, with repairs to be completed as needed. However, this is not a guarantee of anticipated cost and we recommend that the Client consult with a qualified vendor to determine anticipated scopes of work and requisite costs. This component should then be re-evaluated during future Reserve Study updates based on the most current information available at that time.

Useful Life:
10 years

Remaining Life:
5 years

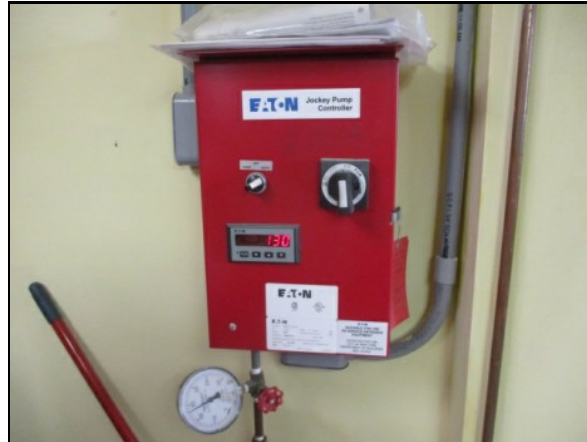
Pump was not tested during site inspection, and is assumed to be functional unless otherwise noted. The system should be inspected, tested and repaired as needed on a regular basis by qualified vendor to ensure optimal performance. Fire sprinkler/suppression pump and control panel should have a long useful life expectancy under normal circumstances, with no aesthetic priority to the Client. Over time, replacement parts may not be available and the Client may need to replace the entire pump assembly, control panel, etc prior to actual functional failure as a safety precaution. Unless otherwise noted, remaining useful life expectancy is based primarily on original installation or last replacement/purchase date, our experience with similar systems/components, and assuming normal amount of usage and good preventive maintenance. However, the Client should track and report all repair/replacement expenditures related to the pump system. This component should be re-evaluated during future Reserve Study updates to incorporate any new information available at that time.

Useful Life:
20 years

Remaining Life:
10 years

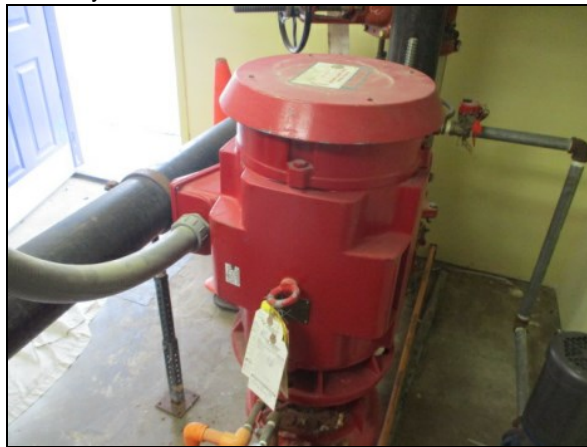
2016: Main and jockey pump systems installed/replaced (per evident tag information)

Pump was not tested during site inspection, and is assumed to be functional unless otherwise noted. The system should be inspected, tested and repaired as needed on a regular basis by qualified vendor to ensure optimal performance. Fire sprinkler/suppression pump and control panel should have a long useful life expectancy under normal circumstances, with no aesthetic priority to the Client. Over time, replacement parts may not be available and the Client may need to replace the entire pump assembly, control panel, etc prior to actual functional failure as a safety precaution. Unless otherwise noted, remaining useful life expectancy is based primarily on original installation or last replacement/purchase date, our experience with similar systems/components, and assuming normal amount of usage and good preventive maintenance. However, the Client should track and report all repair/replacement expenditures related to the pump system. This component should be re-evaluated during future Reserve Study updates to incorporate any new information available at that time.

Useful Life:
30 years

Remaining Life:
20 years

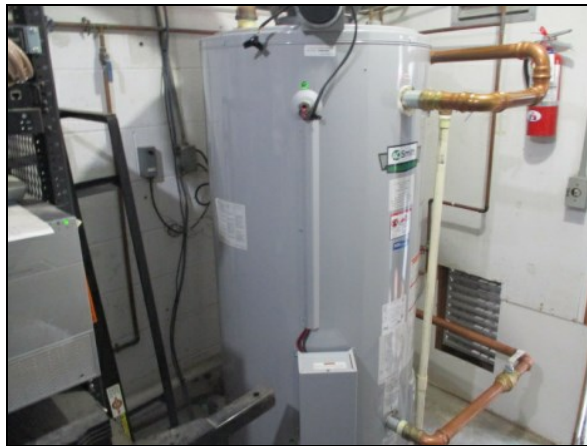
2020: System replaced at an approximate cost of \$10,500 (per information provided)

System was not tested during the inspection, but is assumed to be functional. Water heater life expectancies can vary greatly depending on level of use, type of technology, amount of preventive maintenance and other factors. Minimal or no subjective/aesthetic value for this component. Useful life is based primarily on normal expectations for service/performance life in this location. Heater should be inspected and repaired as-needed by servicing vendor or maintenance staff. Even with ongoing maintenance and repairs considered, we recommend that the Client financially prepare to replace at the approximate interval shown below. Remaining useful life expectancy is based primarily on original installation or last replacement/purchase date, our experience with similar systems/components, and assuming normal amount of usage and good preventive maintenance. When evaluating replacements, we recommend choosing high-efficiency or tankless models if possible in order to minimize energy usage.

Useful Life:
20 years

Remaining Life:
14 years

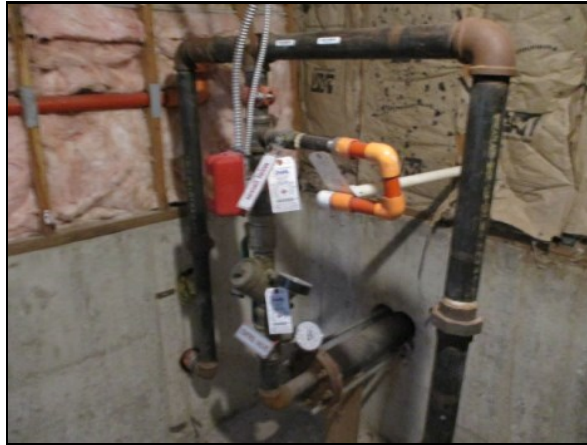
Comp #: 25790 Plumbing - Inspect/Repair Allowance

Useful Life:
5 years

Remaining Life:
2 years
