Client: 9999vp Vacation Ownership - Interiors

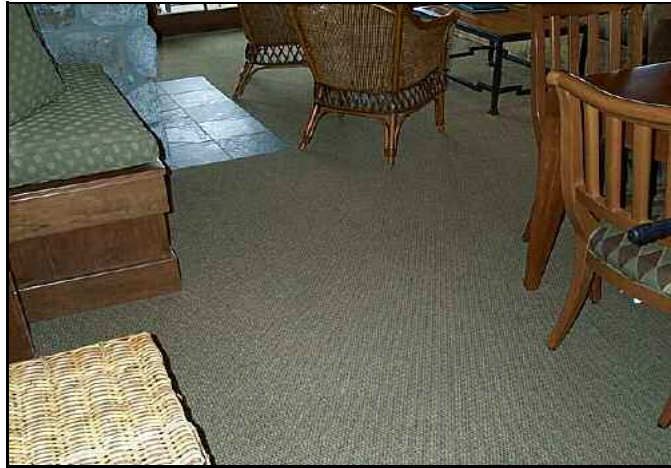
Comp #: 2101 Villa Carpet - Replace

Location: LR & Bdrm flooring of all 40 villas

Evaluation: Generally good condition. Minor wear and stains. No loose seams or significant deterioration noted.

Useful Life:
6 years

Remaining Life:
3 years

Lower est for replacement carpet, installed @
\$35/Sq Yd

Higher estimate, \$45/Sq Yd

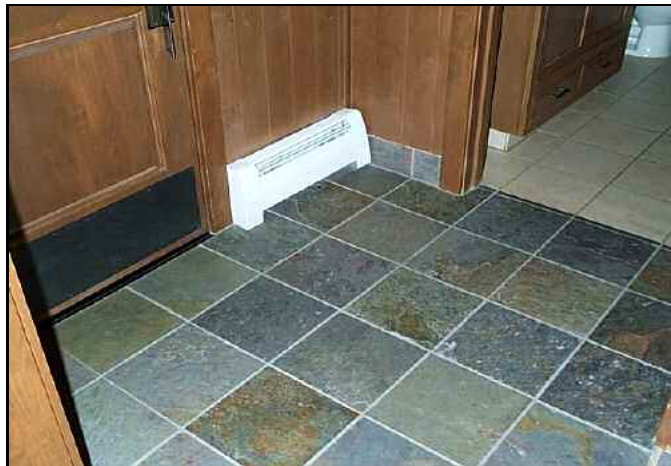
Comp #: 2102 Villa Slate/Tile Floor - Replace

Location: Entryway, kitchen, and bathrooms of all 40 villas

Evaluation: Good general condition. No chips or cracks, no grout loss, no unevenness. No problems noted in all areas inspected. Expect to eventually replace due to aesthetic reasons, not physical wear & tear.

Useful Life:
18 years

Remaining Life:
15 years

Lower estimate to remove and replace, \$20/Sq Ft

Higher estimate, addnl material or labor costs,
\$27.50/Sq Ft

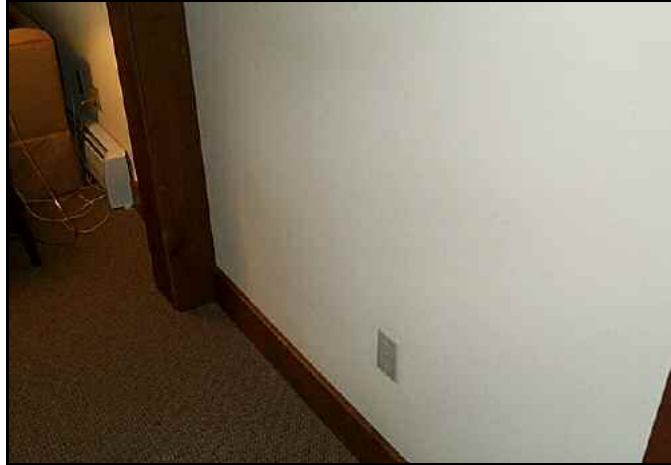
Comp #: 2210 Villa Interior - Repaint

Location: Interior wall surfaces of all units.

Evaluation: Currently painted with a "flat" finish. Minor scuffs and marks showing. No advanced or unsightly deterioration, but expect to repaint with a semi-gloss at next opportunity.

Lower estimate to prep and paint, \$2250/unit

Higher estimate, \$2800/unit

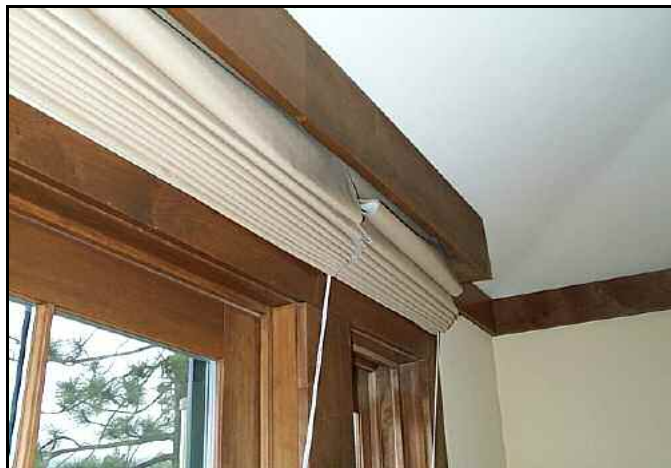
Comp #: 2230 Window Treatments - Replace

Location: Each bedroom window area + LR

Evaluation: Wood mini-blinds (bdrm), fabric drapes (bdrm), and vertical block-outs in LR. Bedroom drapes have no open/close mechanism. Good condition observed in all areas. Expect to replace as part of soft goods replacement project.

Lower estimate for replacement of all window treatments, \$1150/unit

Higher estimate, \$1550/unit

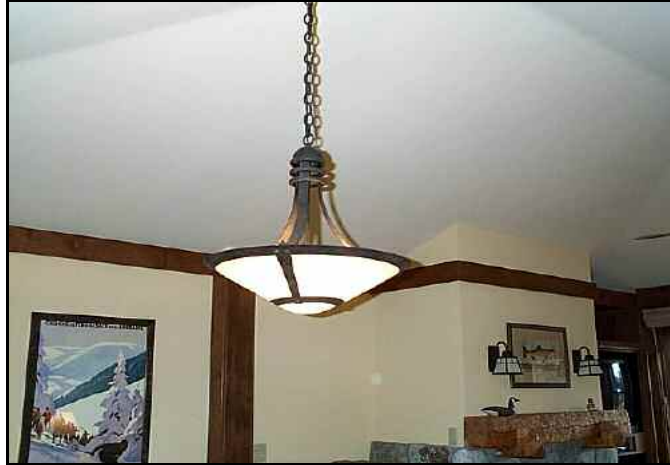
Comp #: 2240 Villa Lighting - Replace

Location: Living Rm, Bedrooms, Dining area (shown), and bathrooms

Evaluation: All fixtures are attractive and functional. Expect to change out a fraction of fixtures that are not built-in to unit (like recessed ceiling fixtures) as part of case goods replacement project.

Lower estimate for (15) replacement lights per unit,
\$125 ea fixture

Higher estimate, \$175 ea fixture

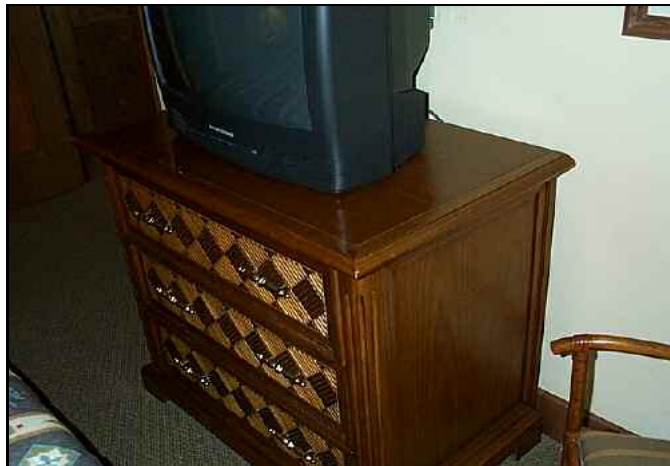
Comp #: 2301 Case Goods - Replace

Location: Living rooms, dining areas, and bedrooms of all 40 villas

Evaluation: General good condition. Minor scuffing on dining chair and barstool legs, moderate scuffing on Master Bedroom dresser top (from TV movement). No problems noted, no accelerated deterioration noted (except for master bdrm dresser, which could/should be replaced with a unit that is not as deep).

Lower estimate for replacement of all case goods,
\$9725/unit

Higher estimate, \$12500/unit

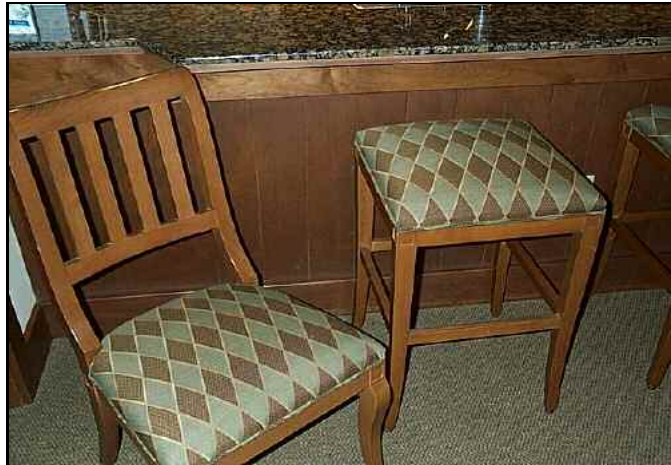
Comp #: 2310 Soft Goods - Replace

Location: Dining, Living rm, and bedroom areas of villas

Evaluation: Sofabed, (3) bedspreads, reupholstering of all seating areas, and shower curtain (guest bathroom). General good condition, no glaring problems noted (accelerated wear or abuse). Expect to keep on a regular cycle to maintain an attractive appearance throughout units.

Lower estimate for replacement of all soft goods,
\$3575/unit

Higher estimate, \$4600/unit

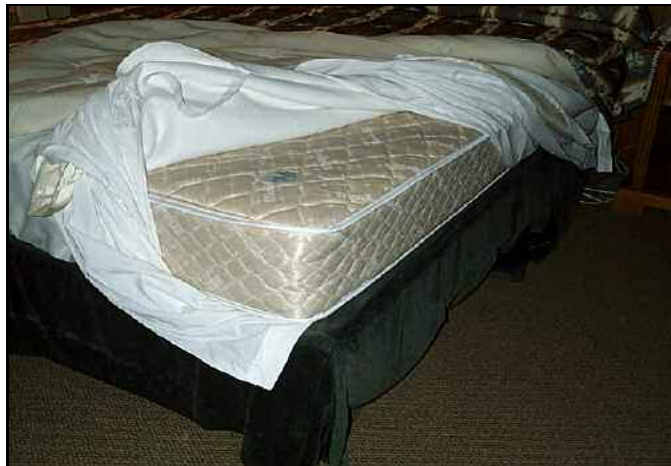
Comp #: 2325 Mattresses - Replace

Location: (1) king in Master Bedroom (shown), (2) double-beds in Guest Bedroom

Evaluation: Good condition observed, no problems reported. Assume rotated regularly. Expect to replace on same cycle as soft goods.

Lower estimate to replace all mattresses, \$900/unit

Higher estimate, \$1250/unit

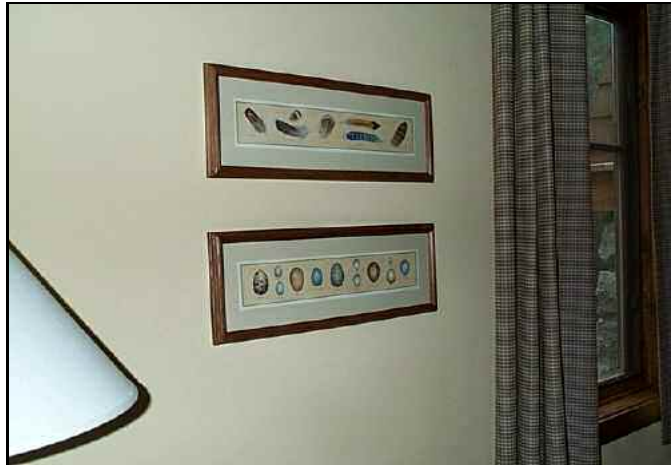
Comp #: 2330 Artwork/Décor - Replace

Location: Scattered throughout villas

Evaluation: Wall-mounted items, small items on countertop or mantelpiece. All in good, attractive condition when inspected, but expect that these will need to be replaced on the same cycle as soft goods for continuity of appearance and styling.

Lower estimate to replace all small decorative items, \$850/unit

Higher estimate, \$1200/unit

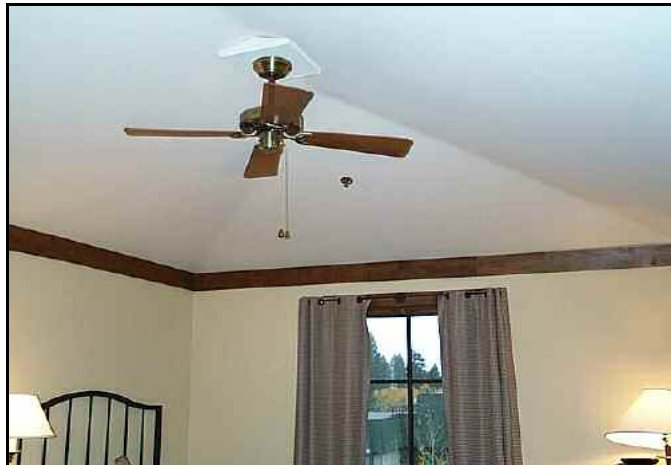
Comp #: 2340 Ceiling Fan - Replace

Location: Living rm and each bedroom

Evaluation: Ceiling fans generally have a long useful life, but as mechanical components they are subject to breakdown on an irregular basis due to varied usage. Expect to replace individually as required on a maintenance basis, not in bulk as a Reserve expense.

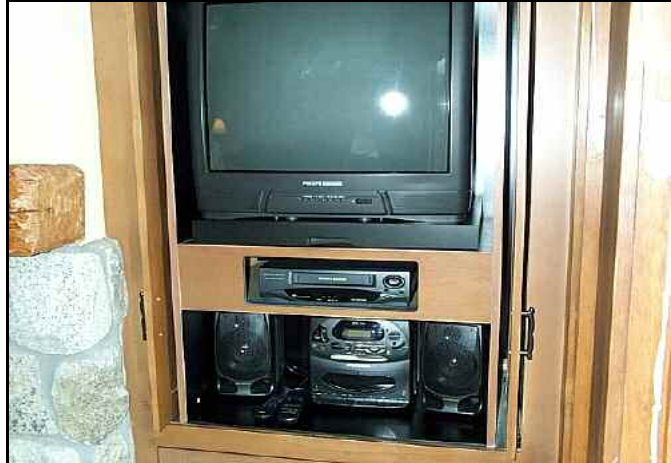
Comp #: 2360 TV/VCR - Replace

Location: Larger TV & VCP in LR, other TVs on dressers in bedrooms

Evaluation: Good Philips brand equipment. All modern in appearance, all in good functional condition. Expect to replace roughly in sequence with soft goods replacement cycle, changing VCPs to DVD players

Lower estimate for replacement TV eqp, \$950/unit

Higher estimate, \$1150/unit

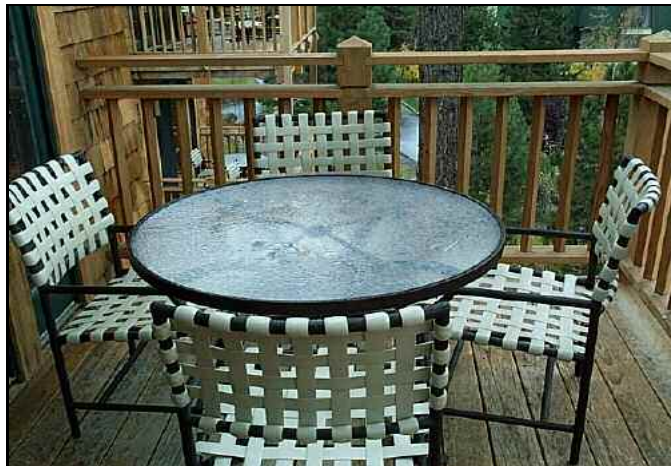
Comp #: 2410 Balcony/Patio Furniture - Replace

Location: Balcony or patio of each villa

Evaluation: (4) chair, (1) table with plastic top. Good general condition. Full outdoor weather exposure. Minimal staining on webbing, minimal chipping on frames.

Lower estimate to replace with similar set, \$550/set

Higher estimate, \$700/set

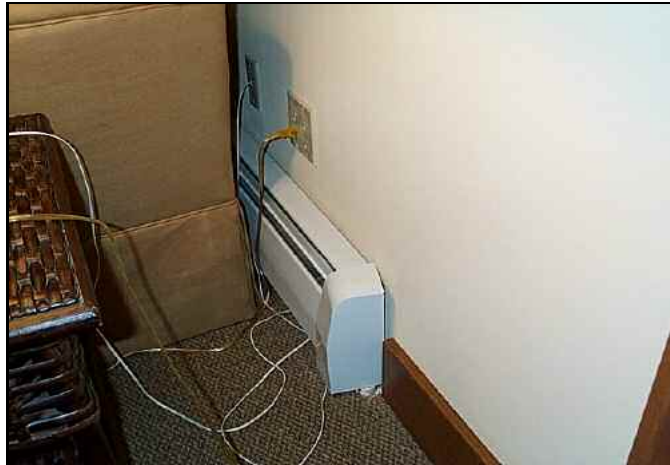
Comp #: 2520 Baseboard Heaters - Replace

Location: Entry, Living Rm, and (2) ea in Master bdrm and Guest Bdrm for a total of 6/unit

Evaluation: Generally good condition observed. Some minor mechanical damage due to bumping. As association ages, expect local random repairs and replacements. Expect to handle these on an ongoing maintenance basis, not in bulk as a Reserve project.

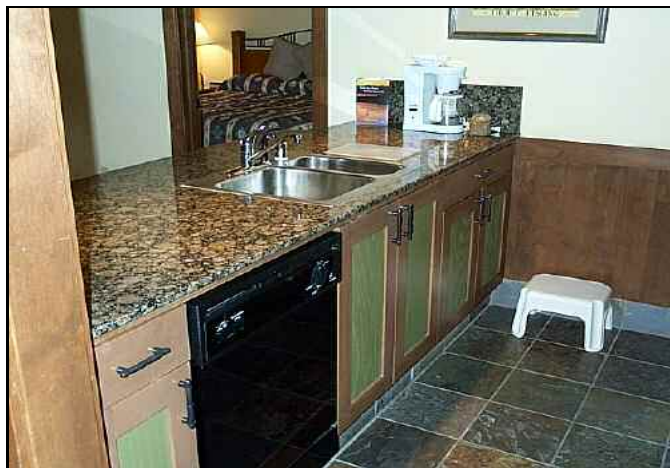
Comp #: 2601 Kitchen - Refurbish

Location: Adjacent to entryway

Evaluation: Granite countertops are clean, shiny, and attractive. Cabinets are two-tone wood, with simple hinges and handles. Stainless steel sink with disposal. All areas are good general condition and appearance.

Lower estimate for new cabinetry, sink, and refurbishing of countertops, \$4500 ea kitchen

Higher estimate, \$6500 ea location

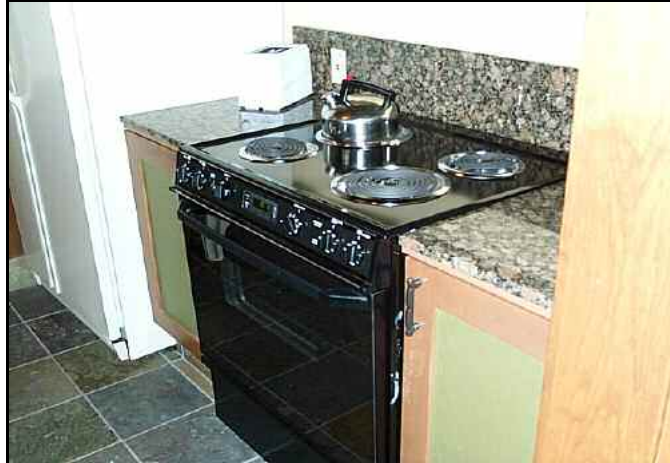
Comp #: 2602 DW, Fridge, Range - Replace

Location: Kitchens

Evaluation: GE side-by-side refrig, GE Potscrubber DW, GE range with mechanical controls. All appliances in good condition with minimal wear, no abuse noted.

Lower estimate to replace with similar pieces,
\$1800/unit

Higher estimate, \$2650/unit

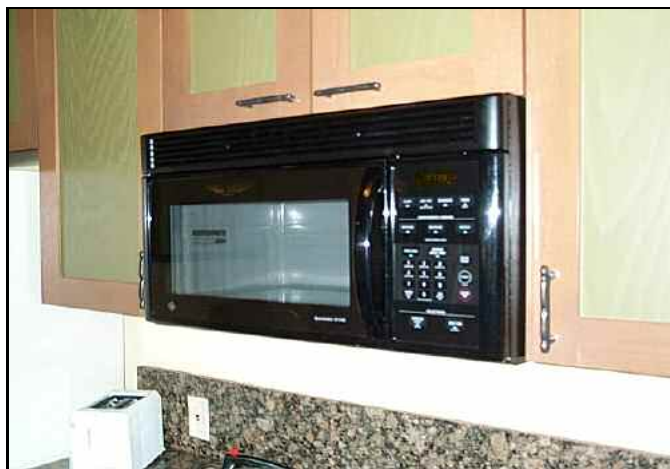
Comp #: 2613 Microwave - Replace

Location: Kitchen

Evaluation: Model XL1400. Good condition when inspected. All digital display and controls. Expect to replace more frequently than other kitchen appliances due to usage and construction

Lower estimate to replace with similar unit, \$225 ea

Higher estimate, \$275 ea

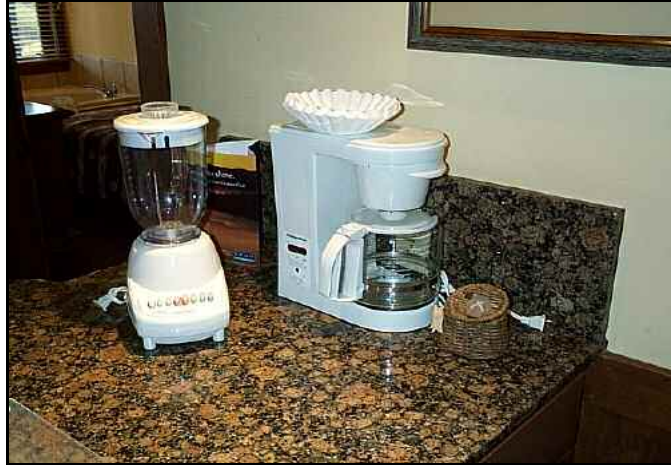
Comp #: 2615 **Small Appliances - Replace**

Location: Kitchen and bathrooms of units

Evaluation: Coffee maker, toaster, blender, hair dryer, etc. Individually small components with small replacement costs. Expect to replace individually as consumables, not in bulk as Reserve projects.

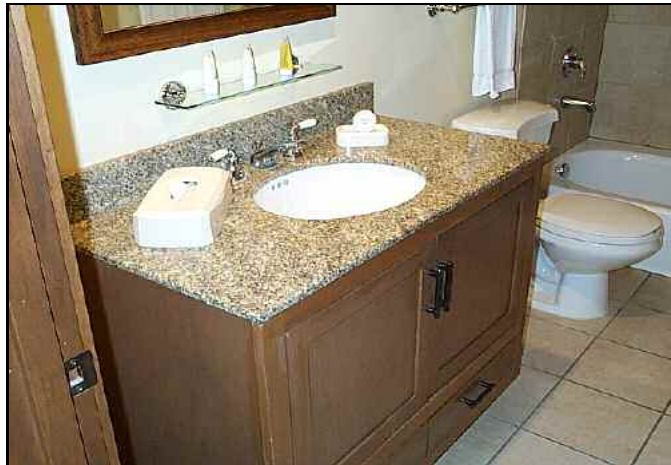
Comp #: 2701 **Bathroom - Refurbish**

Location: Adjacent to bedrooms of each unit

Evaluation: Painted with interior repaint project #2210, tile floor replaced with slate/tile floor project #2102. Same granite countertop as kitchen. Nice wood cabinetry (similar to kitchen styling), with some water stains generally worse in Master bathroom. Shiny chrome fixtures. Master has glass enclosure shower, guest (shown) has tub/shower combination.

Lower estimate to refurbish @ \$3500 ea bathroom (2/villa)

Higher estimate, \$4500 ea
